Joe Kellett Arboriculture

Tree Impact Assessment

Client: ZC Wood Pty Ltd

Site: 31–33 High Street Rd, Ashwood 3147

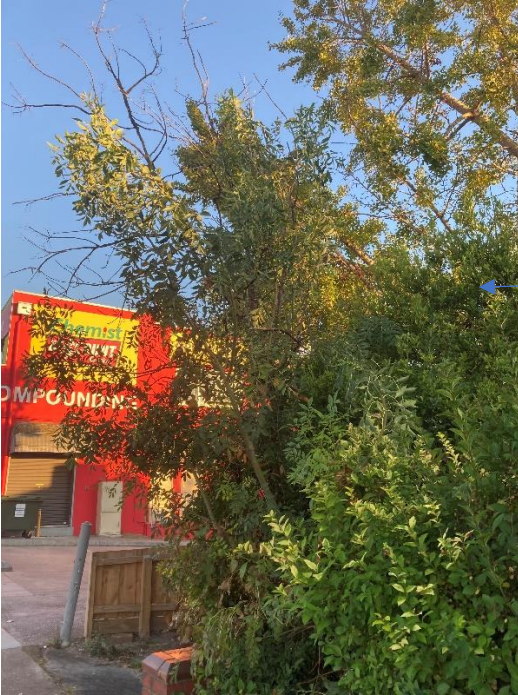
Tree 1 is a *Fraxinus angustifolia* subsp. *angustifolia* (Desert Ash), this exotic tree is a problematic weed tree in our urban landscape. It has been marked for removal to reduce its spread through the local area. It is growing in the front set back and is clear of the proposed building envelope and would not be directly affected by this proposal. Tree 2 is a *Citrus japonica* (Kumquat), this small exotic is growing on the southern boundary, clear of the proposed building envelope. It therefore would not be directly impacted by this proposal. It is suffering from scale infestation, lack of sunlight and long-term neglect; it will not reach its potential and has therefore been marked for removal. It would not be missed in the rejuvenation of this landscape.

Photo A shows Tree 1 a *Fraxinus angustifolia* subsp. *angustifolia* (Desert Ash) as seen from the south east. This exotic weed tree is dying back and has been marked for removal. The blue arrow indicates tree 2 a *Citrus japonica* (Kumquat) growing next to the driveway.

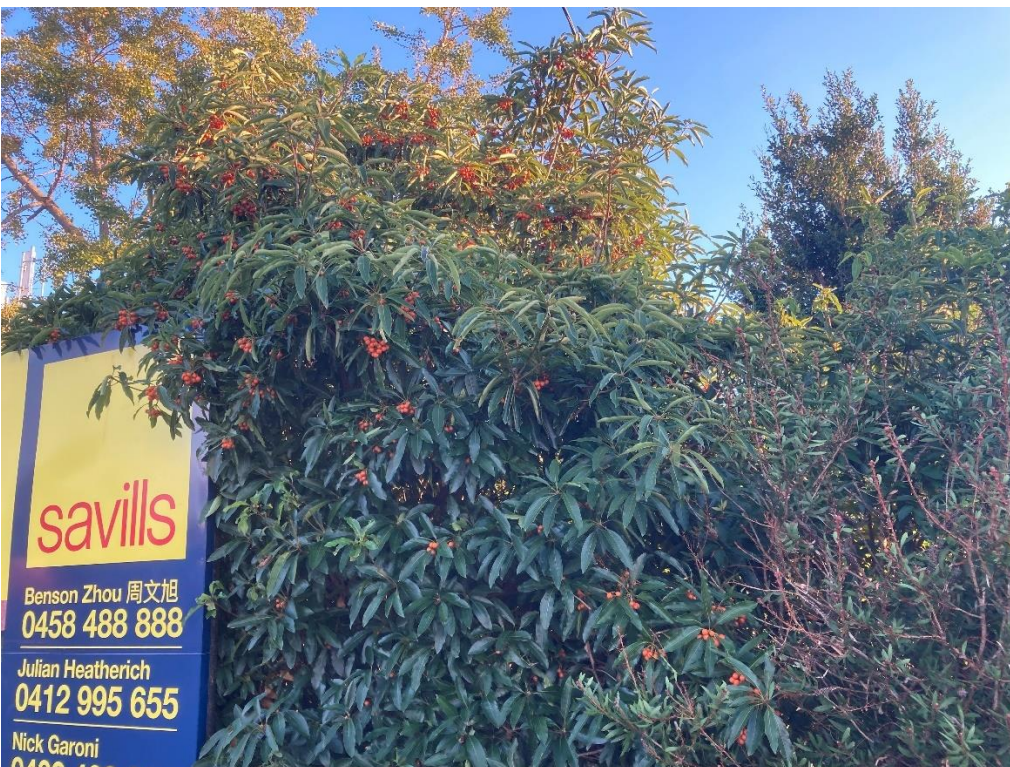
Photo B shows Tree 3 a *Pittosporum undulatum* (Sweet Pittosporum) as seen from the south east. This native is a problematic weed tree and has been marked for removal.

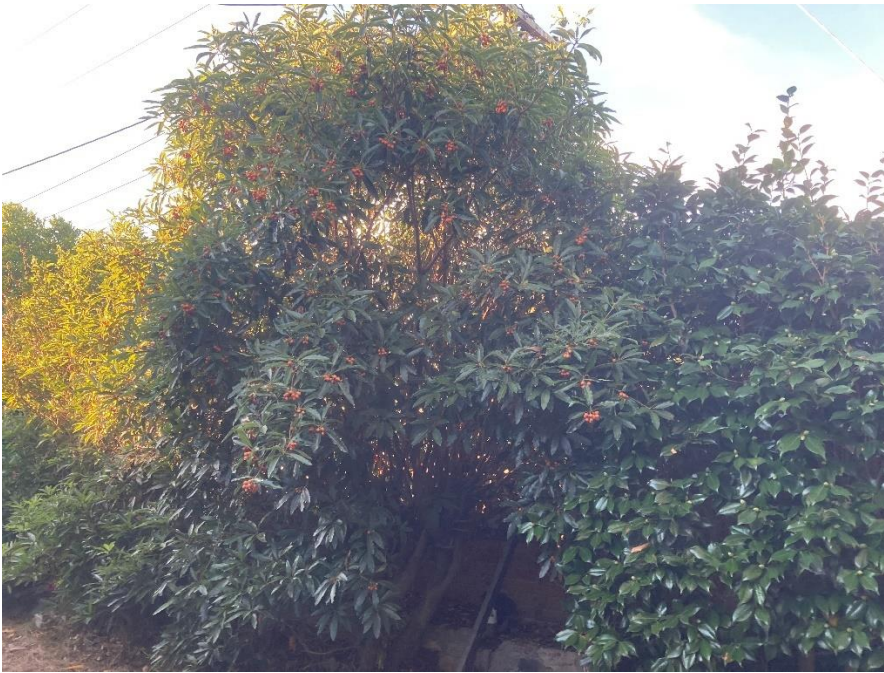
Photo C shows Tree 4 a *Pittosporum undulatum* (Sweet Pittosporum) as seen from the south east. On the right of shot is Tree 5 a *Camellia japonica* (Camellia); both are marked for removal to allow for the rejuvenation of this neglected landscape.

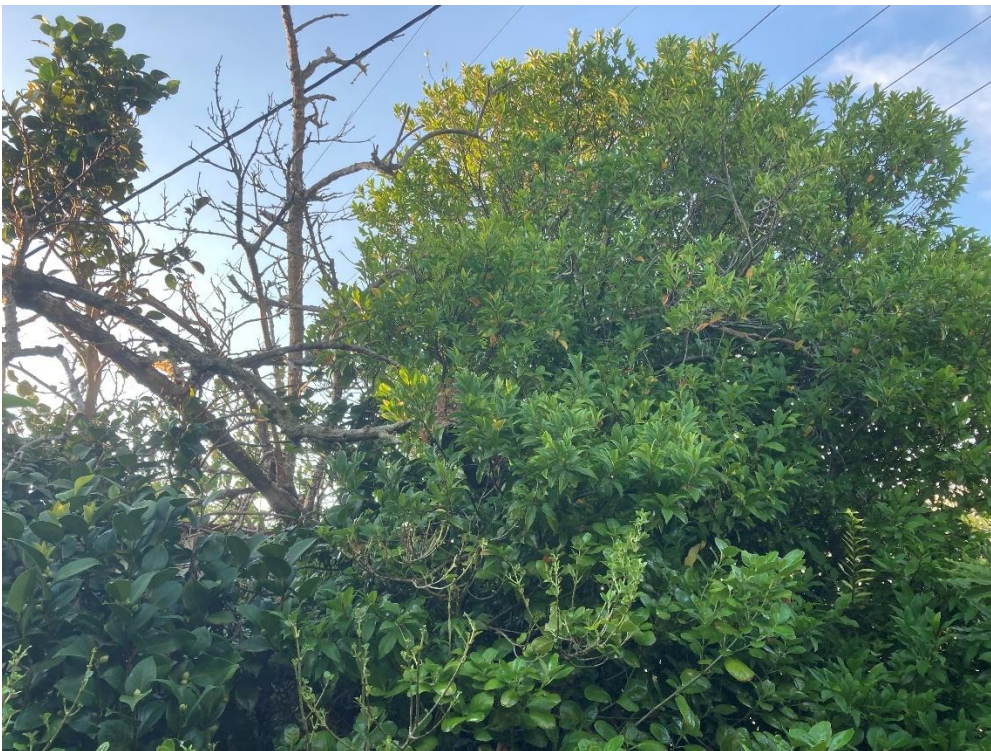
Tree 6 is a *Coprosma repens* (Shiny Mirror Bush), this exotic is a problematic weed in our urban landscape and is dying off in areas of its canopy, see Appendix 4. It has been marked for removal to reduce its spread through the local area. It is growing in the front set back and is clear of the proposed building envelope and would not be directly affected by this proposal. Tree 7 is a *Cinnamomum camphora* (Camphor laurel), this exotic is a problematic weed in our urban landscape and can grow to a very large size and dominate unkempt areas. It has been marked for removal to reduce its spread through the local area. It is growing in the front set back and is clear of the proposed building envelope and would not be directly affected by this proposal.

Photo D shows Tree 5 a *Michelia figo* (Port Wine Magnolia) on the right of shot. On the left of shot is Tree 6 a *Coprosma repens* (Shiny Mirror Bush) dying back at its top, both exotics are marked for removal.

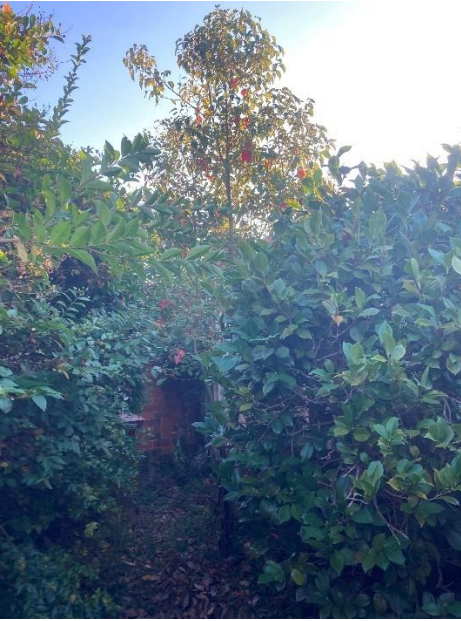
Photo E shows Tree 7 a *Cinnamomum camphora* (Camphor Laurel) in the centre of shot, as self-sewn exotic weed tree. On the left of shot is Tree 8 a *Ligustrum ovalifolium* (Hedge Privet) an exotic that is usually hedged; it has been allowed to out grow this position and has been marked for removal.

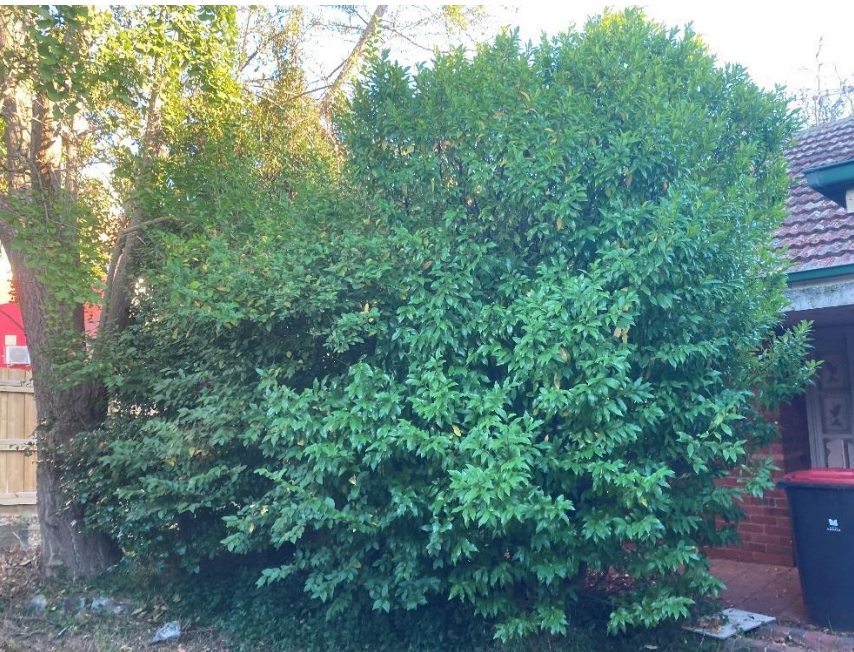
Photo F shows Tree 10 on the right of shot a *Michelia figo* (Port Wine Magnolia), to the left is Tree 11 a *Syzygium smithii* (Lilly Pilly) as indicated by the blue arrow; both are marked for removal. On the far left of shot is the lower trunk of Tree 12 a *Ginkgo biloba* (Ginkgo) an attractive tree marked for retention.

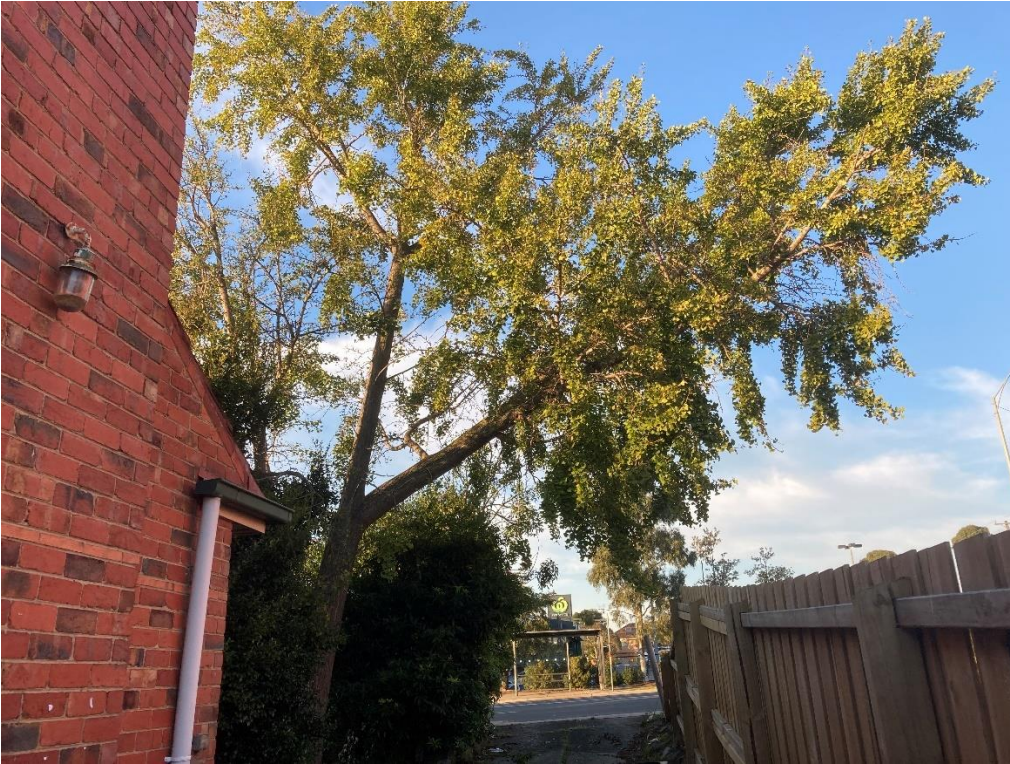
Tree 12 is a *Ginkgo biloba* (Ginkgo), this exotic tree is rare in our landscape, in particular due to its reasonable size and potential. This tree is an attractive feature in this neglected landscape, see Appendix 4. There is already a concrete driveway running along the west side of its trunk and the existing house is less than 2 metres from its trunk. The footing for the existing brick house would be acting as an impervious barrier to the spread of the roots of this tree towards the north. This tree is inside the proposed building envelope of the underground car park; it is therefore not compatible with this proposal. It would have to be removed if this proposal was to be approved as it has been presented here.

Photo G shows Tree 12 a *Ginkgo biloba* (Ginkgo) as seen from the north, illustrating its close proximity to the existing house and the large scaffold branch growing towards the west.

Tree 12 is a *Ginkgo biloba* (Ginkgo), this exotic deciduous tree is still growing towards its mature size. This is the most significant tree detailed in this report. This type of tree is slow growing in our hot and dry climate, though prone to possums over grazing its canopy. This can cause the premature death of this type of tree if it is not managed appropriately. This tree is inside the proposed building envelope and would have to be removed to allow this proposal to proceed as it has been presented here. Tree 16 a *Waterhousia floribunda* (Weeping Lilly Pilly) is marked for removal and is one of two trees of any worth here. It dominates the northern boundary and would greatly restrict the landscaping or possible building envelope if it were to remain in position. It is still growing and is yet to reach its fully mature size. The replacement tree must be able to achieve at least 12 metres in height and greatly enhance this landscape. A deciduous tree would allow winter light to enter this property, while providing good summer shade.

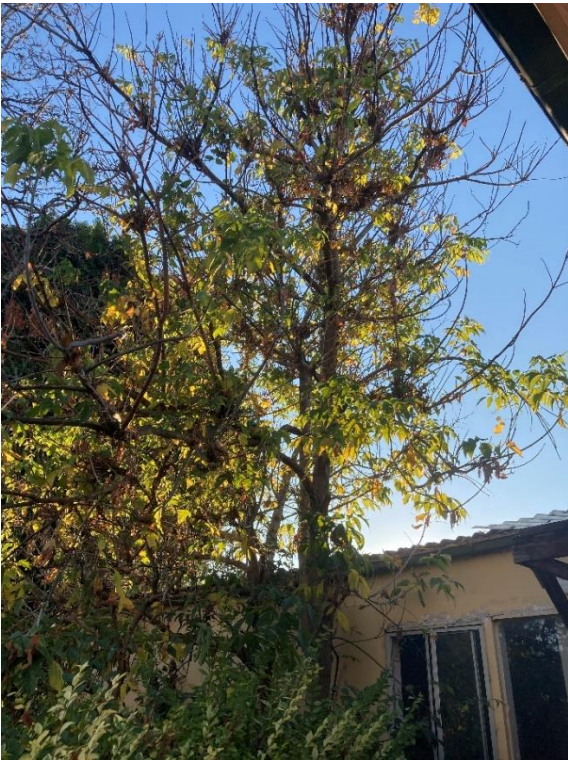
Trees 13 and 15 are *Acer negundo* (Ash leaved Maple), this type of exotic tree is a problematic weed in our urban landscape. They have been marked for removal to reduce its spread through the local area. They are growing inside the proposed building envelope and would have to be removed to allow it to proceed as it has been presented here. Tree 14 is a *Liquidambar styraciflua* (Liquidambar), this exotic tree is dead, it has been grazed to death by possums and cannot be revived; see Appendix 4. It should be removed before it decays and suffers collapsing scaffold branches. It is inside the proposed building envelope and would have to be removed to allow it to proceed as it has been presented here.

Photo H shows Tree 13 an *Acer negundo* (Ash leaved Maple) as seen from the south west; the exotic is a problematic weed in our urban landscape and has been marked for removal. Its patchy canopy a symptom of its poor health.

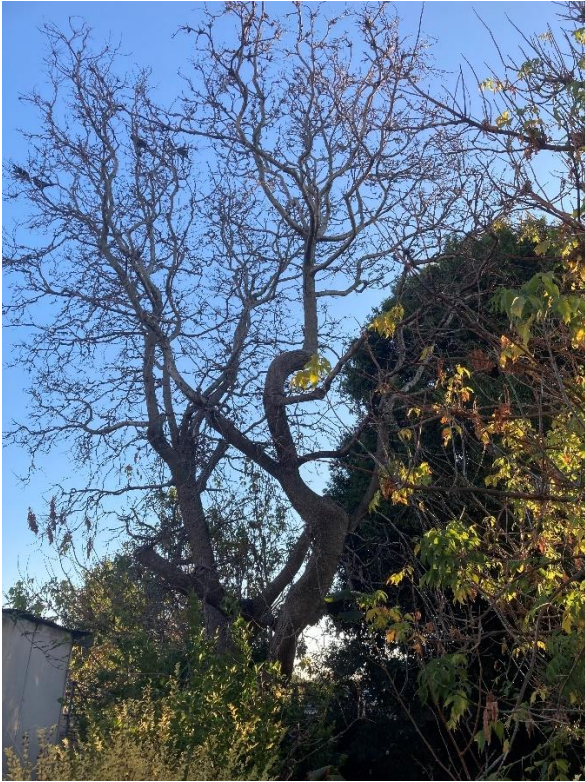
Photo I shows Tree 14 a *Liquidambar styraciflua* (Liquidambar) as seen from the south; it is devoid of leaves as it is dead. It must be removed before it decays and begins to shed branches.

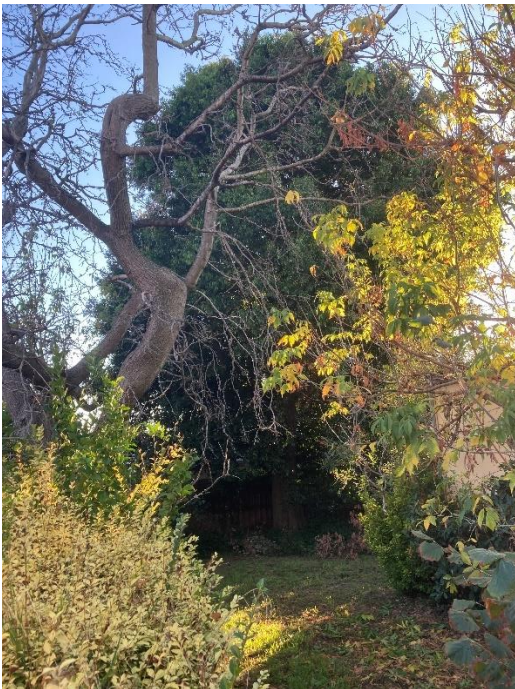
Tree 16 is a *Waterhousia floribunda* (Weeping Lilly Pilly), this native tree has outgrown this confined garden and exceeds the height it is often sold to people as a modest sized tree (below 15 metres in height). This tree dominates this area and over hangs the neighbouring property by a significant margin and greatly restricts how this area could be utilised. This tree is in good health and of fair structure, the only reason to remove this tree is its large size in this confined space and the restriction on how the remainder of this property could be utilised. As it excludes all sun light from entering this area of this property. This tree would be missed from this position, it could be replaced with a more attractive tree, that is deciduous that would allow light into the north side of this property. Trees 17, 22, 25 and 26 are all *Camellia japonica* (Camellia), this type of exotic tree is planted as a screen, see Appendix 4 . These trees have been neglected and allowed to be smothered by vines or have been previously lopped to restrict their height. These small trees would not be missed if removed and replaced with more attractive trees. Most are located inside the proposed building envelope and would have to be removed to allow it to proceed as it has been presented here.

Photo J shows Tree 16 a *Waterhousia floribunda* (Weeping Lilly pilly) as seen from the south; illustrating its thick and dark canopy, blotting out sunlight from this property. There is nothing growing under it, due to its high water use and dense canopy, preventing anything substantial from establishing.

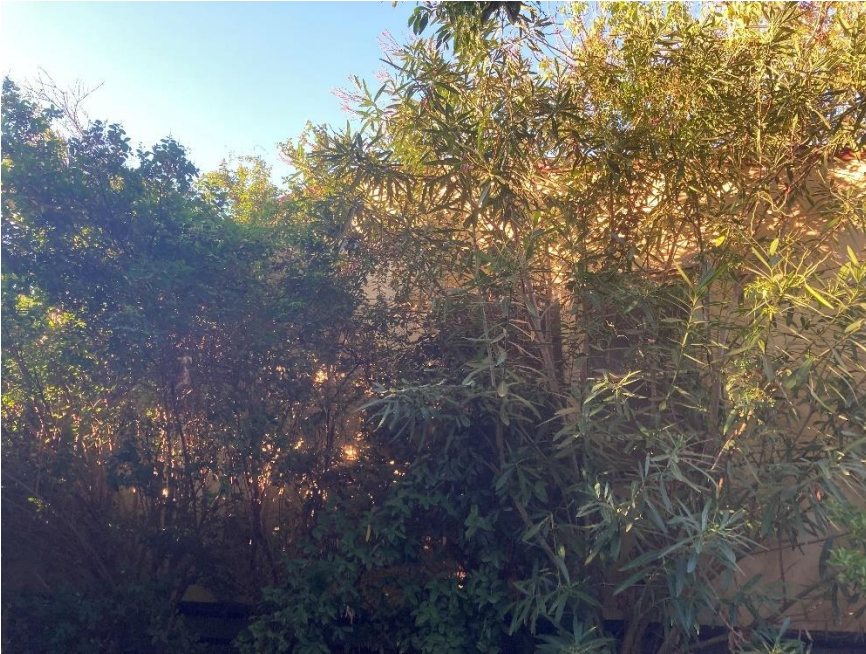
Tree 19 is a *Nerium oleander* (Oleander), this exotic is recognised as having a weedy habit and dominating unkempt areas, due to its tolerance to drought and poor soils; see Appendix 4. This unattractive shrub has been marked for removal to allow for the rejuvenation of this neglected landscape. It would not be missed as it cannot be seen from outside this property. Tree 20 is a *Ligustrum lucidum* (Glossy Privet). This exotic is a problematic weed in our urban landscape. It has been marked for removal to reduce its spread through the local area. It is growing inside the proposed building envelope and would have to be removed to allow this proposal to proceed as it has been presented here.

Photo K shows Tree 19 a *Nerium oleander* (Oleander) on the right of shot. On the left is Tree 18 a *Ligustrum lucidum* (Hedge Privet), these exotics have been marked for removal and replacement.

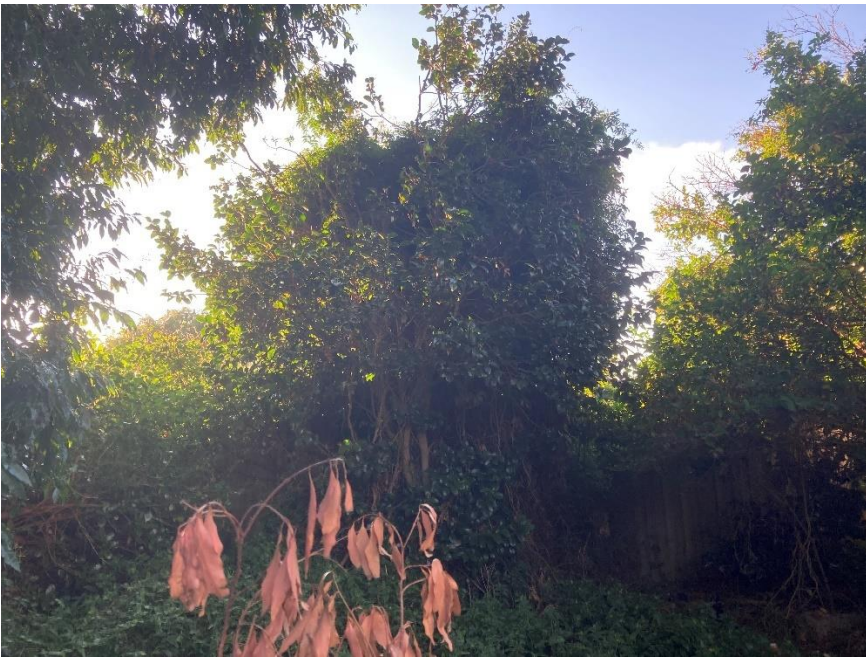
Photo L shows Tree 17 a *Camellia japonica* (Camellia) as seen from the west, growing in the shade of Tree 16 and partially covered in vines. It will never reach its potential and has been marked for removal.

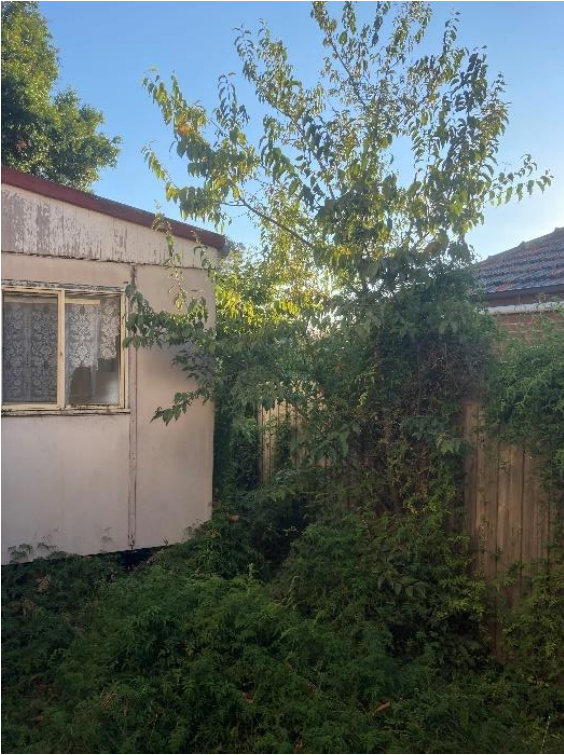
Tree 21 is a *Celtis australis* (European Nettle), this type of exotic tree is becoming a problematic weed in our urban landscape, self-seeding into unkempt gardens; see Appendix 4. This tree is self-sewn and there are some smaller seedlings emerging in these gardens. It has been marked for removal as it is inappropriate in this position. It would not be missed as it cannot be seen from outside these properties. It is inside the proposed building envelope and would have to be removed to allow this proposal to proceed as it has been presented here. Tree 23 is a *Magnolia x soulangiana* (Saucer Magnolia), this type of exotic small tree is drought sensitive and slow growing. This small tree is being over grazed by possums, see Appendix 4. It has entered a spiral of decline from which it cannot be revived. This poor specimen has been marked for removal. It would not be missed as it cannot be seen from outside this property. It is inside the proposed building envelope and would have to be removed to allow it to proceed as it has been presented here.

Photo M shows Tree 21 a *Celtis australis* (European Nettle) as seen from the south west. This self-sewn exotic is recognised as being weedy in our urban landscape and has been marked for removal.

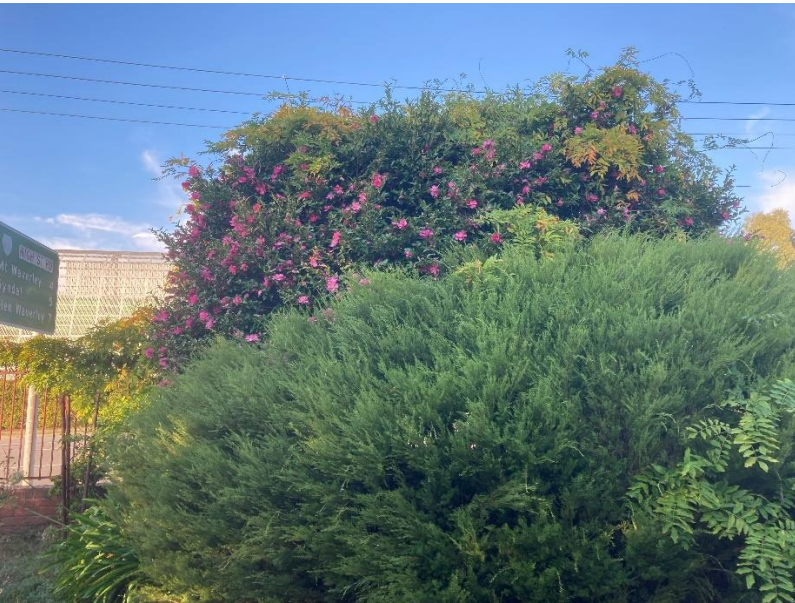
Photo N shows Tree 22 a *Camellia japonica* (Camellia) as seen from the north; this exotic screen tree is covered in vines and will not reach its potential. It has been marked for removal to allow for the rejuvenation of this neglected landscape.

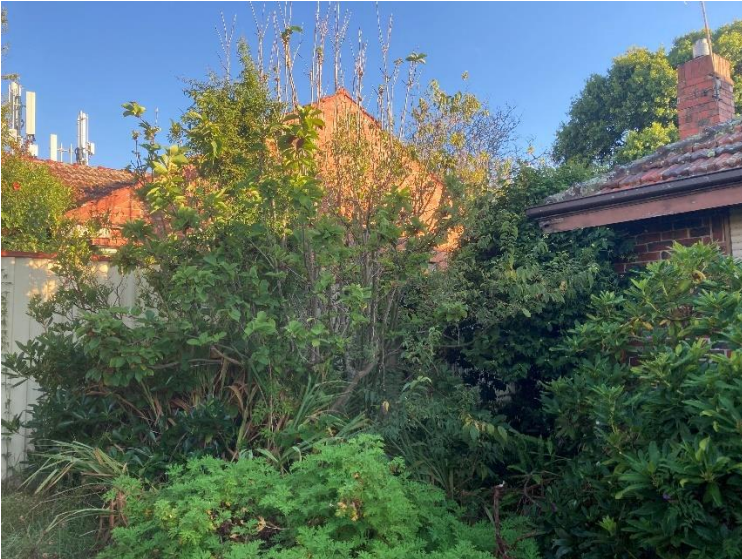
Photo O shows Tree 23 a *Magnolia x soulangiana* (Saucer Magnolia) as seen from the south east. It is being stripped by possums over grazing its leaves; it cannot be recovered from this position and has been marked for removal.

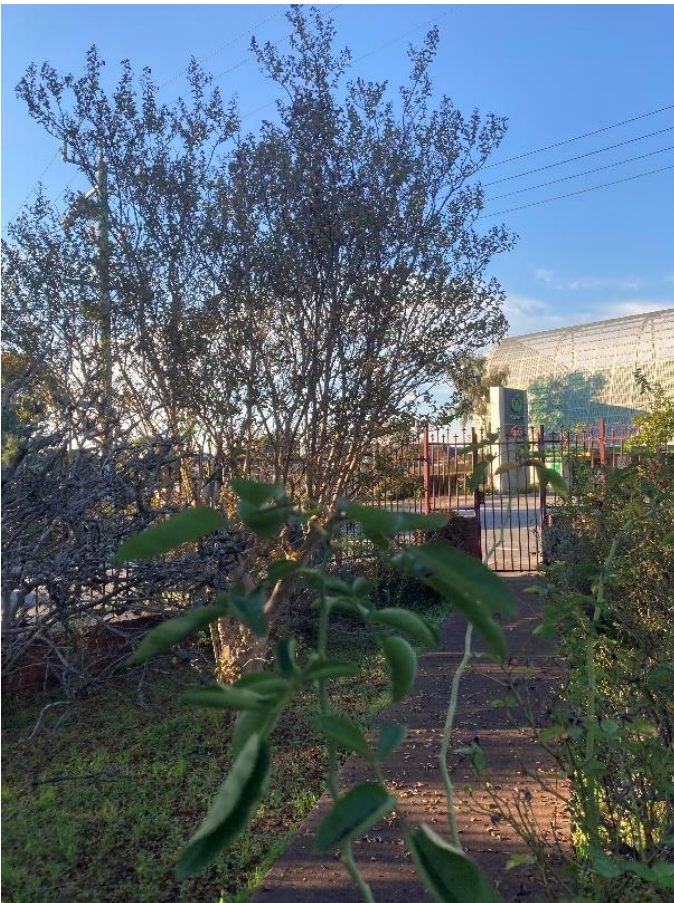
Tree 24 is a *Lagerstroemia indica* (Crepe Myrtle), this small tree has been lopped in the past and allowed to regrow unrestricted. This was typical past practice for this type of small tree. This tree is drought stressed, with all of its leaves with burnt margins, this is consistent with a garden that has been neglected for some years. This small tree has been marked for removal as it could be easily replaced with a more suitable and better positioned tree. It is inside the proposed building envelope and would have to be removed to allow this proposed to proceed as it has been presented here. Trees 27–29 are *Castanea sativa* (Chestnut), these 3 exotic trees have been previously lopped to manage their height. As this type of tree can exceed 20 metres at full maturity. This has reduced the flower and fruit production and allowed these trees to decline in health as well. These are inappropriate trees in this position and have been marked for removal and replacement. They are inside the proposed building envelope and would have to be removed to allow it to proceed as it has been presented here. They would not be missed as they cannot be seen from outside this property.

Photo P shows Tree 24 a *Lagerstroemia indica* (Crepe Myrtle), this exotic has been previously lopped and is inside the proposed building envelope. It has therefore been marked for removal and replacement.

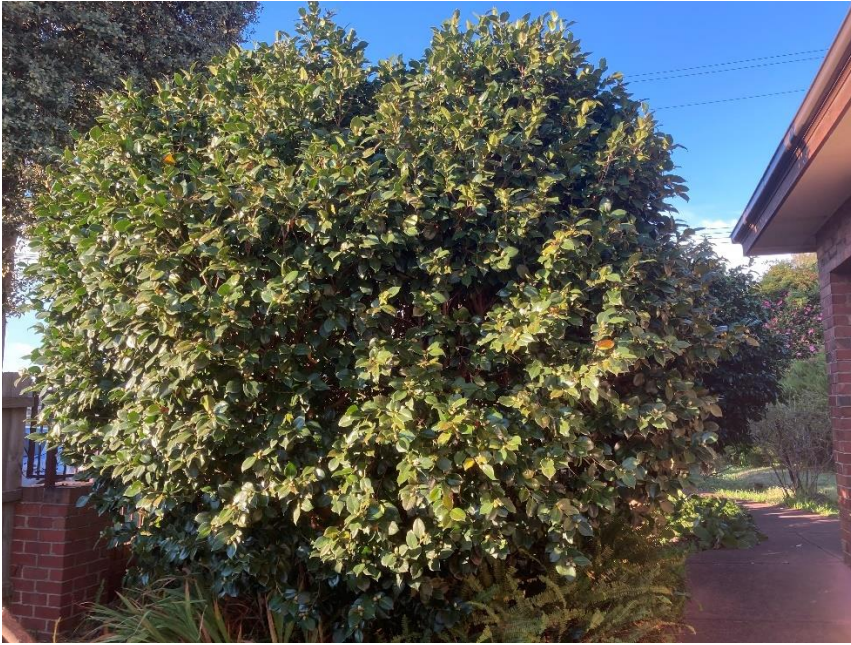
Photo Q shows Tree 26 a *Camellia japonica* (Camellia) as seen from the north; this exotic screen tree has been marked for removal and replacement.

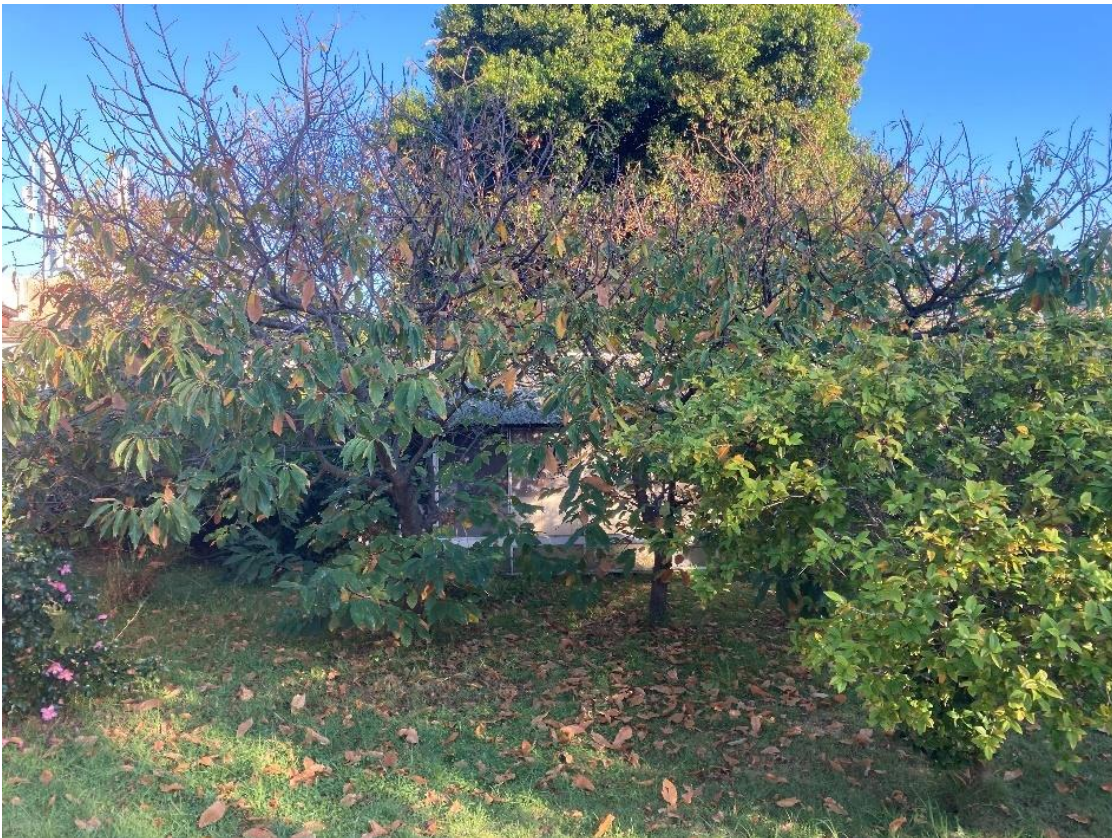
Photo R shows Trees 27 and 28 a pair of *Castanea sativa* (Chestnut) as seen from the south east; illustrating the small size of these exotic nut trees.

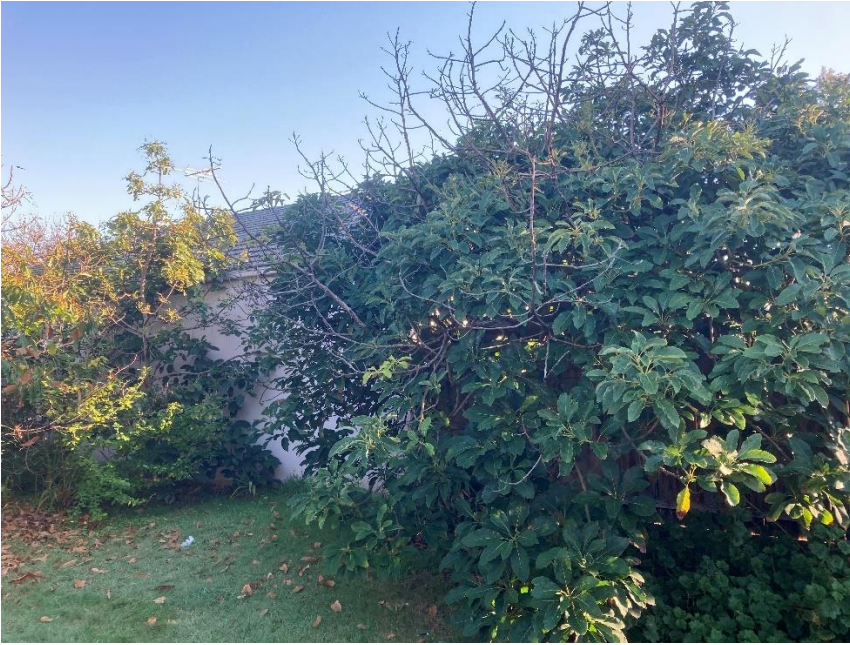
Trees 30 and 31 are *Persea americana* (Avocado), these exotic trees are being over grazed by possums, see Appendix 4. This is a common problem for this type of tree in our urban landscape. If they cannot be isolated from their activity, they will go the same way as Tree 14 the Liquidambar and die prematurely. They are growing up against the northern boundary, there is therefore no way to isolate

them from possums. These trees are inside the proposed building envelope and have been marked for removal to allow it to proceed as it has been presented here.

Photo S shows Trees 30 and 31 a pair of *Persea americana* (Avocado) as seen from the south east. Illustrating the stripped top leaves of Tree 31 on the right of shot; these poor exotics are marked for removal.

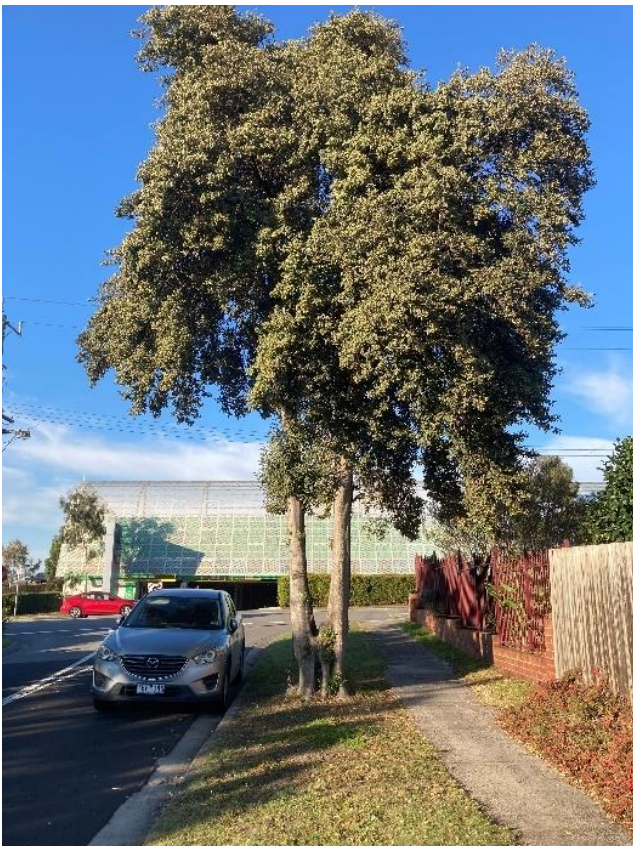
Tree 32 is a *Lagunaria patersonia* (Norfolk Island Hibiscus) is growing on the nature strip in Kennett Street, outside the eastern boundary of this property. It is clear of the proposed building envelope and would not be impacted by this proposal. This type of tree is problematic when people move around near its canopy, as they produce fine fibres in their seed capsules that can cause severe irritation in peoples' skin. Many councils are removing this drought tolerant type of tree to prevent this problem form occurring. It is growing opposite a double brick boundary wall on the boundary of this property. This will have prevented the roots of this tree from entering this property and restricting the proposed building envelope. It will require temporary fencing around it to isolate it from any possible impact. It must be isolate the exposed areas of the TPZ of this tree, to protect it from soil compaction or direct impact.

Photo T shows Tree 32 a *Lagunaria patersonia* (Norfolk Island Hibiscus) as seen from the north; illustrating its position in the nature strip clear of the property boundary.

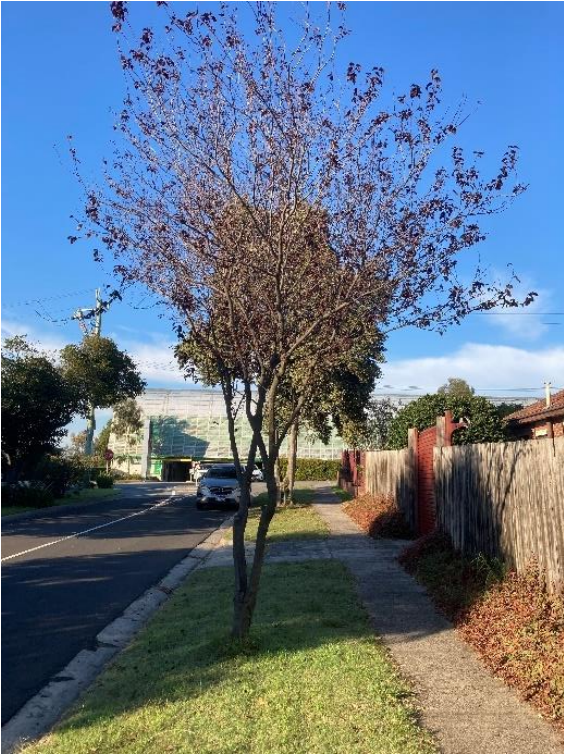
Tree 33 is a *Prunus cerasifera* 'Nigra' (Purple leaf Plum), this exotic tree is growing in the nature strip to the east of this property (see Appendix 4), clear of the proposed building envelope. It is well clear of the proposed works and will not be impacted by it. It will require temporary fencing around it to isolate it from any possible impact. It must be isolate the exposed areas of the TPZ of this tree, to protect it from soil compaction or direct impact.

Photo U shows Tree 33 a *Prunus cerasifera*

'Nigra; (Purple leaf Plum), this exotic is weedy in our urban landscape. This poor tree is clear of the property and would not be affected by this proposal.

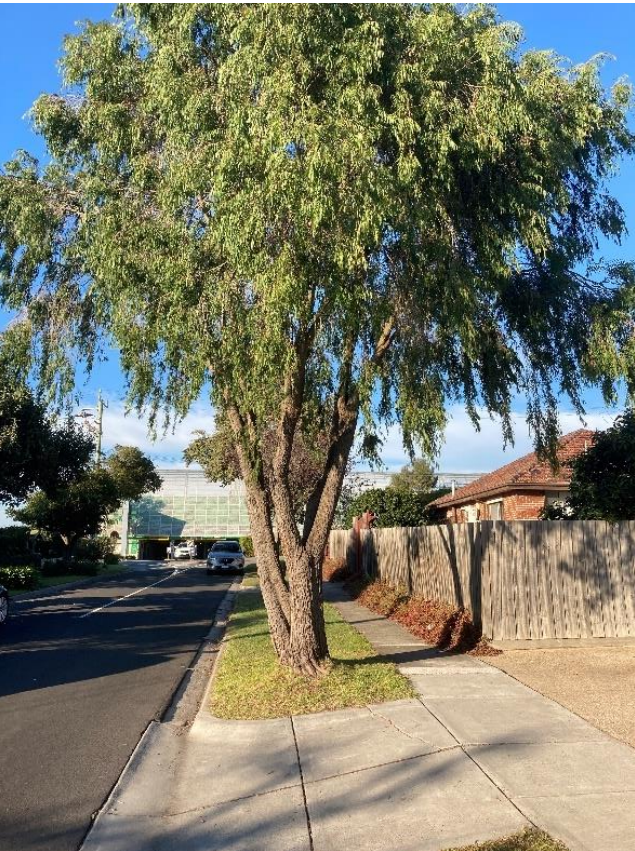
Tree 34 is an *Agonis flexuosa* (Willow Myrtle), this native tree growing 1.5 metre to the north of the northern boundary of this property, on the natures trip to the east of it. It is clear of the proposed building envelope and therefore would not be directly impacted by it, see Appendix 4. It will require temporary fencing around it to isolate it from any possible impact. It must be isolate the exposed areas of the TPZ of this tree, to protect it from soil compaction or direct impact.

Photo V shows Tree 34 an *Agonis flexuosa*

(Willow Myrtle) as seen from the north, 1.5 metres to the north of site; this native is clear of the property; it will require temporary protective to isolate it from the proposed works.
