ARBORIST REPORT

Assessment of five trees

314 Lawrence Road, Mount Waverley

Date: 29th March 2018

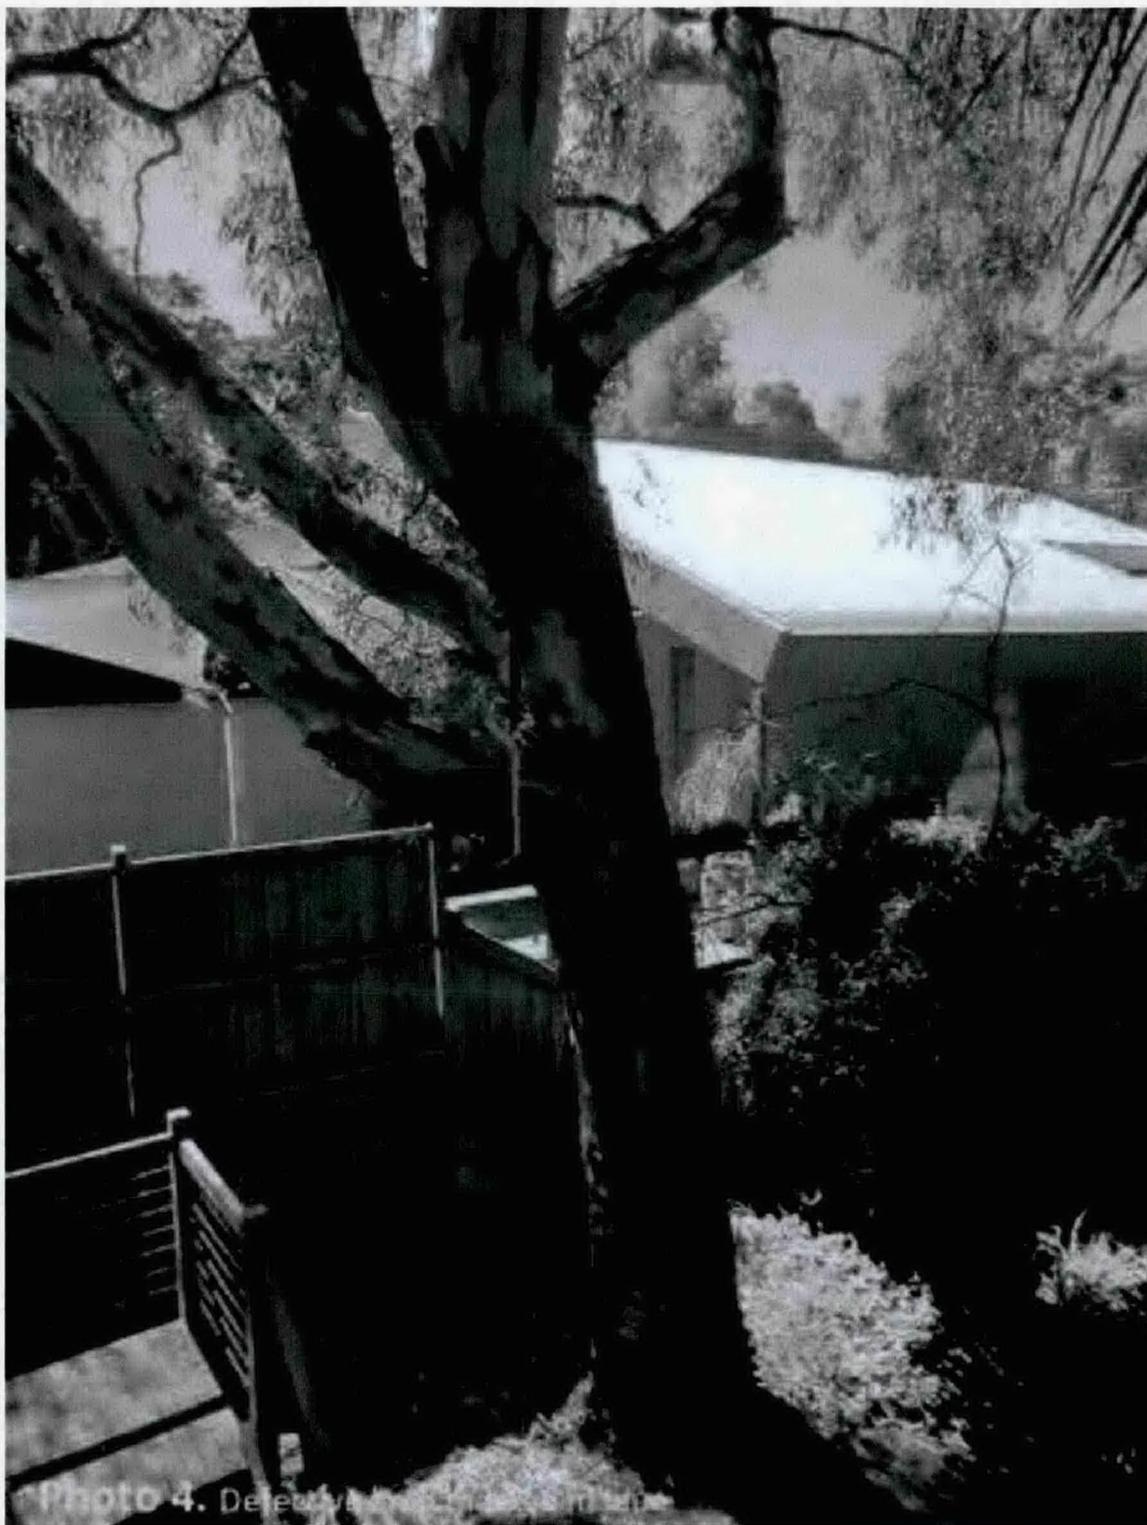
Photo 4. Deletable photo of the tree.

The first primary branch (see Photo 4, 5) is suspect. It has an extensive area of bark cracking, wound wood and rot is present in several sections confirmed by physical probing although no core samples were taken.

3. Tree 2 has a defective primary branch as indicated in Photograph 4. This should be removed at a point adjacent to the branch bark and ridge collar (swollen area).

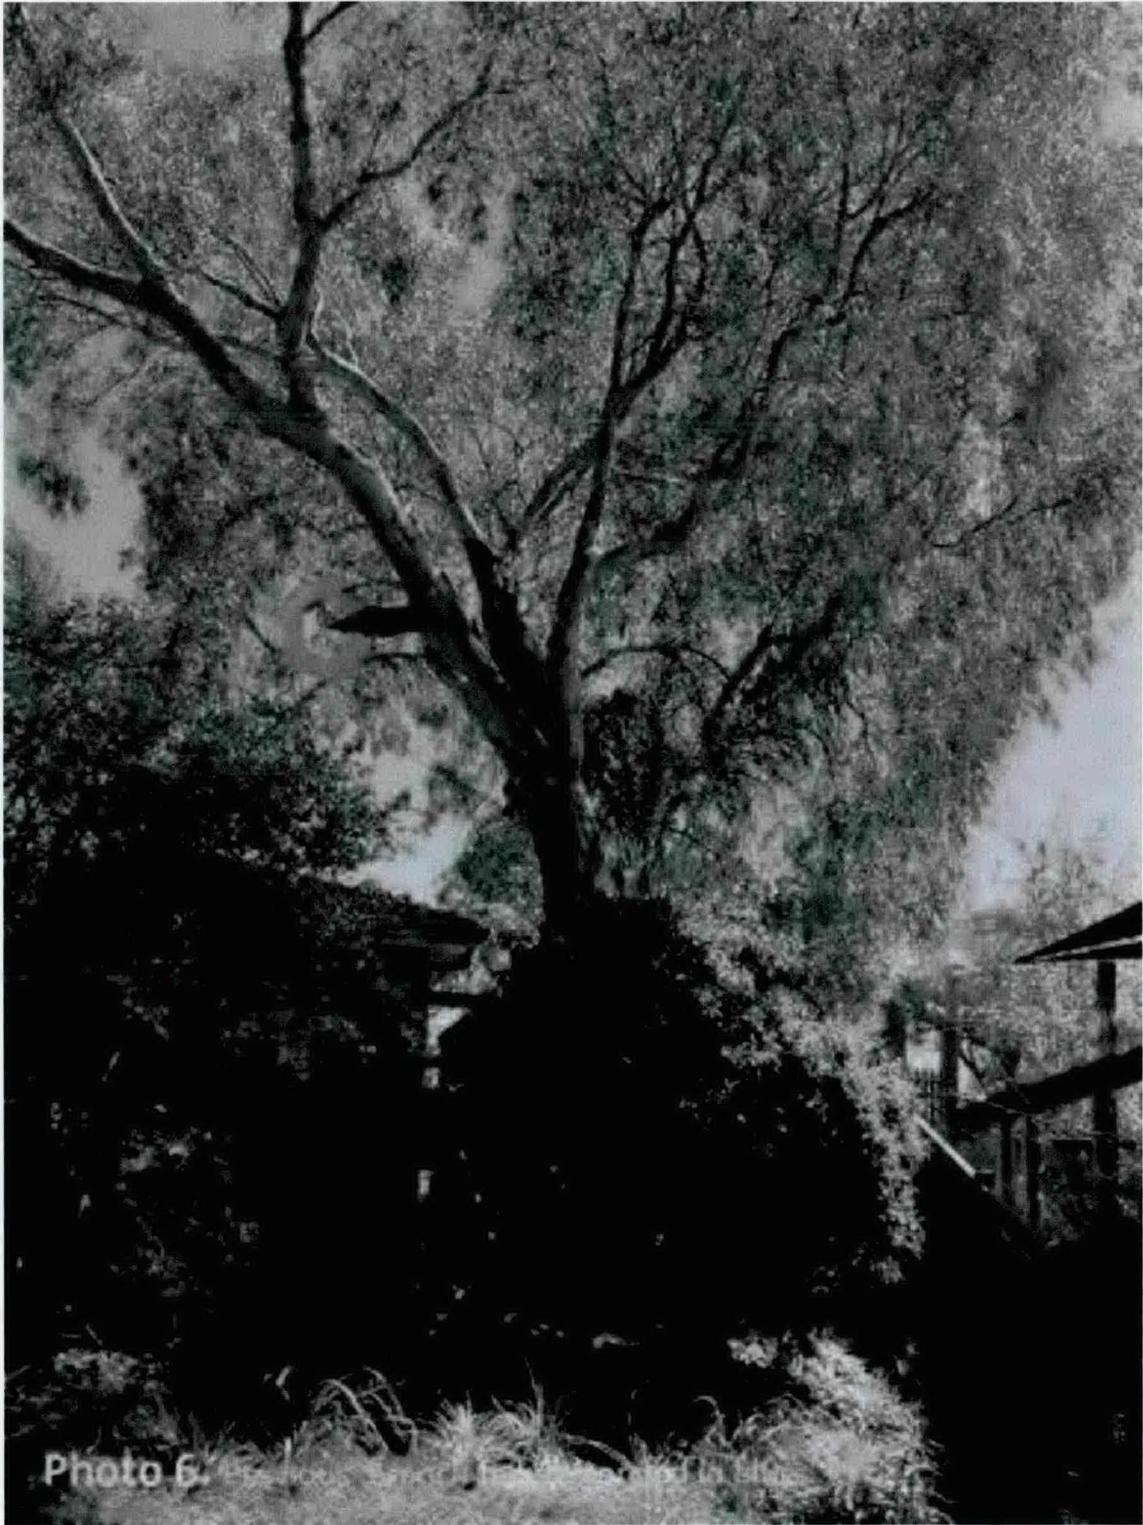
Photo 6.

A previous secondary branch failure is in evidence (see Photo 6).

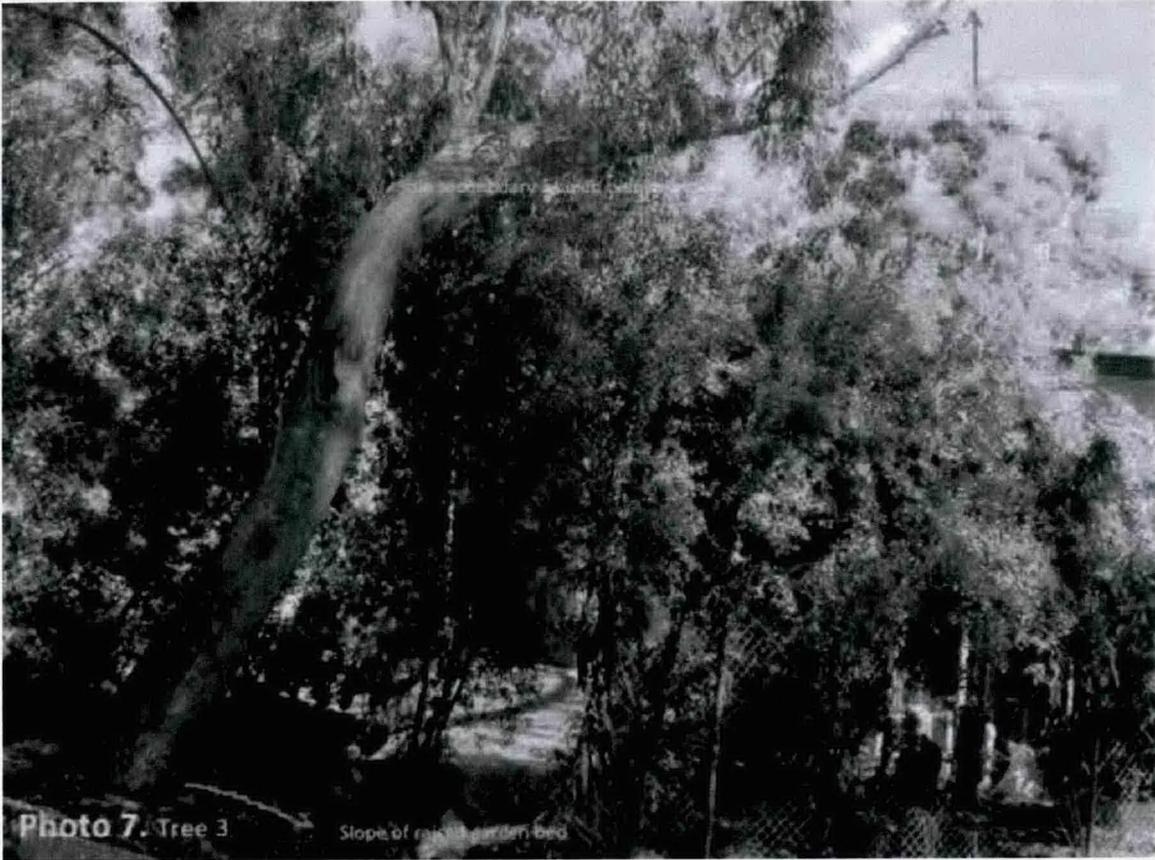
Photo 7. Tree 3

This tree can be described as having **Poor structure** which is described by the following:

- Standing in a sloping confined garden bed bounded by a dry scoria boulder wall of depth x breadth of 0.4 m x .92 m.
- The stem leans at 60° away from the sloping bed for 3 metres (confirmed by measurement and trigonometry) before extending a further 4 metres at an estimated 45° before reaching its narrow asymmetric canopy.
- From centre of base to outer edge of canopy is a measured 9.8 linear metres with an estimated height of 8 metres
- The tree has no counterbalancing branch development (see Photo 7).

Slope of raised garden bed

1. Tree 3 has an excessive lean and it is recommended that this tree be removed.
2. This property has an adequate number of canopy trees and recent plantings and it is not considered necessary to replace it with a similar class of tree. Its present location in a sloping raised bed is not considered a suitable location for trees with the potential to achieve large size.
