# LANDFILL CASE STUDY

# MELBOURNE SITE

- Historical uses of the property include
  - market gardening (1892-1933),
  - sand quarrying (1933-1985), average depth of 20m
  - landfilling (1976-1989)
  - filled with a mixture of soil, demo waste and some limited putrescible material
- No liner or capping of the landfill.
- Sandy soil, groundwater at 15m
- High Density Residential Development (in construction)

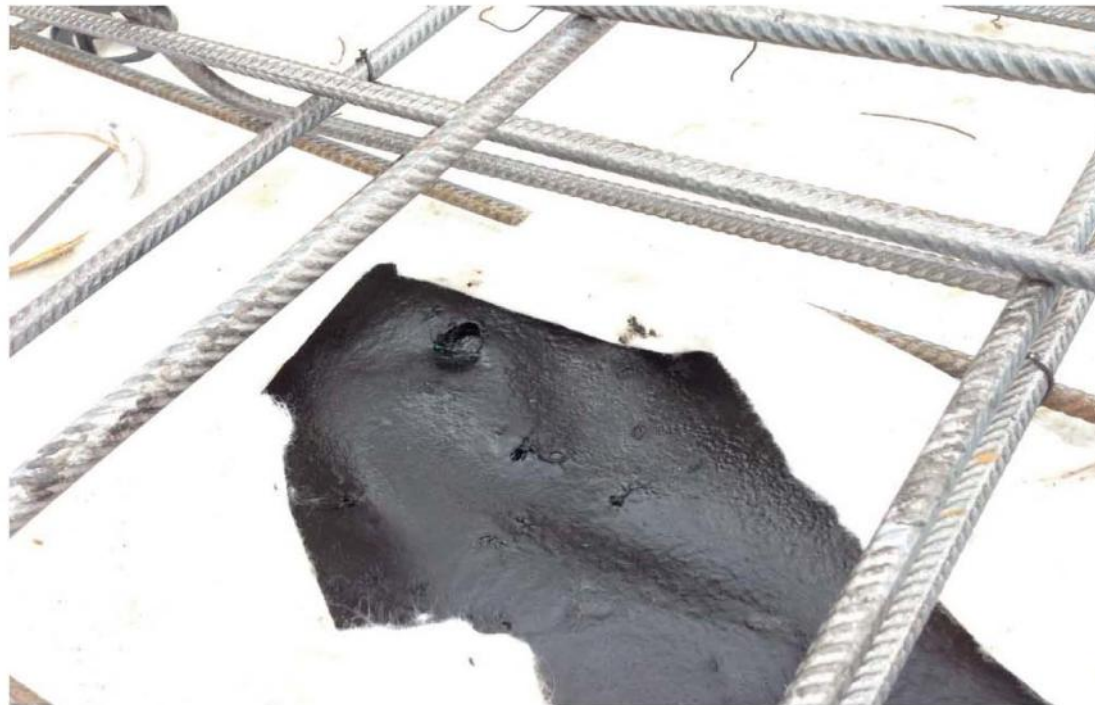
Photograph 2 – Punctured membrane. Based on size of puncture, cause possibly due to steel. Puncture and sealed with Liquid Boot roll grade.

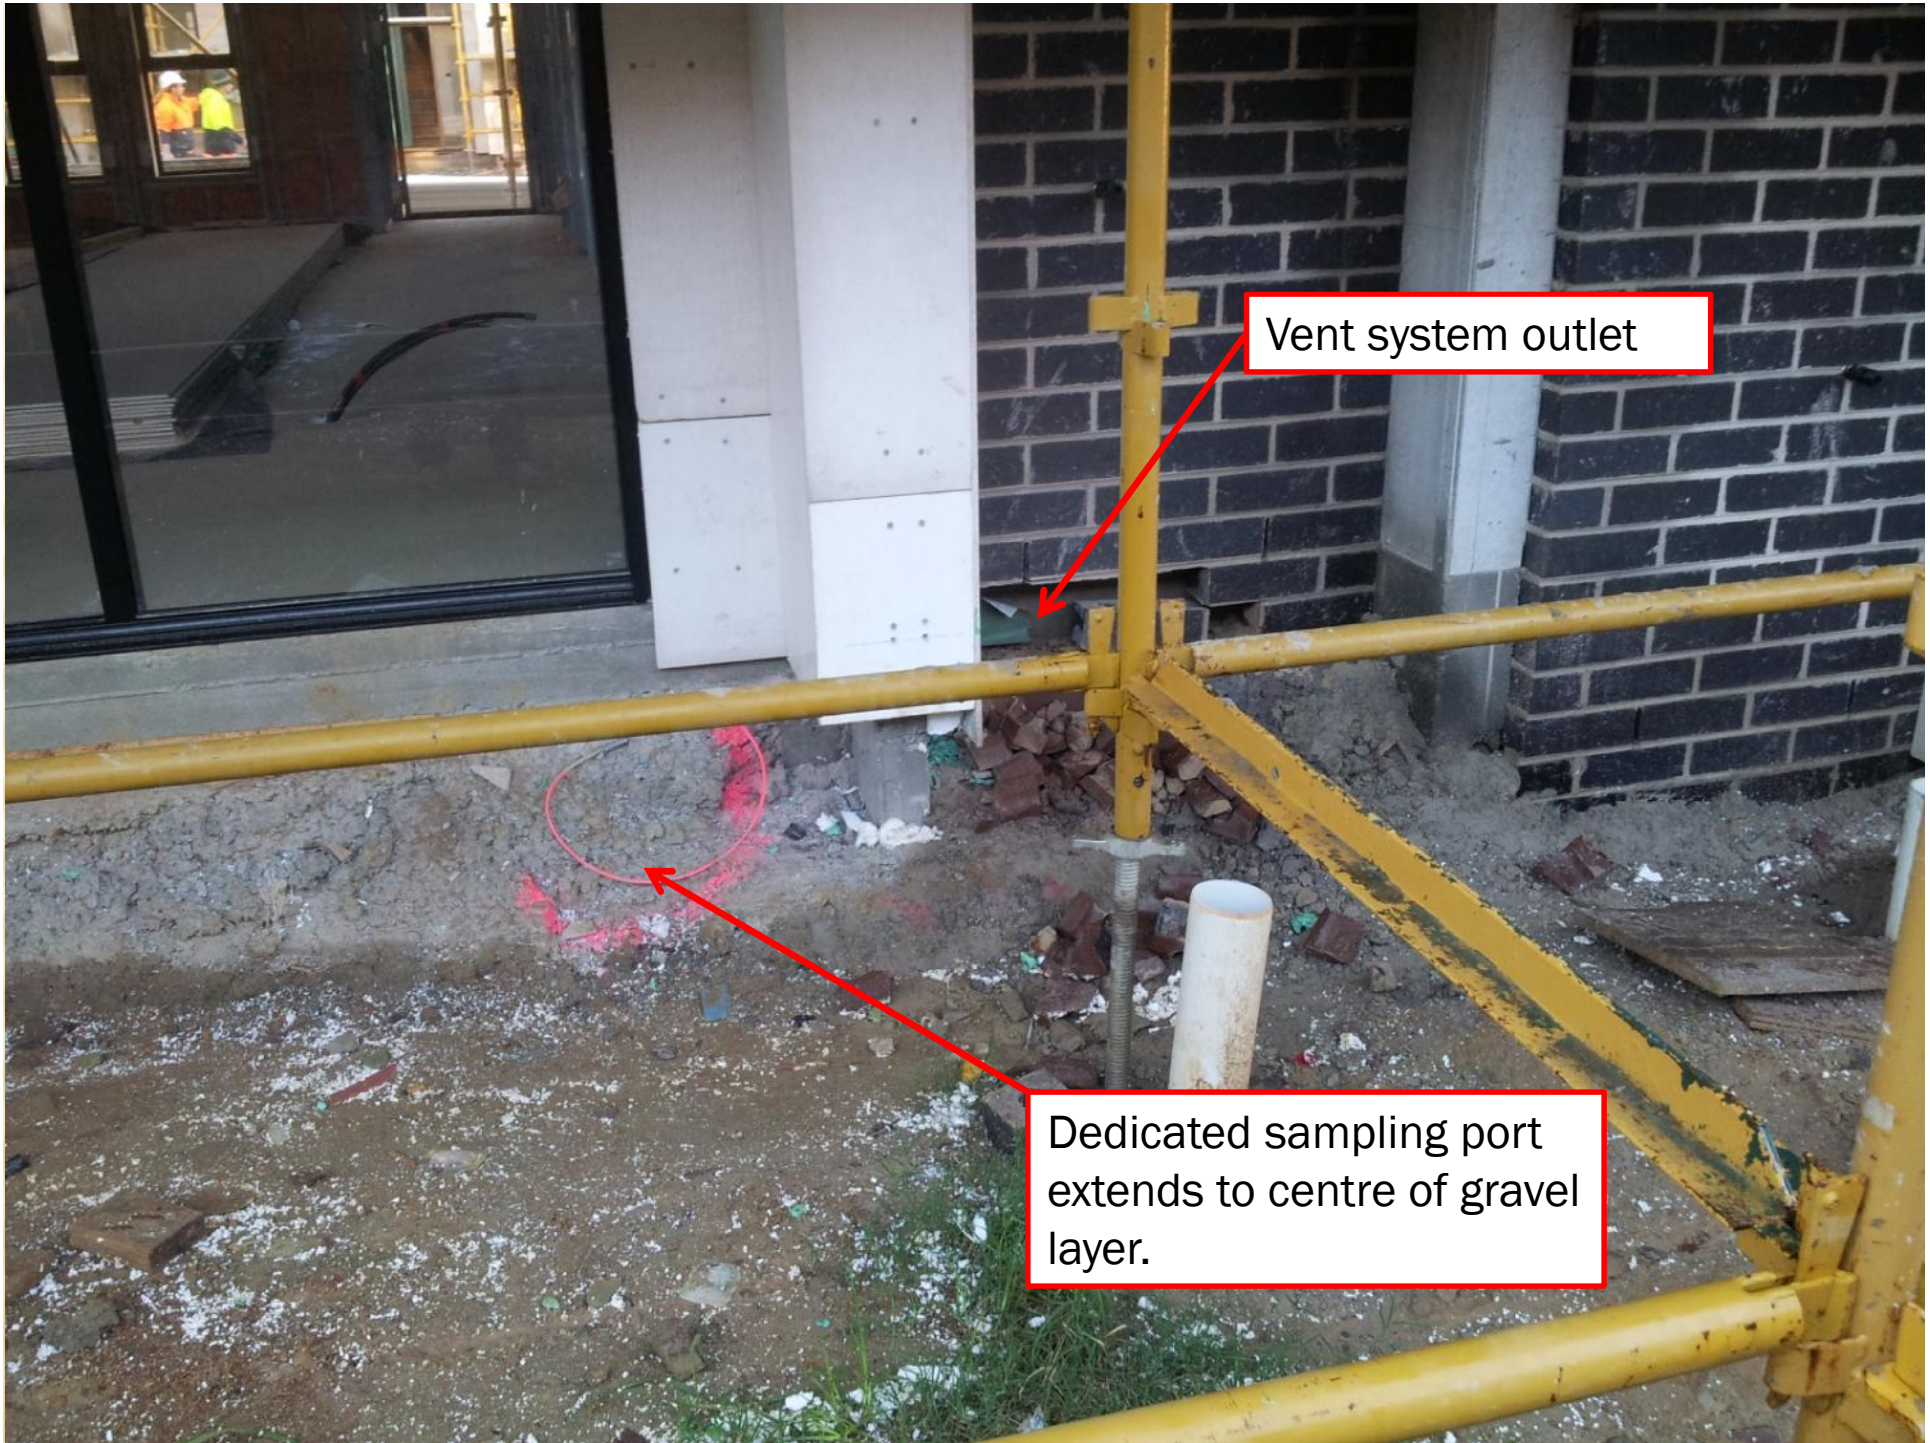
Vent system outlet

Dedicated sampling port extends to centre of gravel layer.

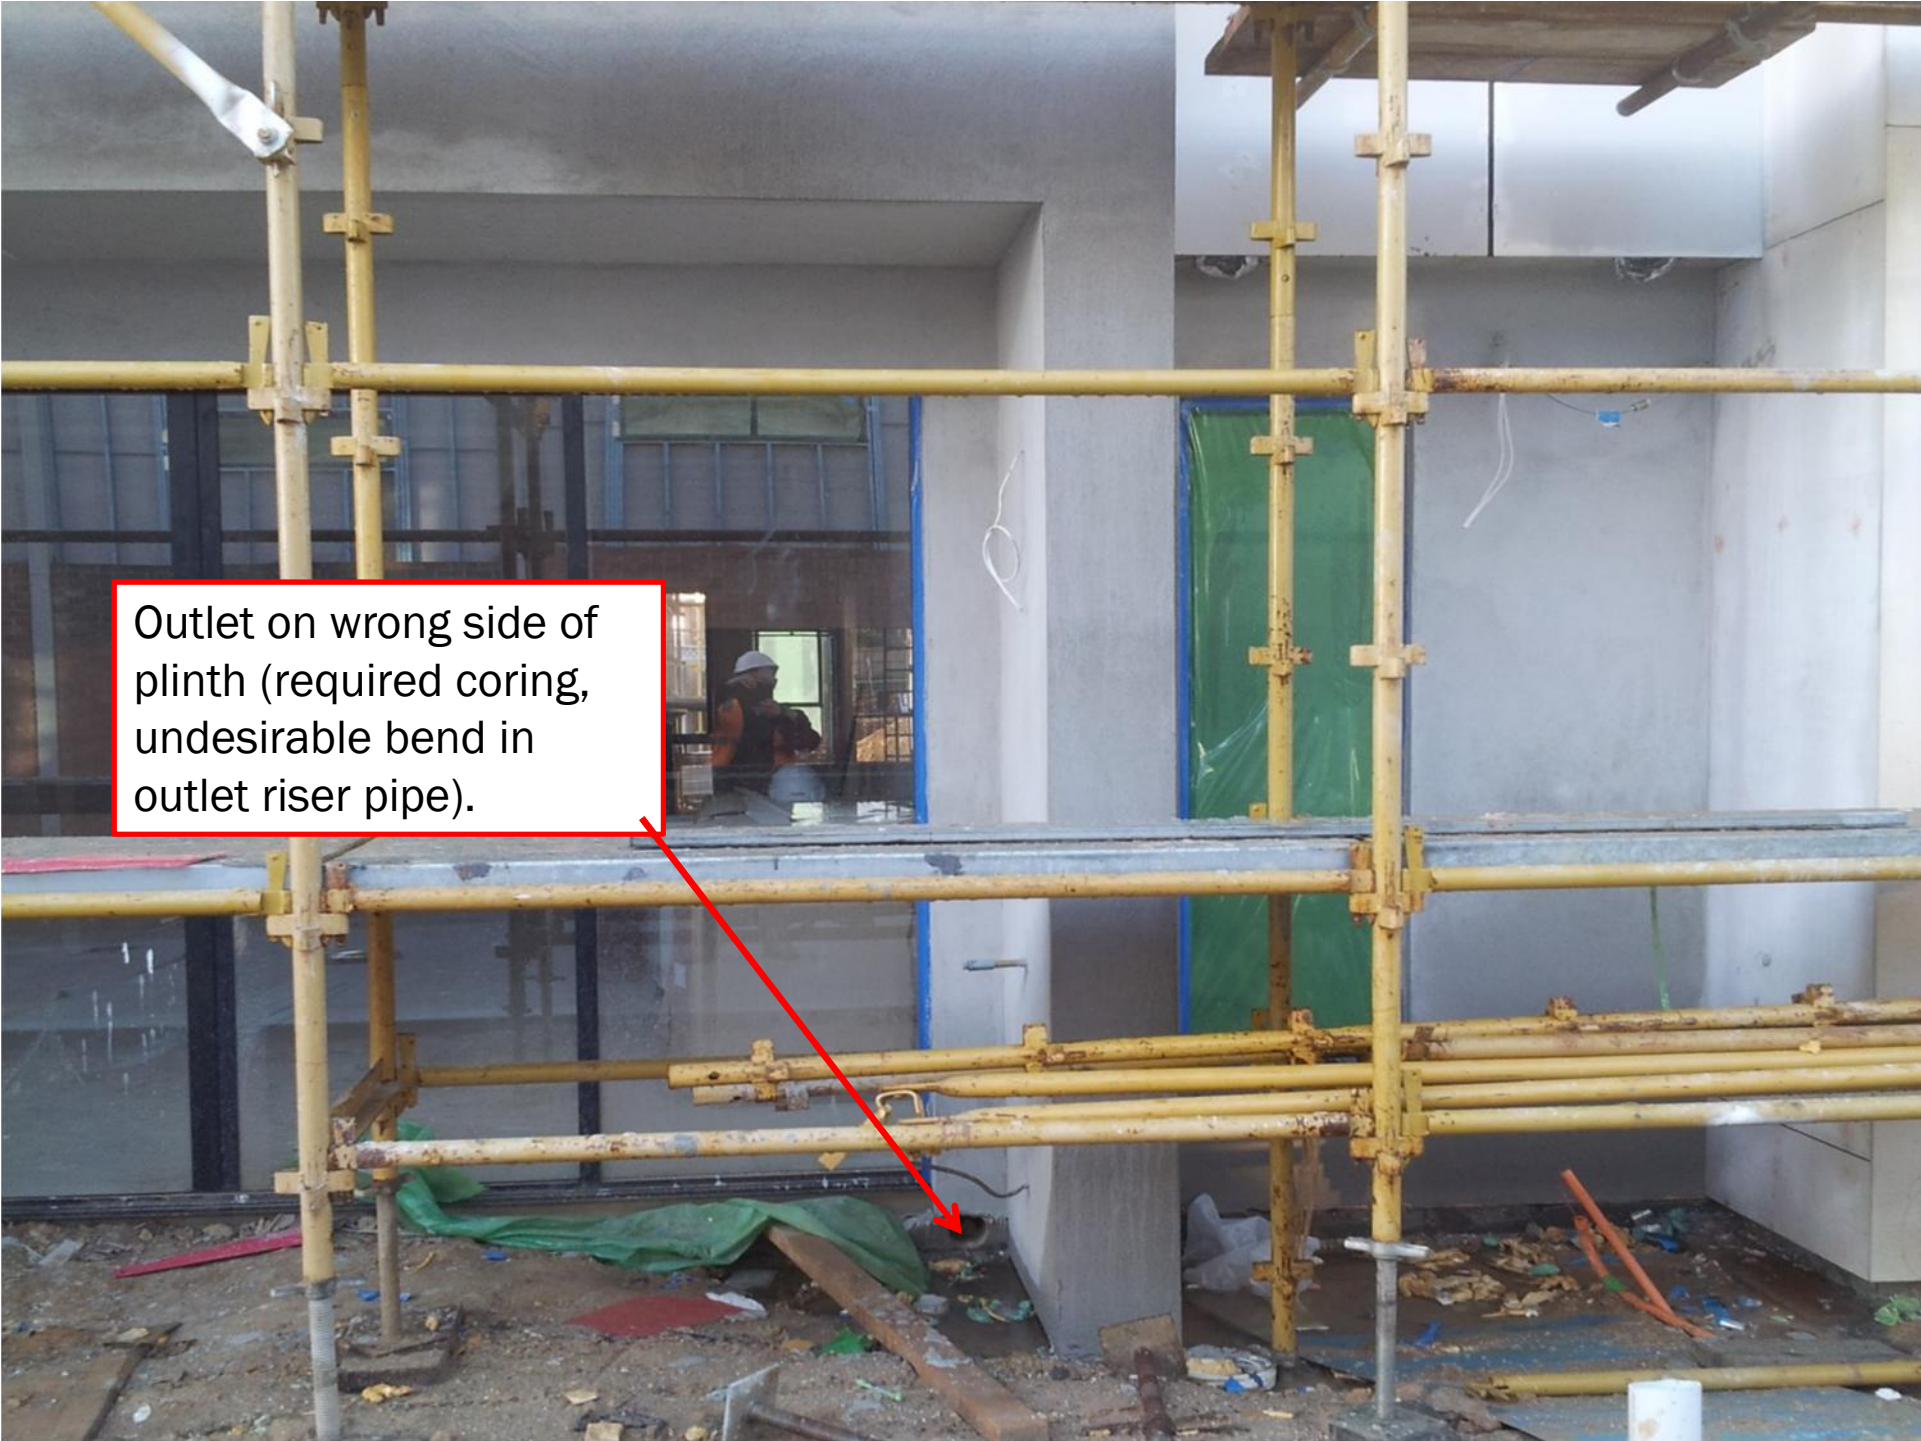
Outlet on wrong side of plinth (required coring, undesirable bend in outlet riser pipe).

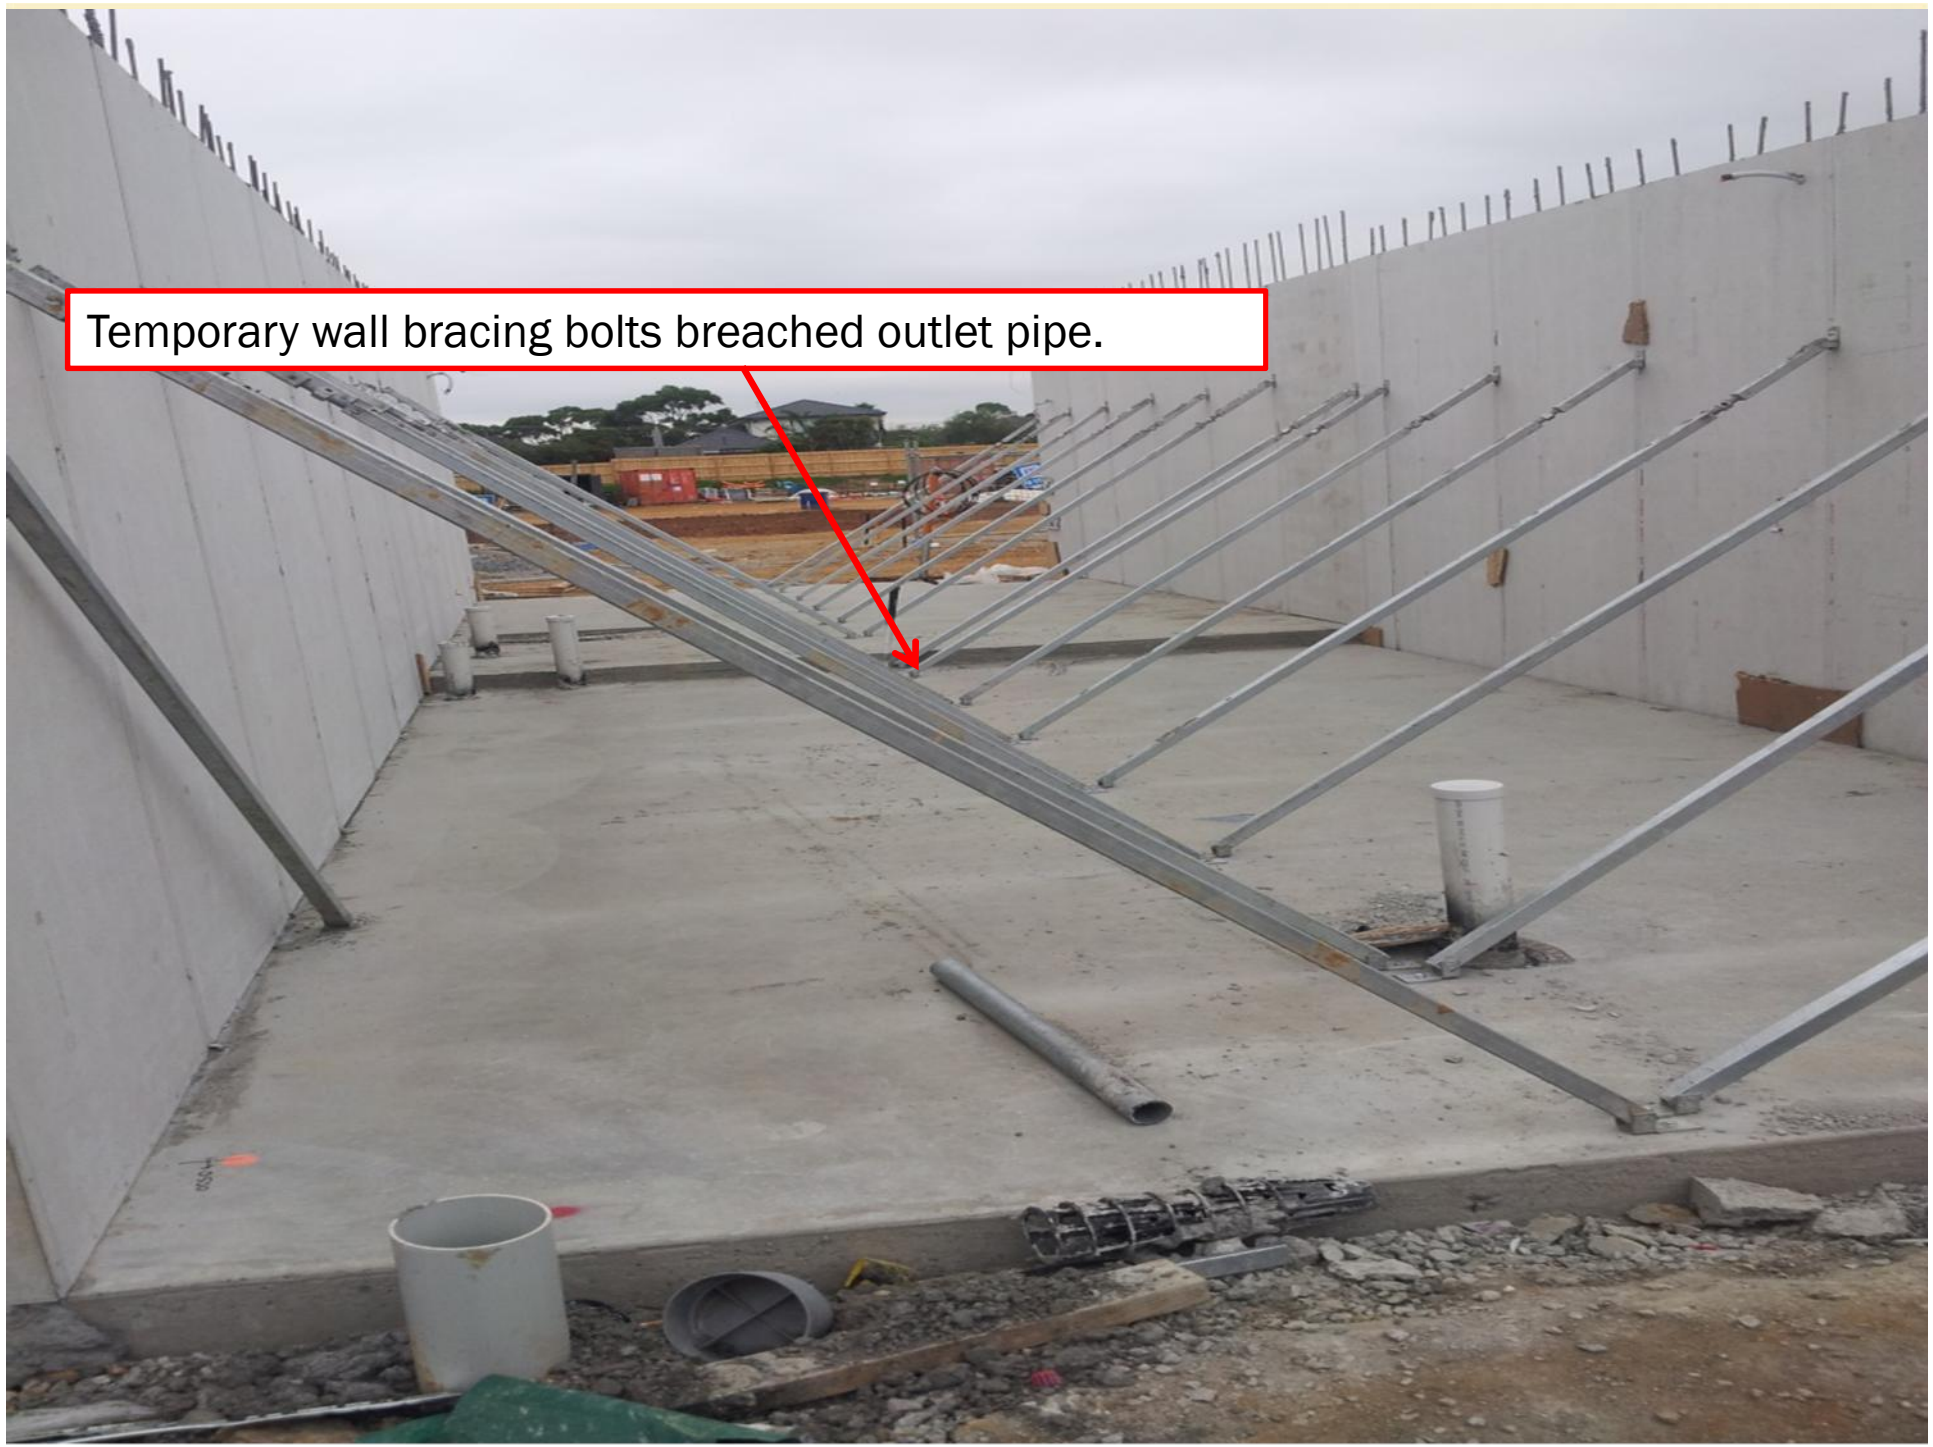
Temporary wall bracing bolts breached outlet pipe.

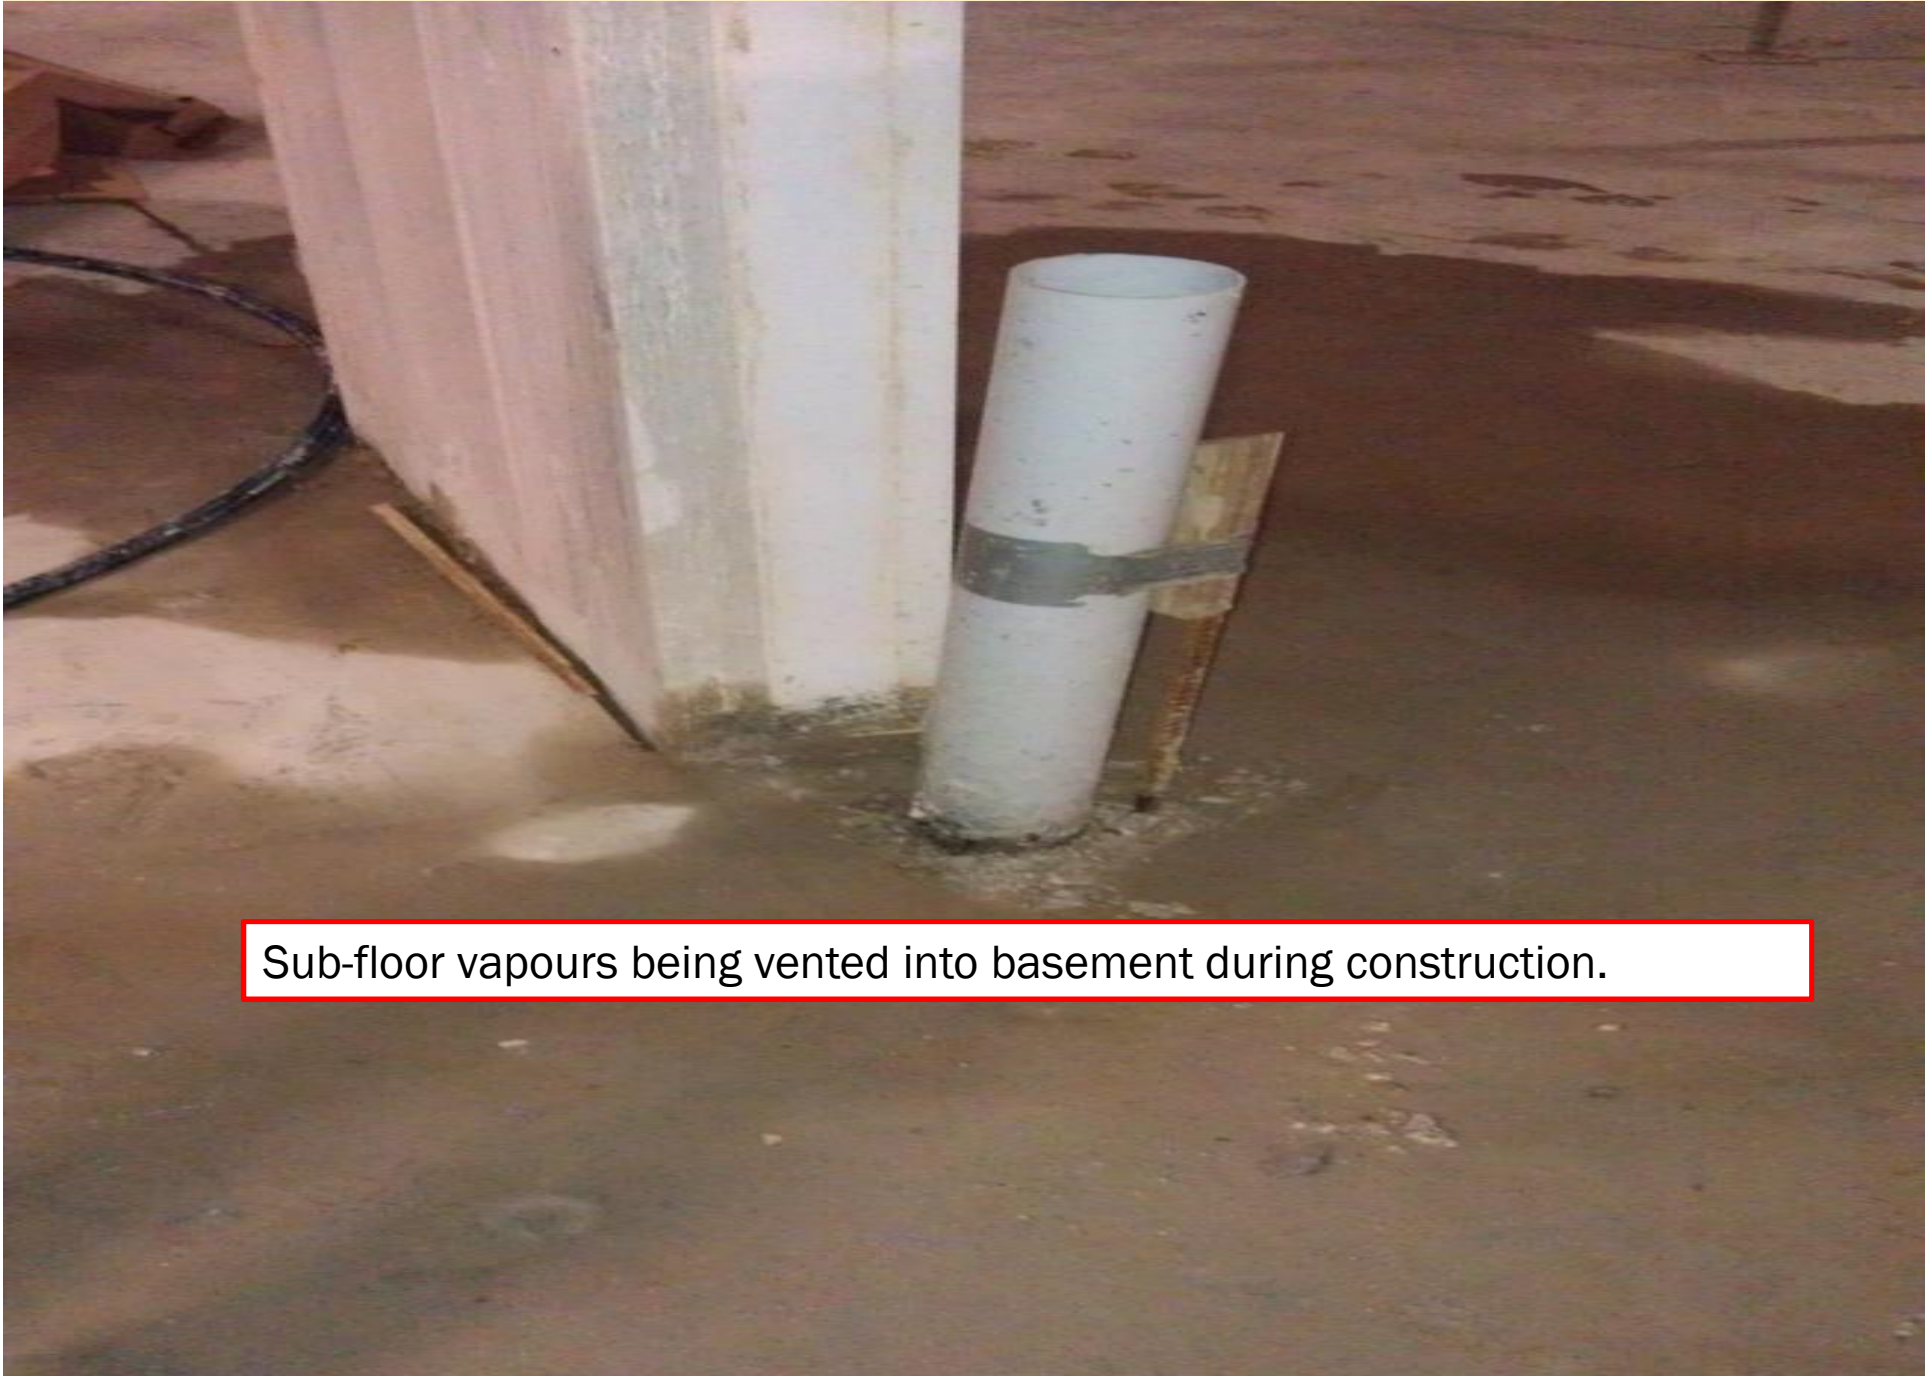
Sub-floor vapours being vented into basement during construction.
