Tree Removals.

The table below lists the details of the trees to be removed, including tree location, tree species and condition assessment. For replacement details, please refer to map below.

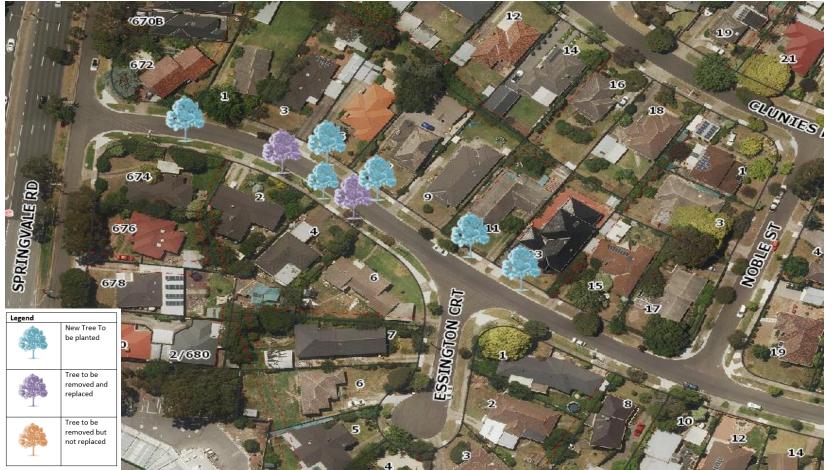
MAP - Removals, Replacements & Infill Planting

The map below details the removals, replacements and infill plantings. All other trees have been assessed as having more than 2 years useful life and will be retained.

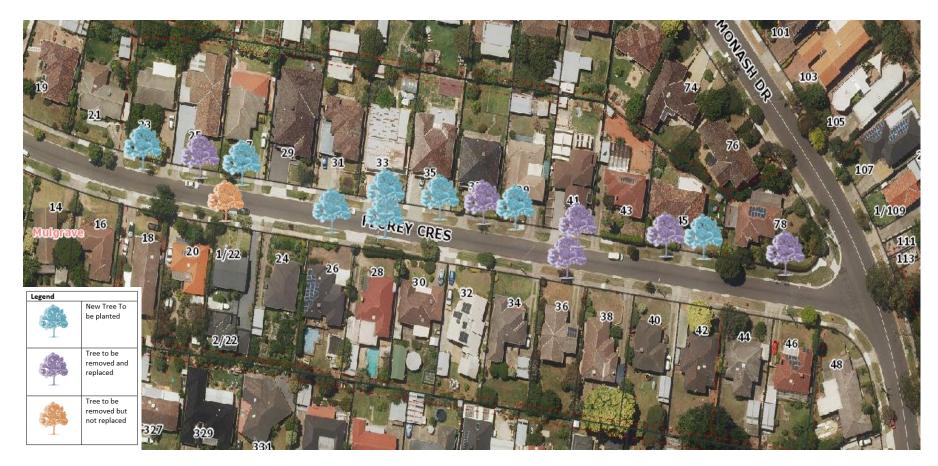
MAP - Removals, Replacements & Infill Planting

The map below details the removals, replacements and infill plantings. All other trees have been assessed as having more than 2 years useful life and will be retained.
