# ARBORICULTURAL REPORT 71 – 73 BEDDOE AVENUE, CLAYTON.

14 DECEMBER 2018

D18-942851

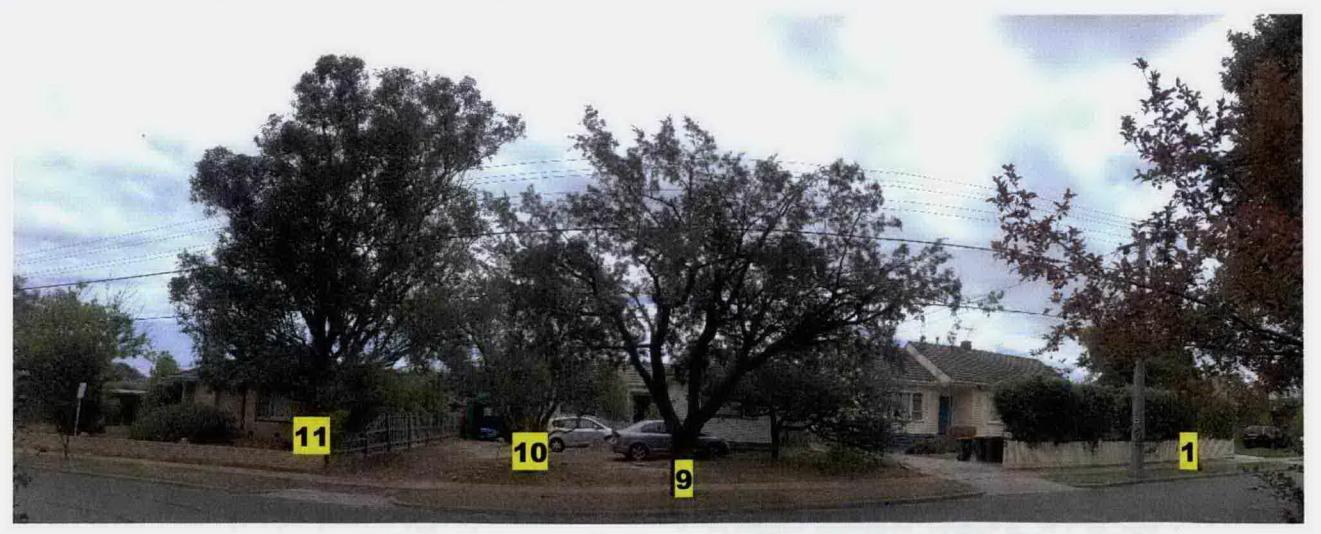
Image 2: Street frontage 23/10/2018, showing trees 11, 10, 9 & 1 (left - right).

- 5.1 Tree 1, is a council street tree of poor structure. It is not worthy of retention and its removal and replacement could be justified, with the approval of the responsible authority.

- 5.4 Tree 9, a council owned street tree at the front of 73, is proposed to be removed to allow for the installation of the new driveway crossover. There is opportunity to replace it with a new tree in the nature strip, further north because the crossover to 71 is being removed. Its removal and replacement must be approved in writing by the City of Monash.

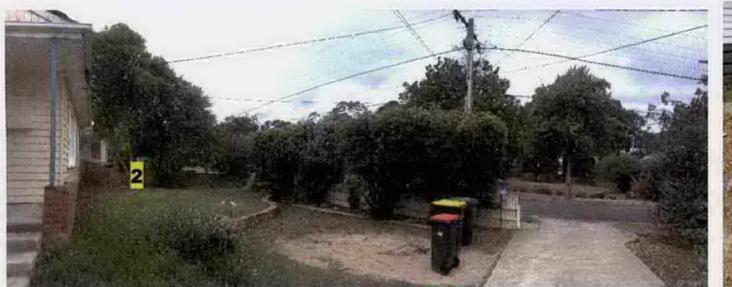
Image 3: Front yard of 71.

- 5.2 There are no trees within 71, that are of a condition worthy of retention and therefore they all have a low arboricultural value. They are all proposed to be removed.

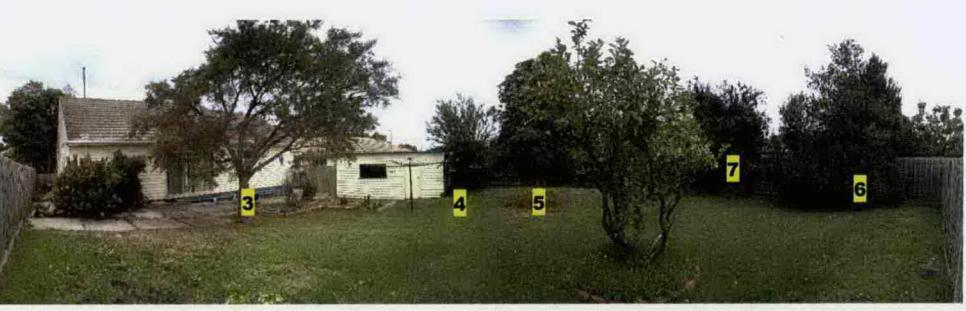
Image 5: Rear yard of 71, showing Trees 3 – 7. Lemon in foreground not surveyed, riddled with wasp gall.

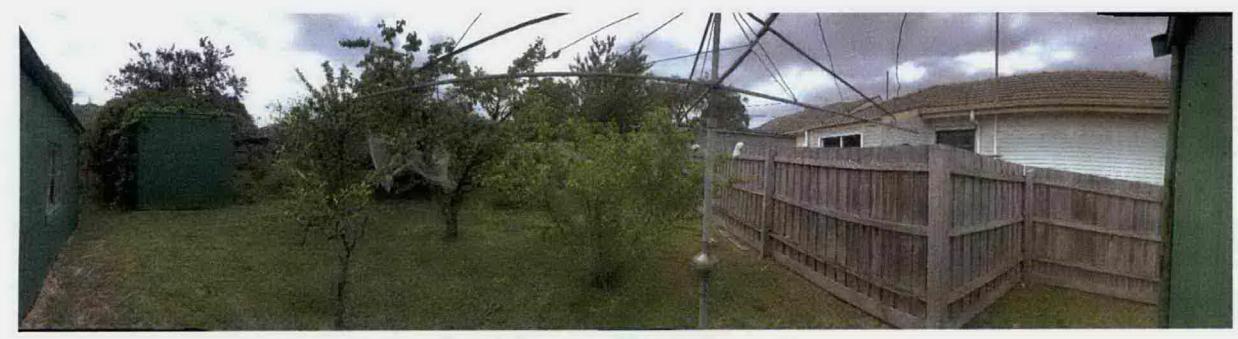
Image 6: Rear yard of 73 showing Tree 12 behind shed and other fruit trees not assessed.

- 5.3 There are no trees in 73 that are worthy of retention because of their poor condition. There are several fruit trees in the rear yard, that were not assessed, due to their small size.

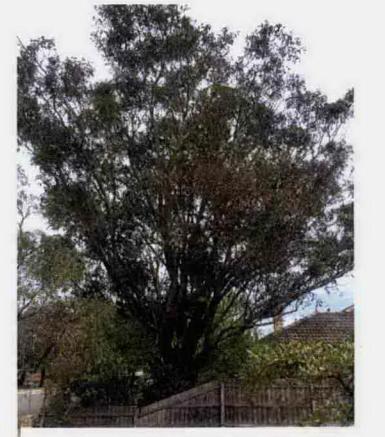
Image 7: Tree 11, looking from 73

- 5.5 Tree 11 and 13 are growing on the boundary in 75 and need to be protected in accordance with AS-4970. Their TPZ's cannot be encroached greater than 10% of their overall TPZ, unless it can be proven the trees will not be detrimentally impacted. I.e. a non-destructive root investigation.

- 5.6 Tree 11, is encroached 17% in total. However, 7% of that is for the vehicle crossover and section of driveway in the front setback, before it descends into the basement. If this area is constructed at existing ground level and made permeable, then Tree 13 can be retained in a healthy condition. The large Lemon Scented Gum, whose stump remains, was growing in this area and is likely to have prevented many roots from Tree 11 to encroach into the alignment of the driveway. Thus, it is not expected that roots of Tree 11 will be significantly impacted, if at all.

- 5.8 Installation of underground services I.e. gas, water etc. are not to be trenched through the TPZ of retained trees, including council and neighbouring trees. Boring must be used or hydro-vac, if installing services within the TPZ.

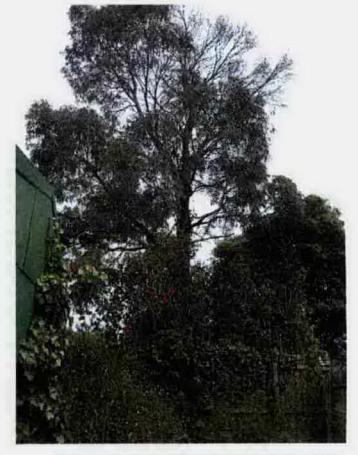
Image 8: Tree 13, with top dying off

- 5.7 Tree 13, Is encroached 8.8% by the basement. This is within the 10% allowed in accordance with AS-4970 'Protection of Trees on Development Sites, and therefore can be retained in a healthy condition.
