Addendum to Arboricultural Report (009978) - Design Review – Brandon Park Shopping Centre

I advise the following in relation to the tree impact assessment undertaken with regard to the proposed Residential and Mixed Use developments in the northeast corner of Brandon Park Shopping Centre, in Wheelers Hill.

1. Residential (TPA/52260)

2. Mixed Use (TPA/52250)

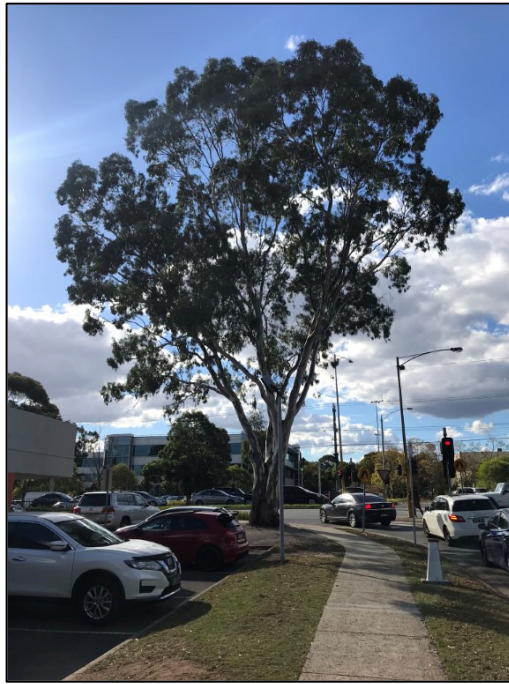
Image 1. Tree 55

Two trees (Trees 55 & 56) are considered for this development application. Tree 55 is a High rated River Red Gum (*Eucalyptus camaldulensis*) growing on the corner of Brandon Park Drive and Ferntree Gully Road (Image 1). Tree 56 is a Mod.A rated Red Ironbark (*Eucalyptus sideroxylon*) growing on Brandon Park Drive (Image 2). Both trees are growing on the site boundary so it is unclear whether they are council or privately managed trees. The intention is to retain both trees within the landscape.

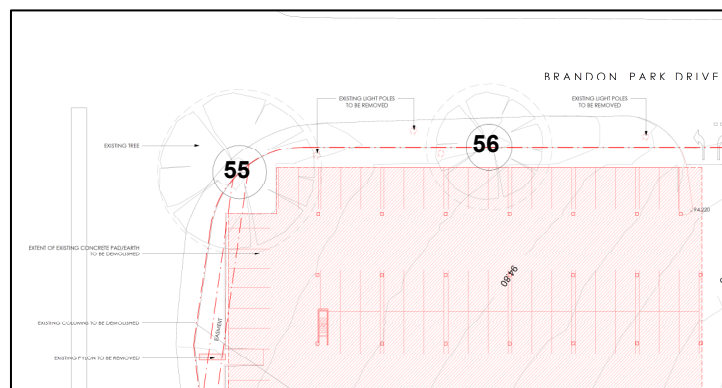
Figure 1. Edited extract of DA060 – Demolition ground plan (tree numbers added).

- a. **Demolition:** As shown in Figure 1, demolition includes removal of the existing carpark, including the asphalt road surface and the raised carpark structure. As shown in Images 1-2 and in Figure 1, the carpark kerb and asphalt surface are close to both trees, so there is a moderate possibility that tree roots exist here. It is therefore important that the demolition is undertaken in a root sensitive manner to protect any underlying roots from damage.

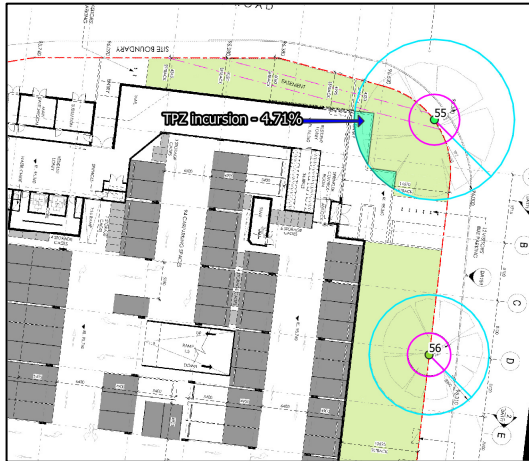
Figure 2. Edited extract of DA100A (proposed mezzanine plan). Tree points coloured according to arb rating; Bright green = High, Light green = Mod.A. Light blue circles = TPZs, magenta circles = SRZs.

- b. **Ground floor:** As shown in Figure 2, the ground (lowest) floor of the proposed residential building would intercept the TPZ of Tree 55 by ~4.7%. This is considered minor TPZ encroachment under the Australian Standard (AS4970) and this level of incursion is not expected to impact the tree's ongoing viability or condition. It is noted in Figures 5&6, that fill is proposed between the new building and both tree stems. The following is recommended to prevent fill impacts to the tree root zone:
- i. The level of the existing permeable environment should remain unaltered.
 - ii. Fill over the existing asphalt area will likely be tolerated although this should be kept to a depth of <100mm within 5 metres of the trees.
 - iii. If a retaining wall is required to achieve this, the wall should be supported by isolated pegs or similar, i.e. a continuous strip footing should not be used.

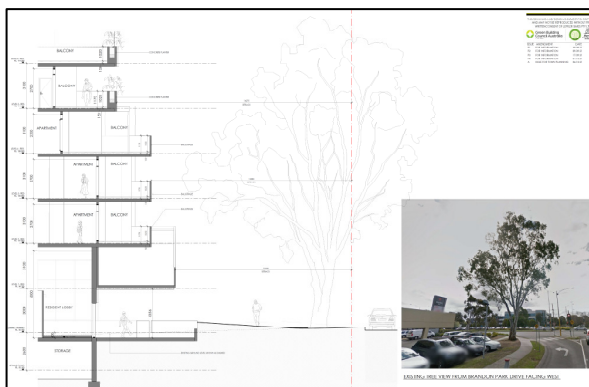
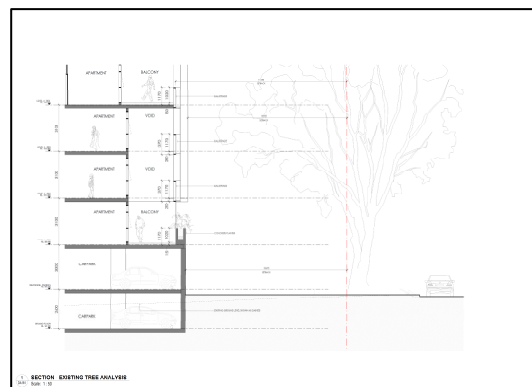
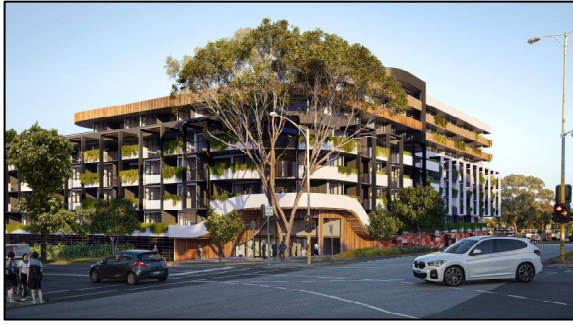
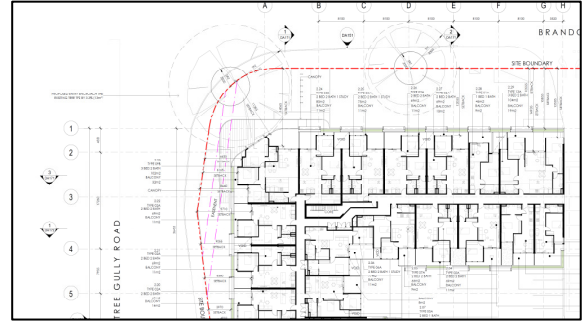
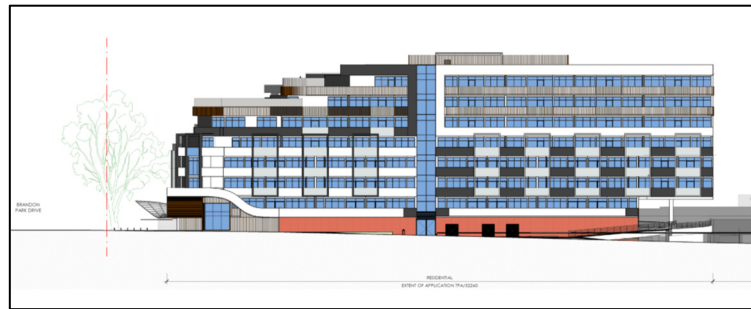
- c. Above ground floors:** Figures 5-9 indicate that there will be no physical conflict between the building and either tree crown although some minor pruning may be required, depending on construction requirements (e.g. scaffolding). The 'architectural canopy' on the corner of the building is the only area that may come into close proximity to the crown of Tree 55 during construction (as seen in Figures 8 & 9). If any pruning were required, it would be removal of one lower branch (<5% total live crown), which the tree would be expected to tolerate. Tree 56 is set back adequately from the proposed building and there would be no anticipated pruning requirements.

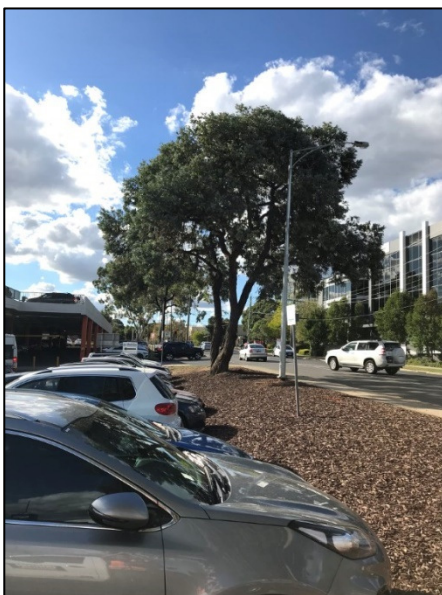
Image 3. Tree 57

Five trees (Trees 57-62) are considered for this development application. Tree 57 is a Mod.A rated Argyle Apple (*Eucalyptus cinerea*), Tree 58 is a Mod.B rated Spotted Gum (*Corymbia maculata*), Tree 59 is a Mod.C rated Southern Blue Gum (*Eucalyptus globulus*), Tree 60 is a Mod.B rated Red Ironbark (*Eucalyptus sideroxylon*), Tree 61 is a Mod.B rated Spotted Gum and Tree 62 is a Mod.A rated Spotted Gum. All are growing along Brandon Park Drive. Trees 57-60 all appear to be just outside the site boundary and are thus council managed trees while Trees 61 & 62 are within the property. The intention is to retained all five trees within the landscape.

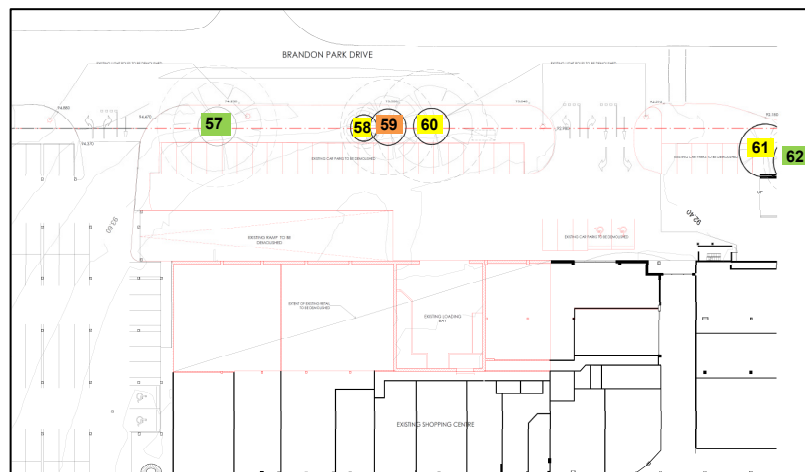
Figure 10. Edited extract of DA060 – Demolition ground floor plan (tree numbers added). Tree numbers colour coded according to arb. rating; light green = Mod.A, yellow = Mod.B, orange = Mod.C.

- a. **Demolition:** As shown in Figure 10, demolition includes removal of the existing carpark, including the asphalt road surface and kerbs along with existing ramp, loading bay and part of the retail building. As shown in Images 3-5 and in Figure 10, the carpark kerb and asphalt surface are close to all trees (aside from Tree 62), so there is a moderate possibility that tree roots exist here. It is therefore important that the demolition is undertaken in a root sensitive manner to protect any underlying roots from damage.

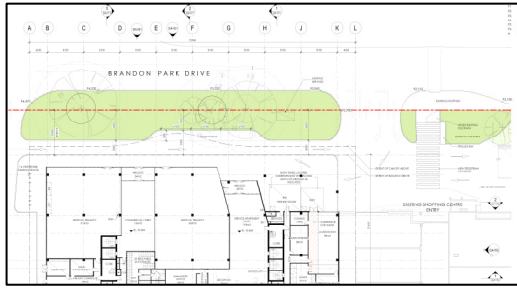
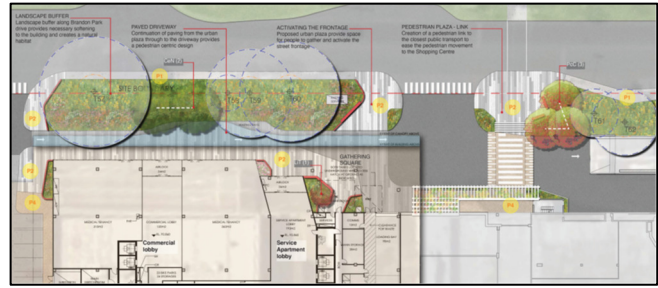
- b. **Ground floor:** As shown in Figures 11 & 12, the proposed ground floor plan will result in no additional TPZ encroachment into any of the five trees and will expand the permeable growing environment of all trees. Nevertheless, construction of the new road and waiting bays will take place within some TPZs so care needs to be taken to ensure any underlying roots are not damaged. It is noted in Figure 14, that fill is proposed between the waiting bays and the trees. The following is recommended to prevent fill impacts to the tree root zone:

- i. The level of the existing permeable environment should remain unaltered.
- ii. Fill over the existing asphalt area will likely be tolerated although this should be kept to a depth of <100mm within 5 metres of the tree.
- iii. If a retaining wall is required to achieve this, the wall should be supported by isolated pegs or similar, i.e. a continuous strip footing should not be used.

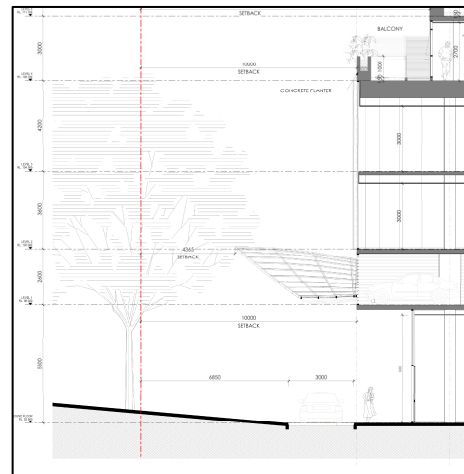
- c. **Above ground floors:** The section diagram at Figure 14 measures the relative setback of the building edge to the site boundary at ~10m. This should be sufficient space for construction activities to take place without requiring any canopy pruning. The only part of the design that comes closer is the architectural canopy extending from the first floor, although as shown in Figure 13, this is positioned outside the canopy of the larger trees so it is also not expected to necessitate any canopy pruning.

Figure 14. Extract of DA181 – Street interface section 1. Note tree silhouette (Tree 57) is in the foreground in this section so the furthest extent of the architectural canopy does not intercept the tree canopy (See DA101)
