12 November 2021

Addendum to Arboricultural Report (009978) - Design Review – Brandon Park Shopping Centre

1. Residential (TPA/52260)

2. Mixed Use (TPA/52250)

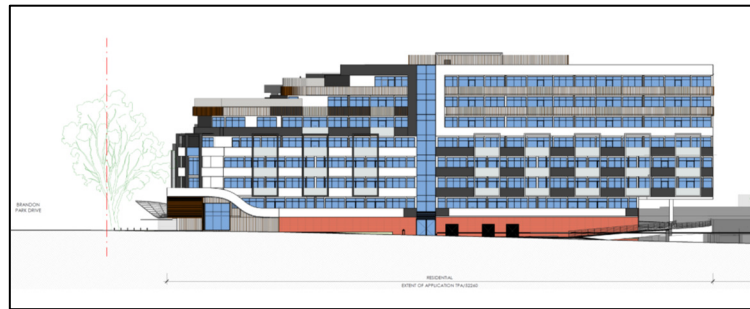
- c. Above ground floors:** Figures 5-9 indicate that there will be no physical conflict between the building and either tree crown although some minor pruning may be required, depending on construction requirements (e.g. scaffolding). The 'architectural canopy' on the corner of the building is the only area that may come into close proximity to the crown of Tree 55 during construction (as seen in Figures 8 & 9). If any pruning were required, it would be removal of one lower branch (<5% total live crown), which the tree would be expected to tolerate. Tree 56 is set back adequately from the proposed building and there would be no anticipated pruning requirements.

Figure 5. Extract of DA183 (street interface section), relative to Tree 55.

Figure 6. Extract of DA184 (street interface section), relative to Tree 56

Figure 7. Extract of DA221 – artists impression of northeast section showing Tree 55 relative to NE corner of building.

Figure 8. Extract of DA102 – Level 2 Plan with relative distance of 'architectural canopy' from crown of Tree 55.

Figure 9. Extract of DA161 (streetscape elevations) – north section showing Tree 55 relative to building and architectural canopy.

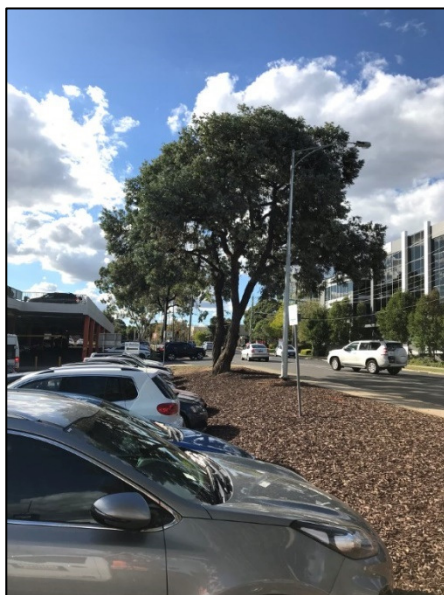
Image 3. Tree 57

Five trees (Trees 57-62) are considered for this development application. Tree 57 is a Mod.A rated Argyle Apple (*Eucalyptus cinerea*), Tree 58 is a Mod.B rated Spotted Gum (*Corymbia maculata*), Tree 59 is a Mod.C rated Southern Blue Gum (*Eucalyptus globulus*), Tree 60 is a Mod.B rated Red Ironbark (*Eucalyptus sideroxylon*), Tree 61 is a Mod.B rated Spotted Gum and Tree 62 is a Mod.A rated Spotted Gum. All are growing along Brandon Park Drive. Trees 57-60 all appear to be just outside the site boundary and are thus council managed trees while Trees 61 & 62 are within the property. The intention is to retained all five trees within the landscape.

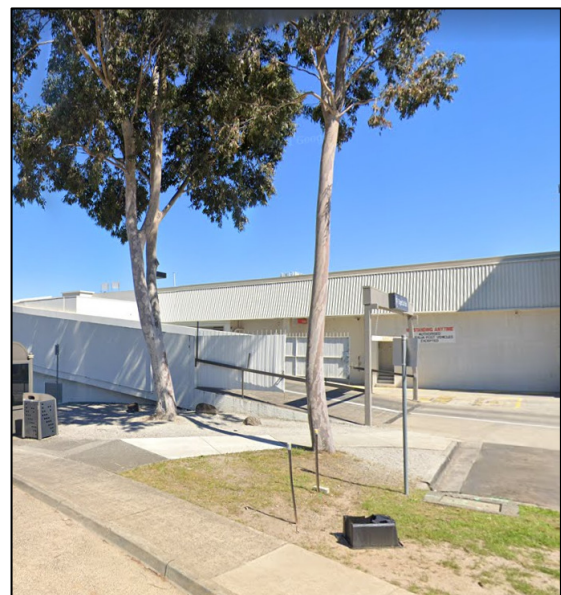
Image 4. Trees 61 & 62 (right to left)

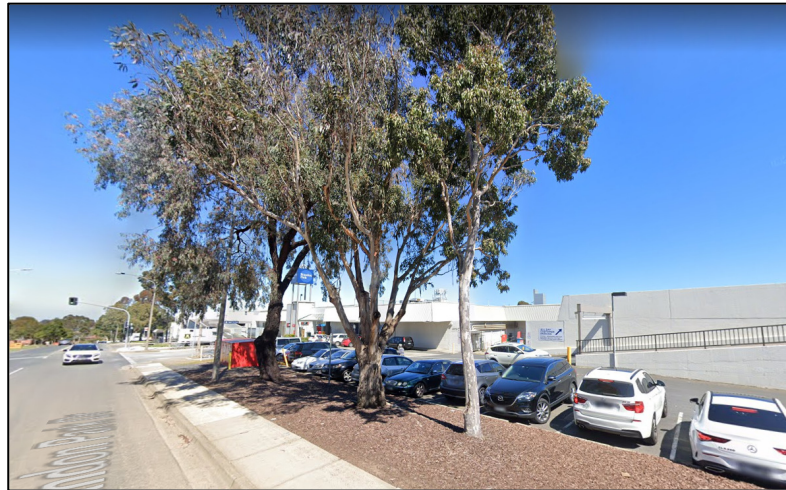
Image 5. Trees 58-60 (right to left)

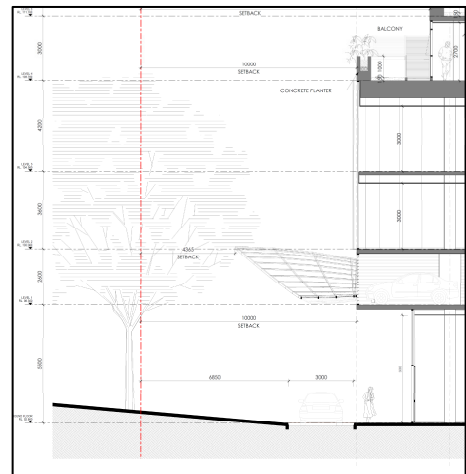
- c. **Above ground floors:** The section diagram at Figure 14 measures the relative setback of the building edge to the site boundary at ~10m. This should be sufficient space for construction activities to take place without requiring any canopy pruning. The only part of the design that comes closer is the architectural canopy extending from the first floor, although as shown in Figure 13, this is positioned outside the canopy of the larger trees so it is also not expected to necessitate any canopy pruning.

Figure 14. Extract of DA181 – Street interface section 1. Note tree silhouette (Tree 57) is in the foreground in this section so the furthest extent of the architectural canopy does not intercept the tree canopy (See DA101)
