Reference No. 1656748-001-P-Rev0

**LANDFILL GAS RISK ASSESSMENT**  
**10 ALVINA STREET OAKLEIGH SOUTH**

Spire Group Pty Ltd (Spire) engaged Golder Associates Pty Ltd (Golder) to provide a landfill gas risk assessment as part of the planning process for the redevelopment of the former Clayton West Primary School Site at 10 Alvina Street, Oakleigh South into a residential estate (Figure 1).

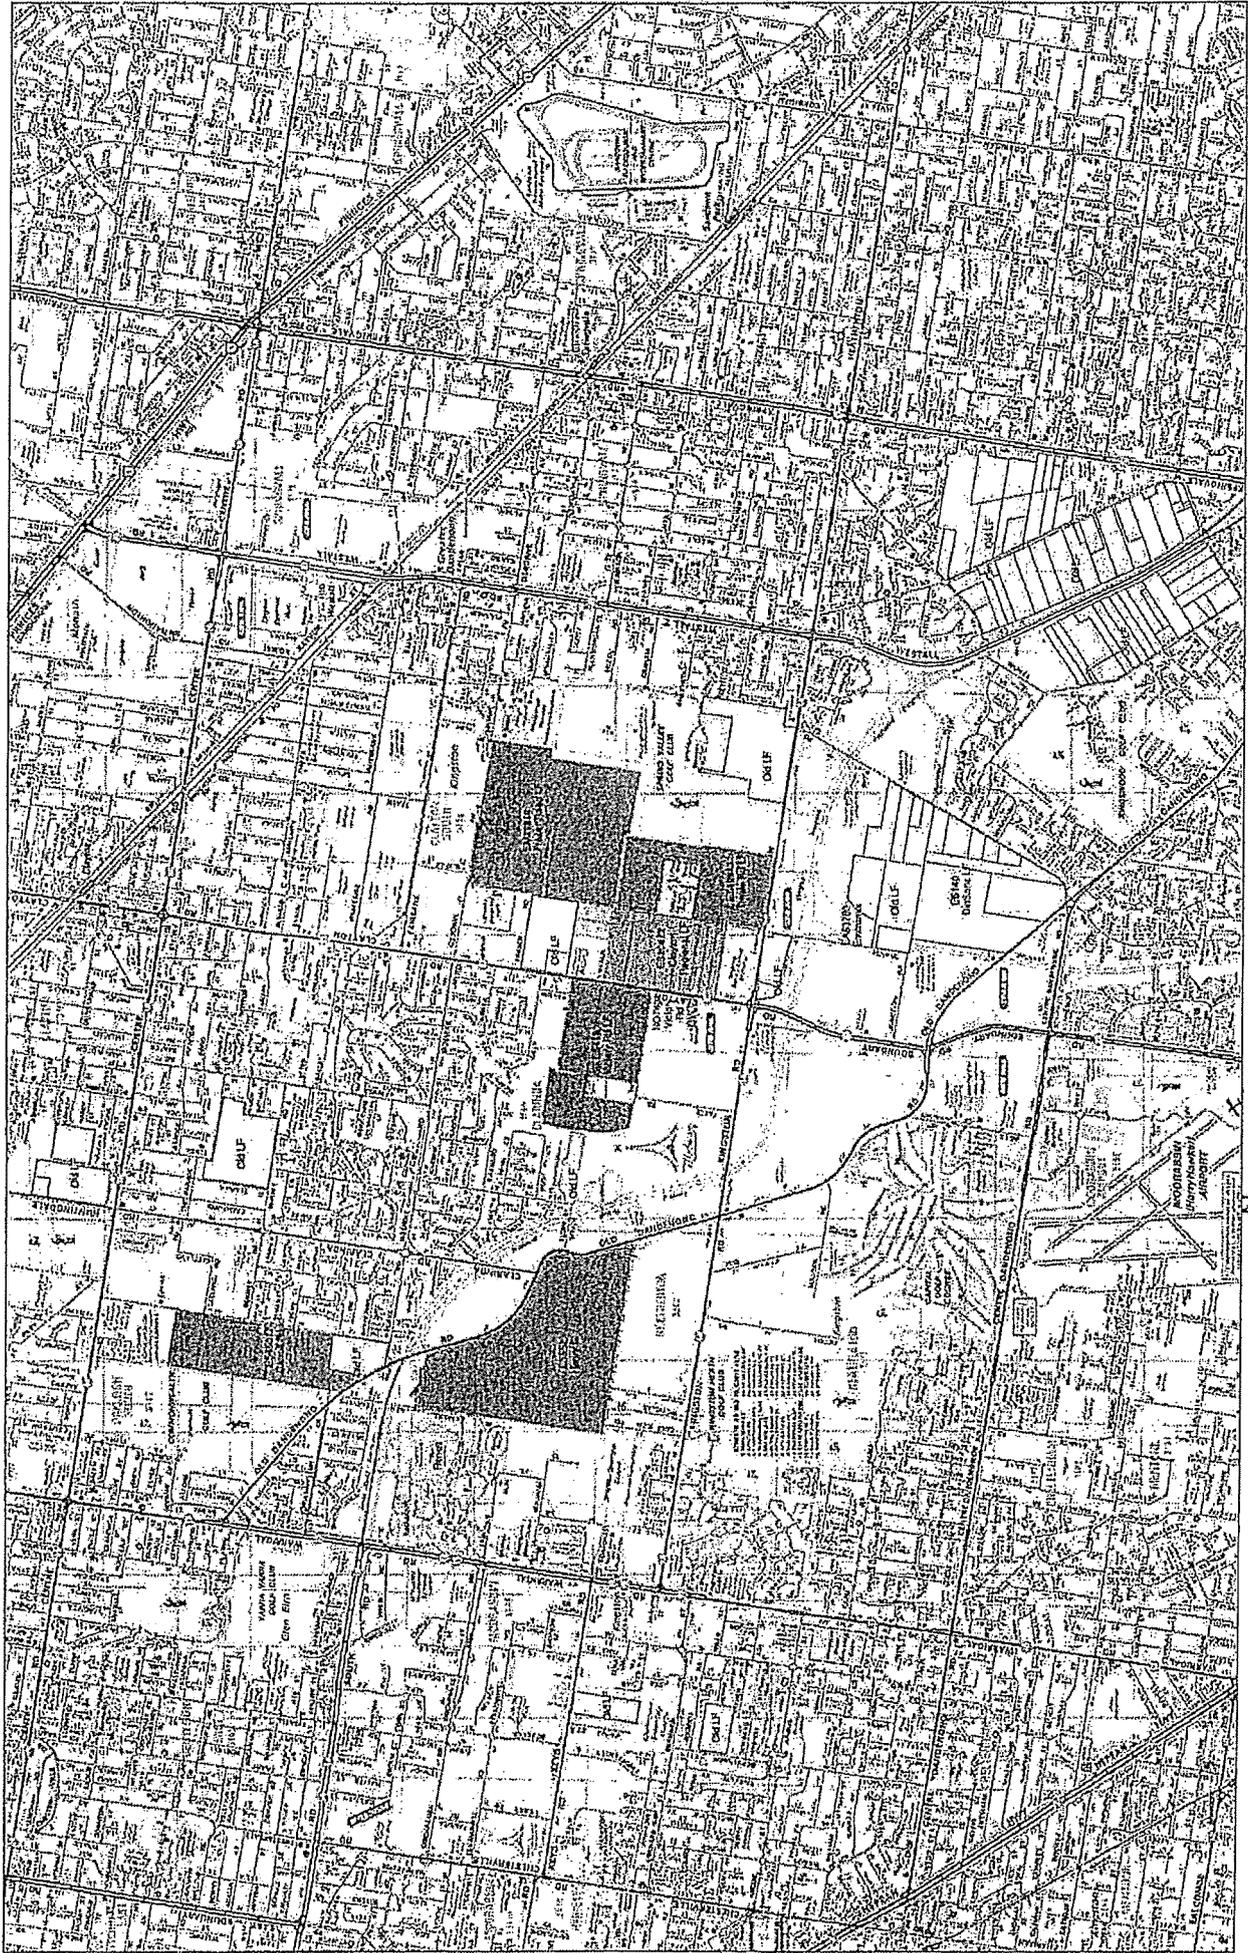
Clayton Area current and closed Landfills and Composters

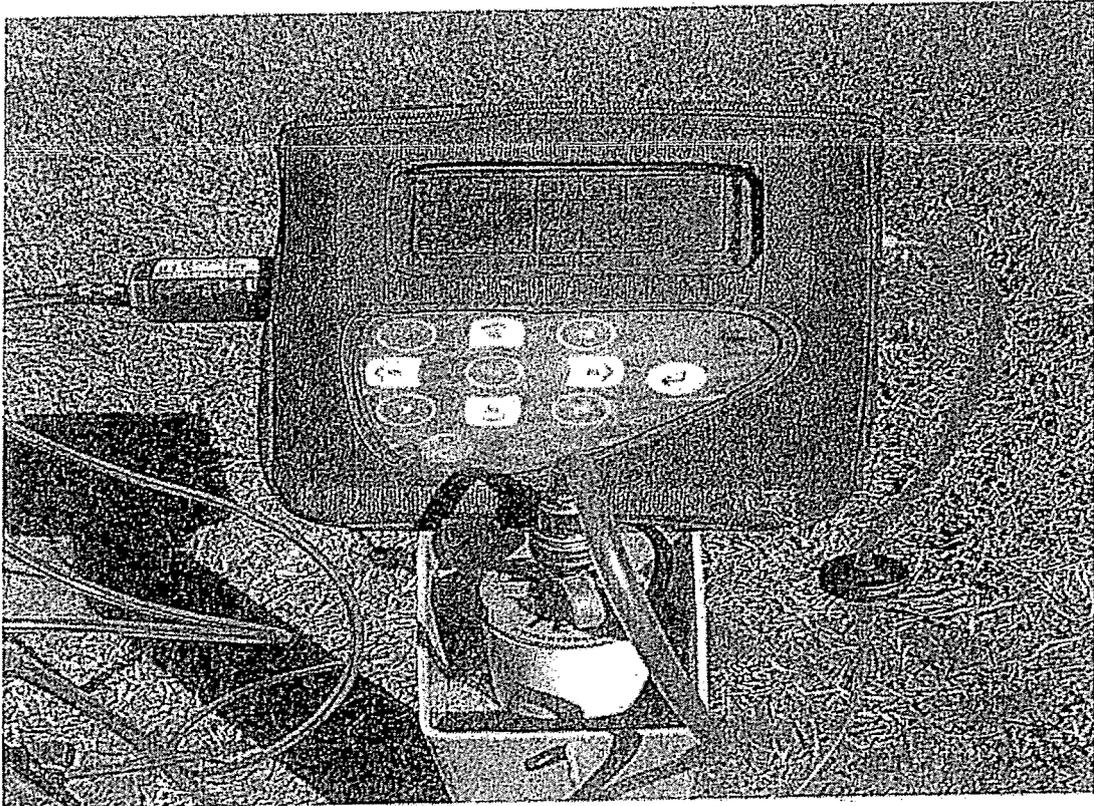
Photo 1 : Sampling with Landfill Gas Analyser

The extractive landfill gas analyser that was used to monitor the soil gas bores on site was the GA2000 Landfill Gas Analyser. It should be noted that the landfill gas analyser that was used does meet the performance specifications stated in Table 4.1 of the VIC EPA Draft Publication 1416 September 2011 - DRAFT LANDFILL GAS FUGITIVE EMISSIONS. Refer Appendix 6: Instrumentation Calibration Data.

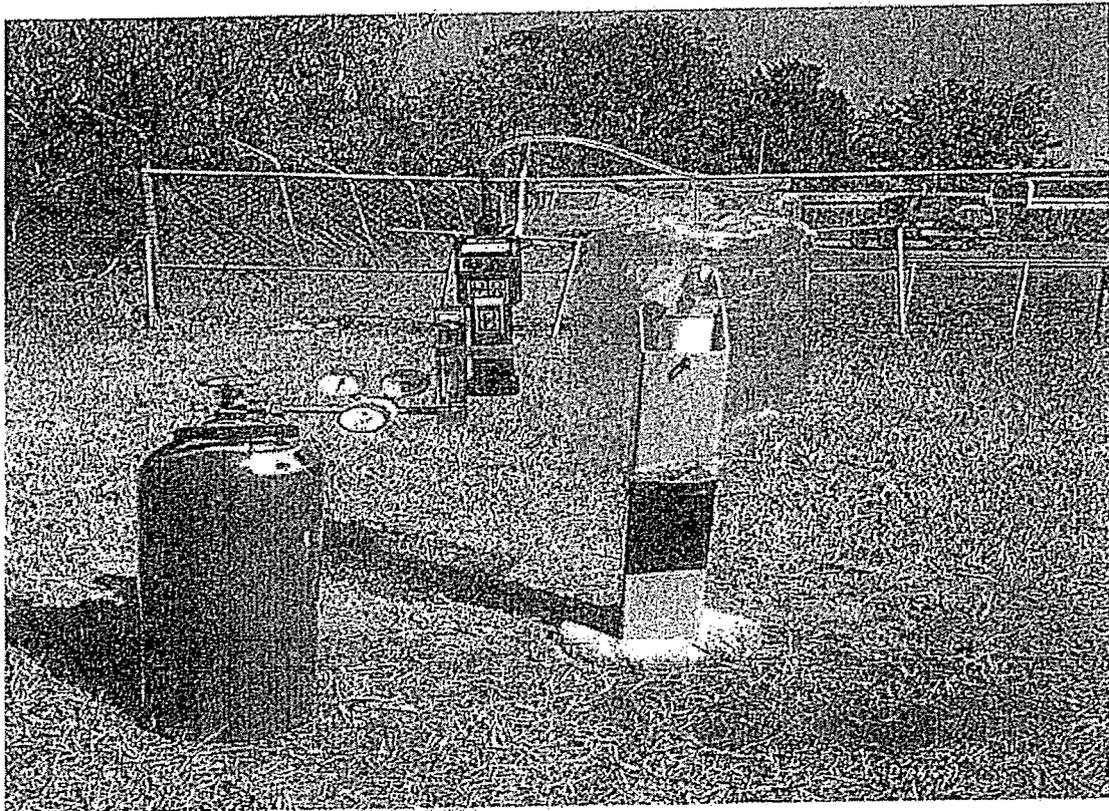
Photo 2 : Leak Testing of Gas Bore

All soil gas Bores were leak tested utilising Helium as a tracer in accordance with Eurofins mgt's In-House Method AISOP002.

The Extractive Helium Analyser that we used for leak testing of the bores was the GasCheck 5000is. This unit was calibrated with certified calibration gas. Refer Appendix 6: Instrumentation Calibration Data.

Soil Gas Probe	Sample Time (Hours)	Sample Depth (m)	Internal Diameter (mm)	Initial Pre-Purge Check (Pass / Fail)	Pre Purge He Probe Reading (% vol)	Helium Shroud Conc. (% vol)	Holding Volumes Removed	Purge Time (min)	Post Purge Helium Reading (% vol)	Helium Leak Check (Pass / Fail)	Comments
GB1	1108	1.8	50	Pass	<1	>95	>3	9	<1	Pass	
GB2	1150	2.0	50	Pass	<1	>95	>3	9	<1	Pass	
GB3	1130	1.9	50	Pass	<1	>95	>3	9	<1	Pass
