Tree Removals.

MAP - Removals, Replacements & Infill Planting

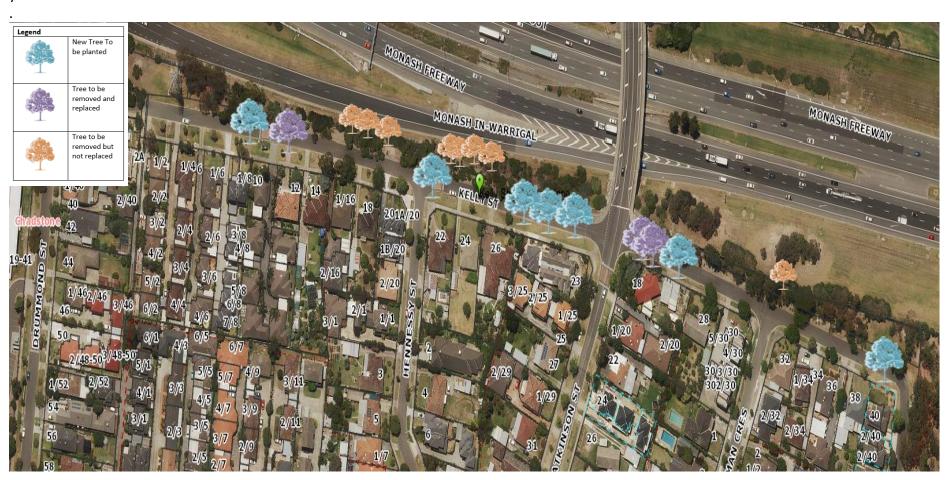
The map below details the removals, replacements and infill plantings. All other trees have been assessed as having more than 2 years useful life and will be retained
