Huntingdale Estate, Oakleigh South, VIC

Domain 4 Backfill Design Report
GEOTABTF09257AA-AQ Rev14

16 December 2022

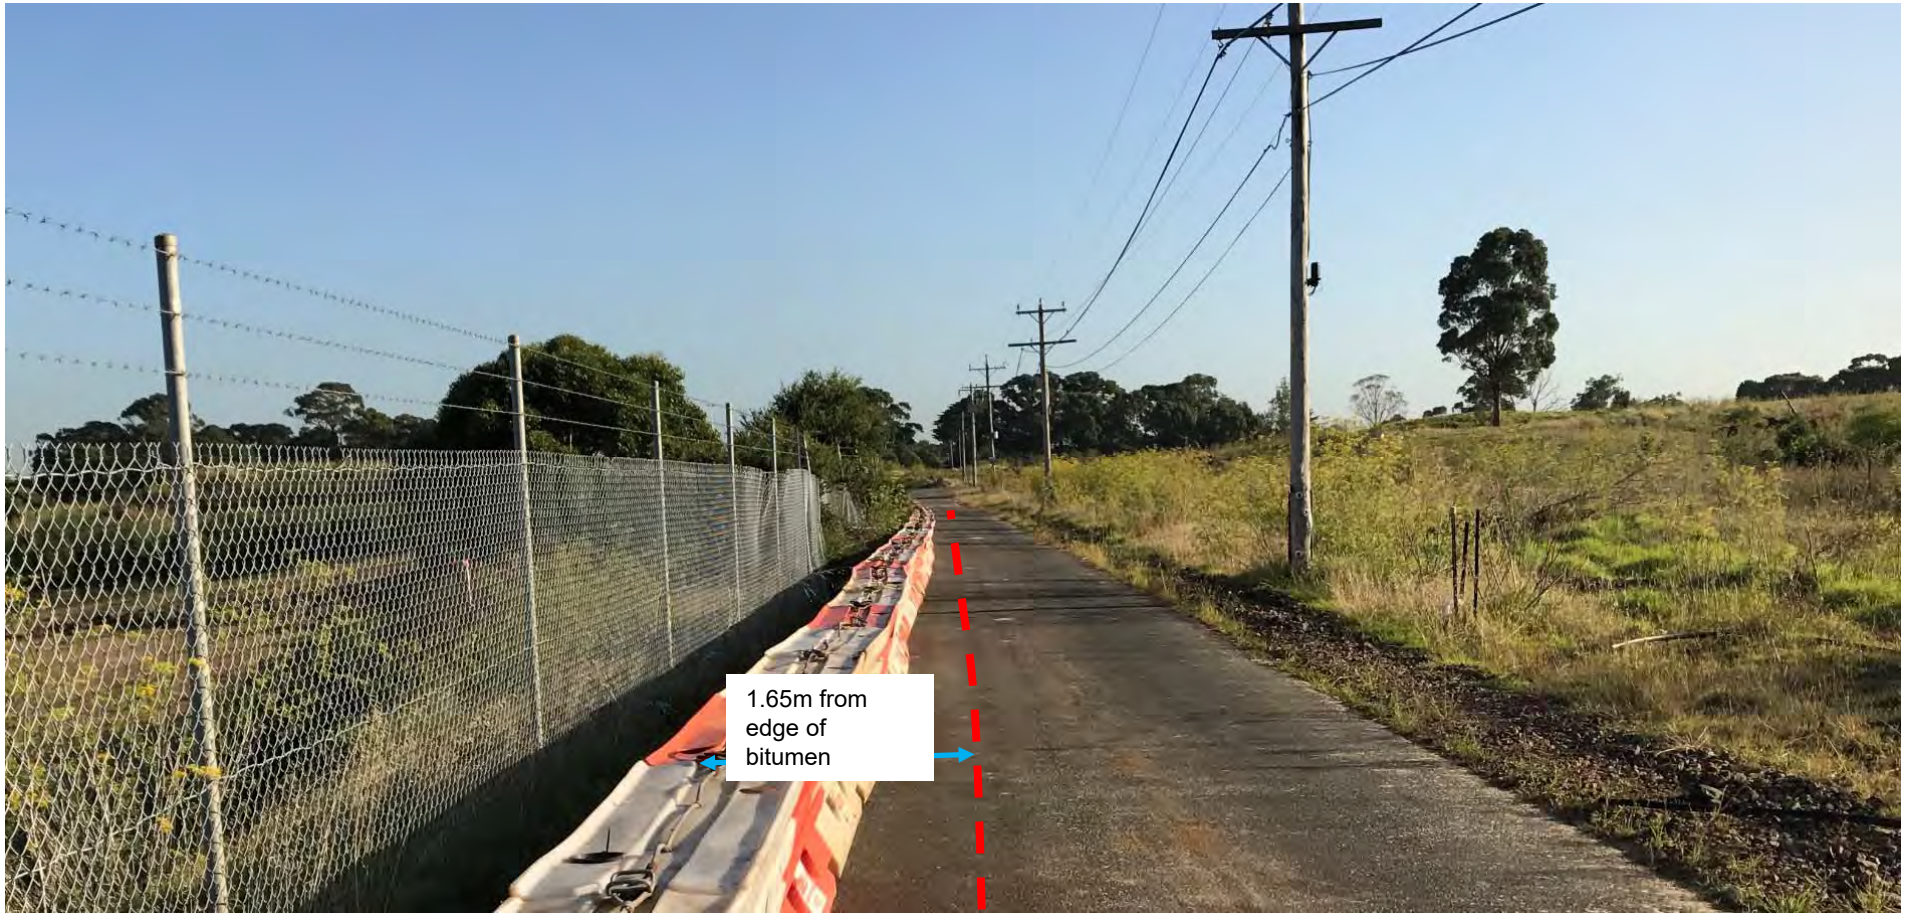
Exclusion Zone with 1.65m offset measured from the edge of the bitumen to be applied over a 57m length as shown in D03_Rev03. The barriers are to be located so that the truck wheel tracks are to be at least 1.65m from the edge of the bitumen.

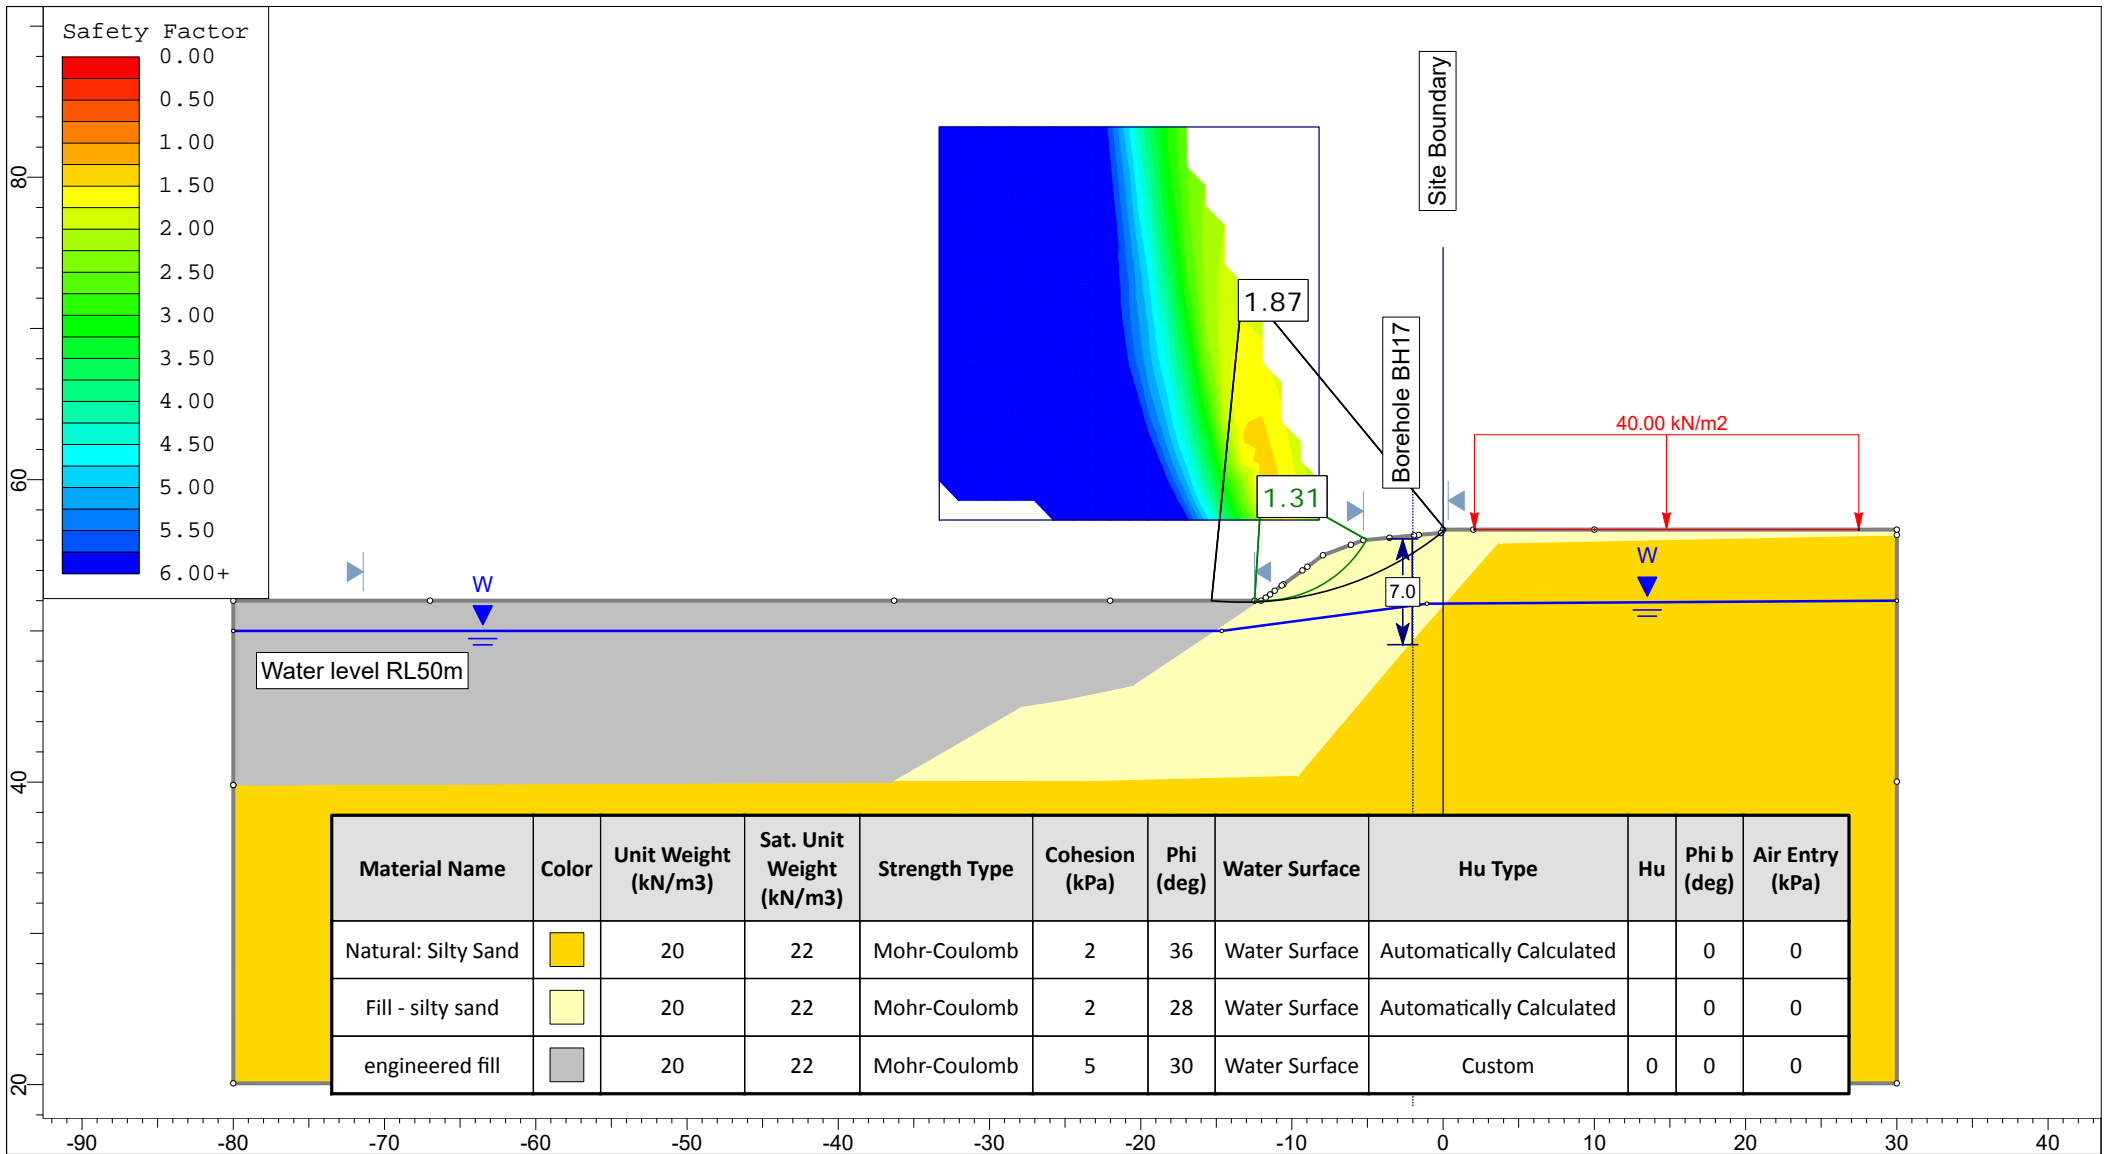
<i>Project</i>			Huntingdale Estate, Oakleigh		
<i>Analysis Description</i>			Domain 4 - Stability of south batter with fill platform at 52 mRL		
<i>Drawn By</i>	MF	<i>Scale</i>	1:500	<i>Company</i>	Talbot Road Finance Pty Ltd
<i>Date</i>	11/09/2017			<i>File Name</i>	SOUTH Figure C4.slim

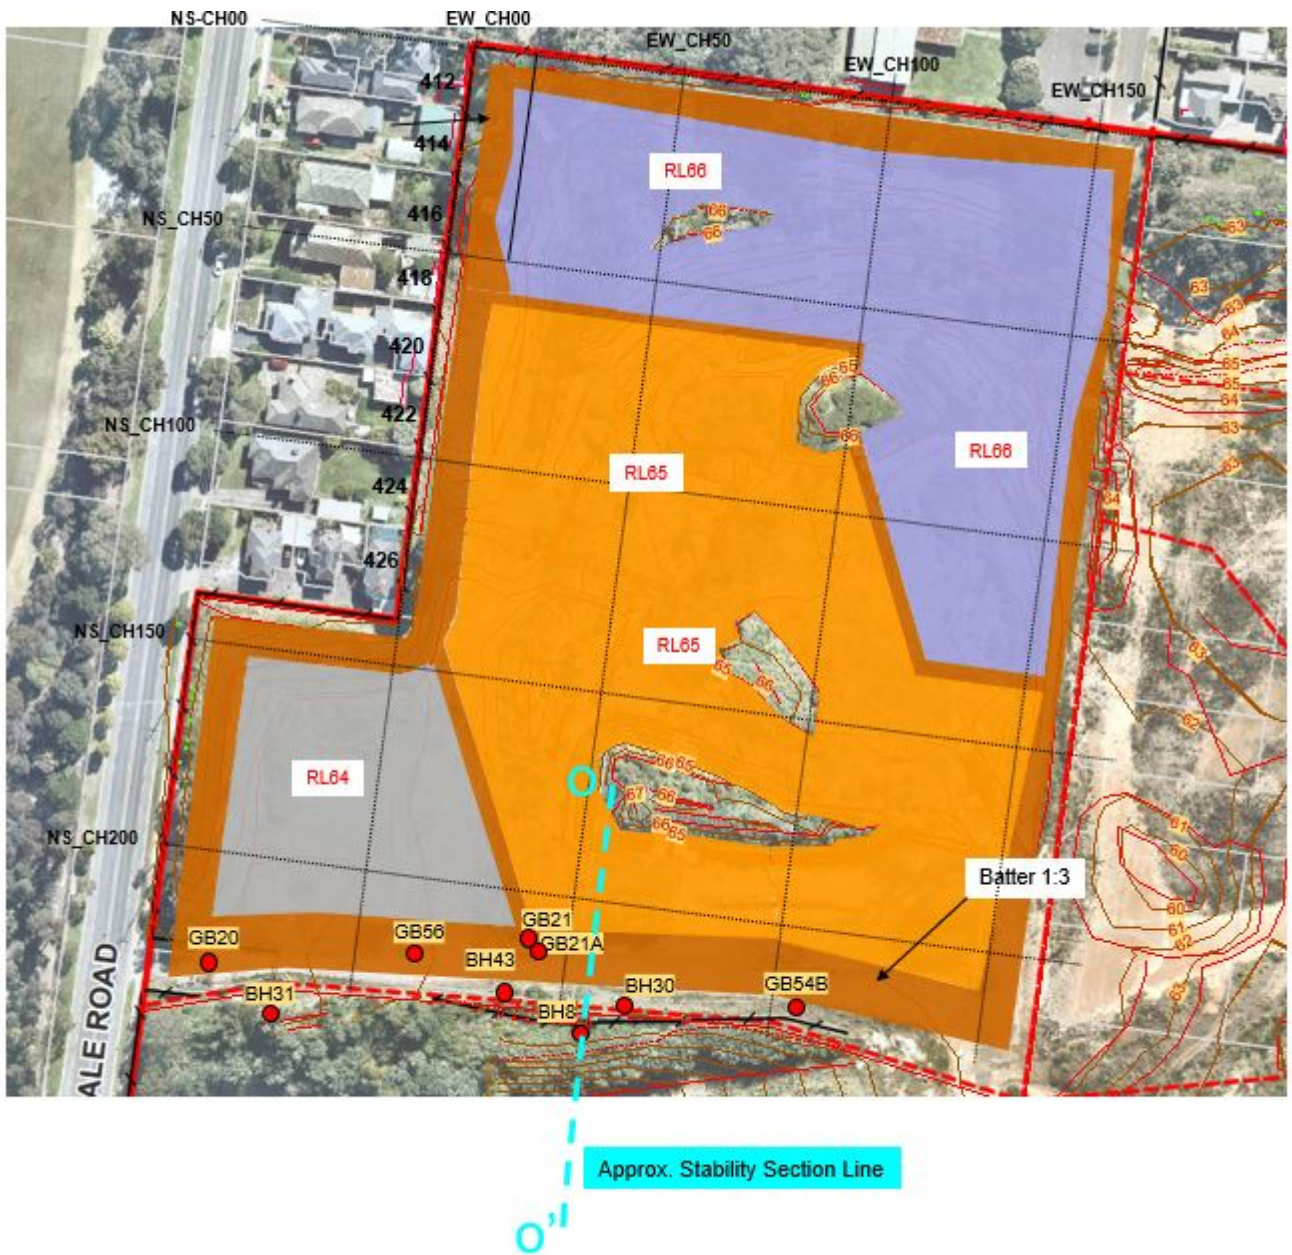
Figure D1 – Domain 1 proposed preload extending to the crest of the Domain 4 north batter

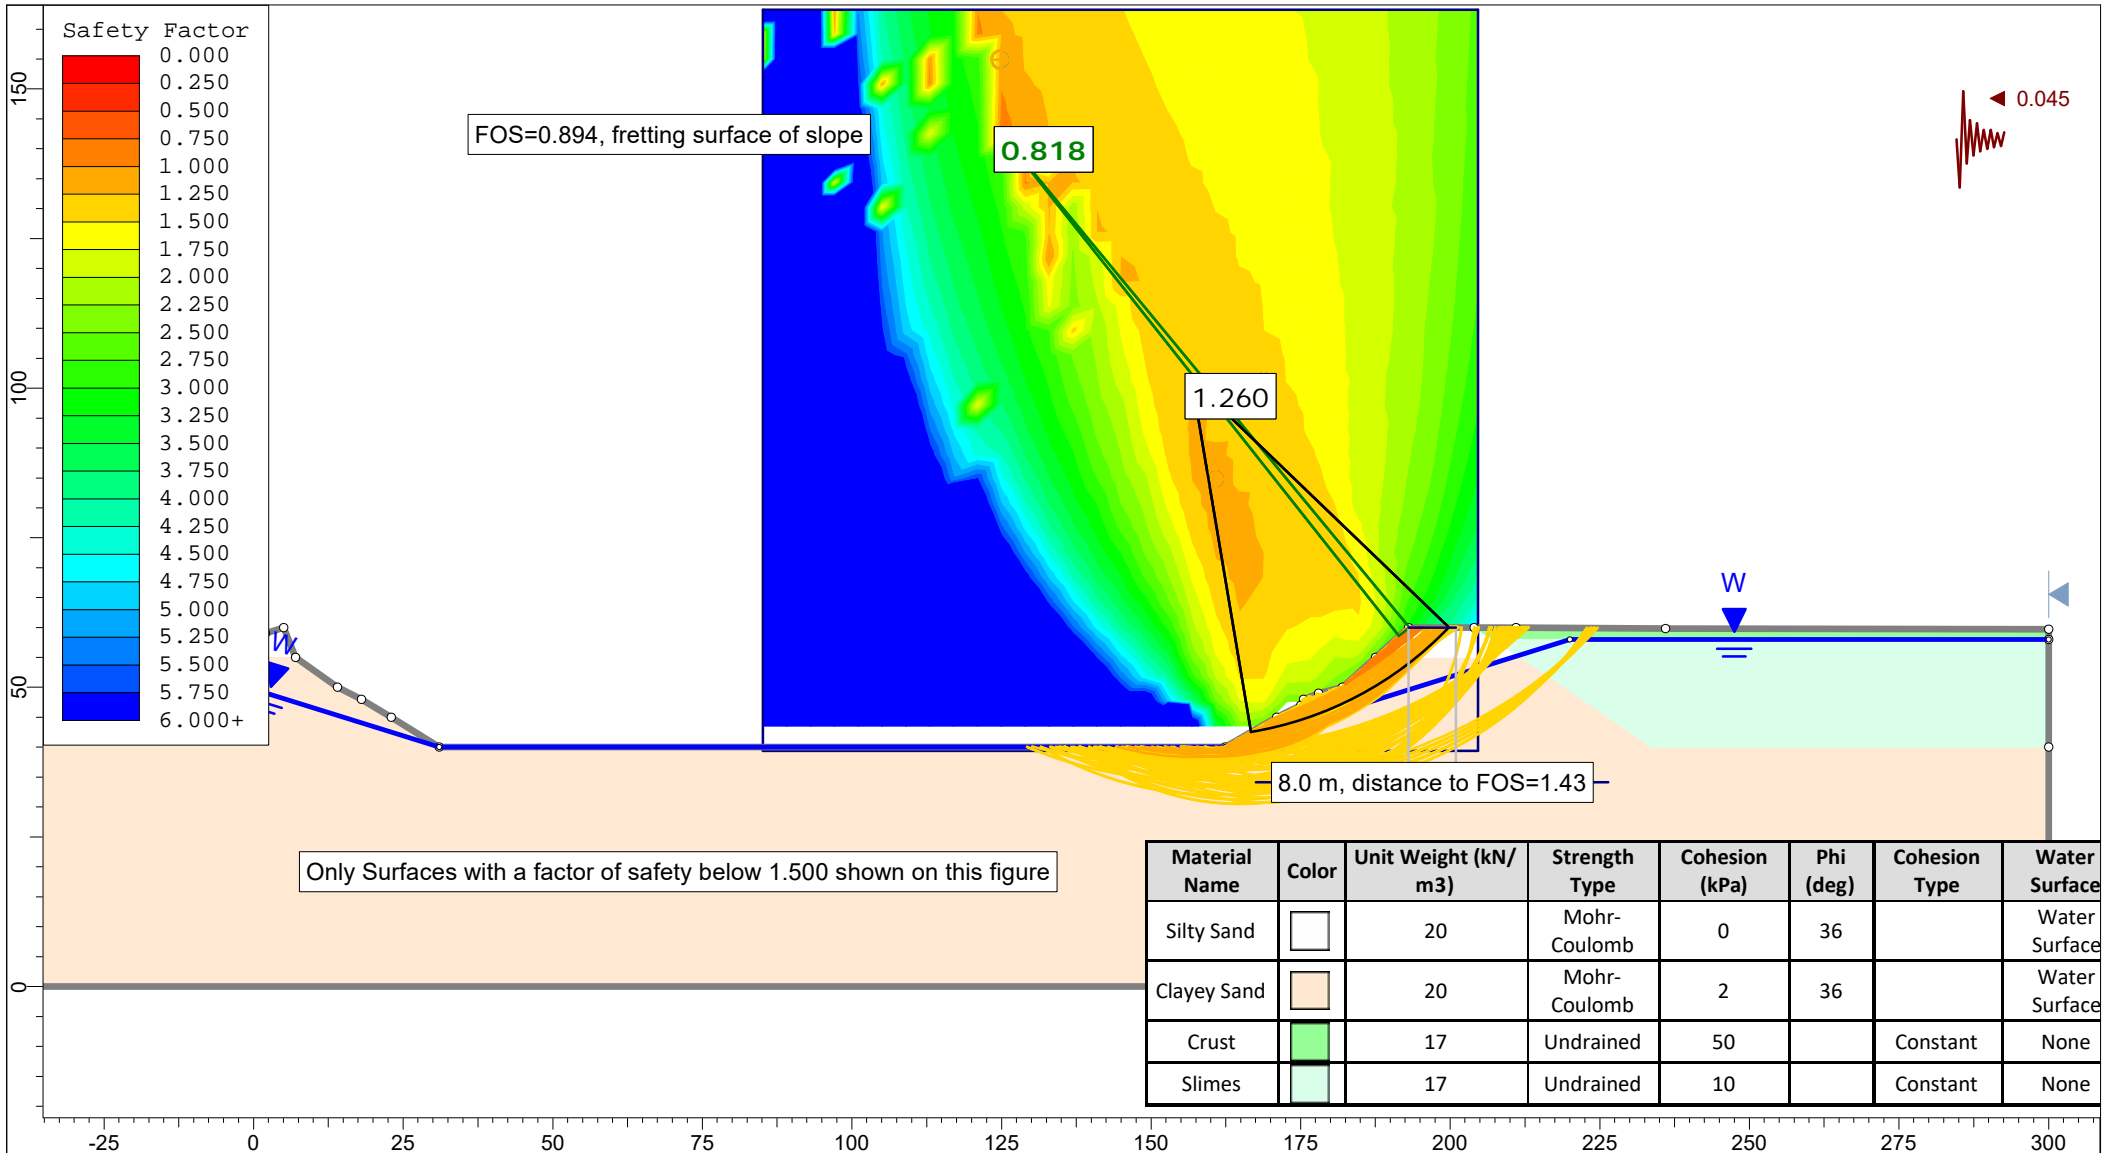
Project		Huntingdale Estate, Oakleigh South, Victoria	
Analysis Description		East batter - Earthquake loading	
Drawn By	CB/hhk	Scale	1:1264
Date		Sept 2021	
Company		Talbot Road Finance Pty Ltd	
File Name		EAST Figure F2.slim

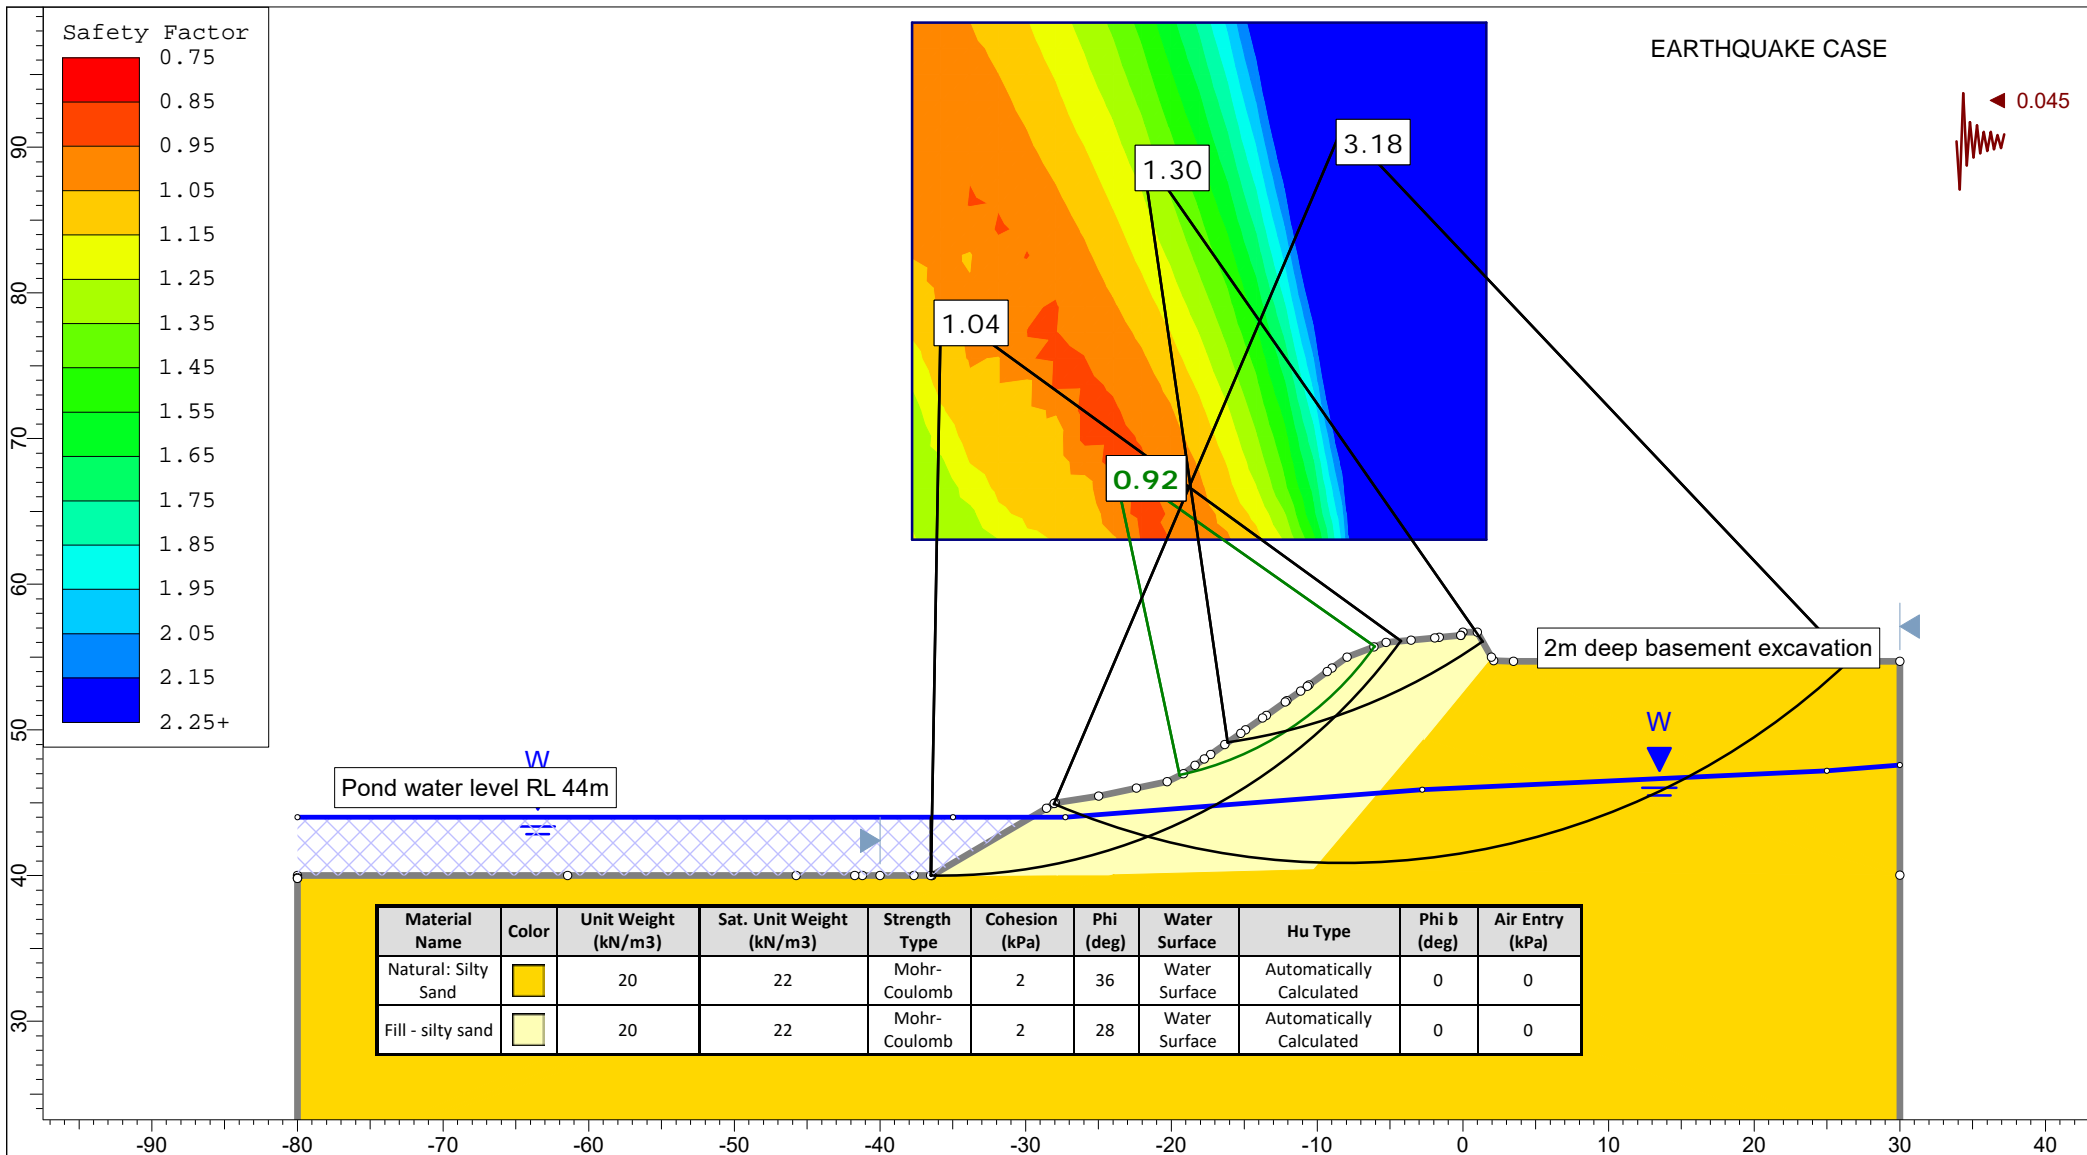
Project		Huntingdale Estate, Oakleigh	
Analysis Description		Domain 4 - Stability of south batter - current water level -After construction of apartments	
Drawn By	MF/HHK	Scale	1:519
Date		Sept 2021	
Company		Talbot Road Finance Pty Ltd	
File Name		SOUTH Figure G5a.slim
