# ARBORICULTURAL REPORT 71 – 73 BEDDOE AVENUE, CLAYTON.

14 DECEMBER 2018

D18-942851

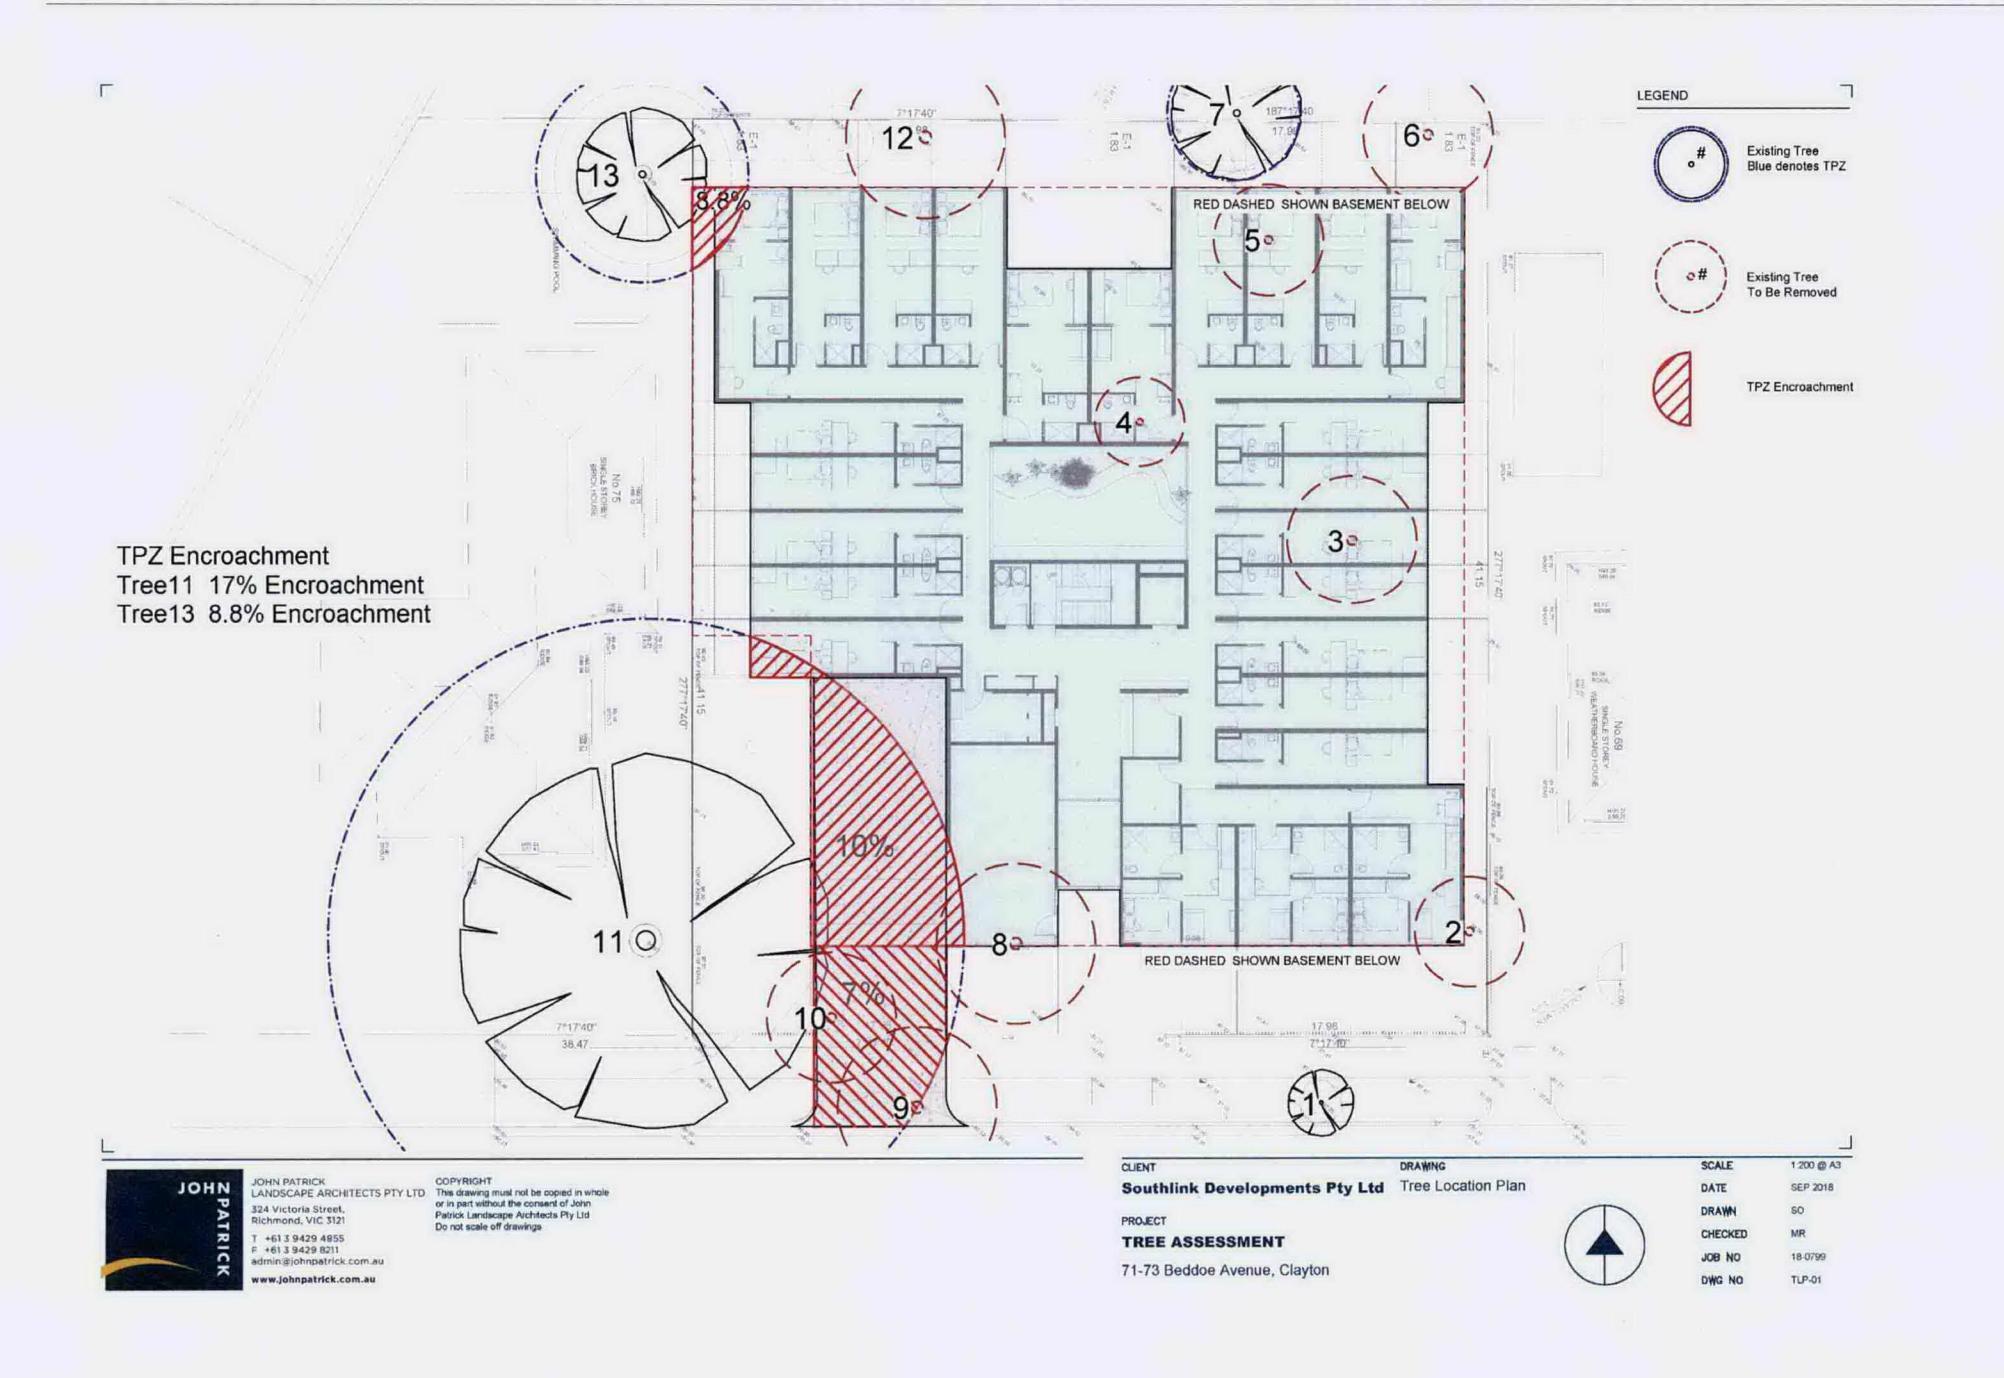
7 TREE LOCATION PLAN

- 5.1 Tree 1, is a council street tree of poor structure. It is not worthy of retention and its removal and replacement could be justified, with the approval of the responsible authority.

- 5.2 There are no trees within 71, that are of a condition worthy of retention and therefore they all have a low arboricultural value. They are all proposed to be removed.

- 5.3 There are no trees in 73 that are worthy of retention because of their poor condition. There are several fruit trees in the rear yard, that were not assessed, due to their small size.

- 5.6 Tree 11, is encroached 17% in total. However, 7% of that is for the vehicle crossover and section of driveway in the front setback, before it descends into the basement. If this area is constructed at existing ground level and made permeable, then Tree 13 can be retained in a healthy condition. The large Lemon Scented Gum, whose stump remains, was growing in this area and is likely to have prevented many roots from Tree 11 to encroach into the alignment of the driveway. Thus, it is not expected that roots of Tree 11 will be significantly impacted, if at all.

- 5.7 Tree 13, Is encroached 8.8% by the basement. This is within the 10% allowed in accordance with AS-4970 'Protection of Trees on Development Sites, and therefore can be retained in a healthy condition.

- 5.4 Tree 9, a council owned street tree at the front of 73, is proposed to be removed to allow for the installation of the new driveway crossover. There is opportunity to replace it with a new tree in the nature strip, further north because the crossover to 71 is being removed. Its removal and replacement must be approved in writing by the City of Monash.

- 6.3 The removal of Tree 9, is proposed for the installation of the new crossover. This must be negotiated and agreed to by the City of Monash.
- 6.4 Neighbouring Trees 11 and 13, are encroached by the proposed development. However, engineering solutions, such as the driveway within the front setback, being constructed at existing ground level and made permeable, will allow for encroachments to be reduced below the 10% in accordance with AS-4970 and therefore Trees 11 and 13 can be retained in healthy conditional.
- 6.5 A Tree Management Plan must be prepared and implemented prior to any works occurring on the property, including demolition, to ensure neighbouring trees, to be retained are protected. An arborist must oversee any excavations within the TPZ of Trees 11 and 13 to ensure roots are not indiscriminately damaged.
