Addendum to Arboricultural Report (009978) - Design Review – Brandon Park Shopping Centre

I advise the following in relation to the tree impact assessment undertaken with regard to the proposed Residential and Mixed Use developments in the northeast corner of Brandon Park Shopping Centre, in Wheelers Hill.

1. Residential (TPA/52260)

2. Mixed Use (TPA/52250)

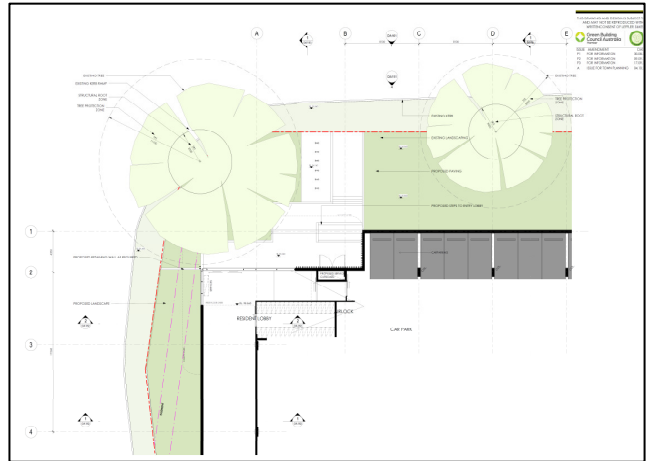
Figure 3. Extract of DA181, 'street interface plan'.

- b. **Ground floor:** As shown in Figure 2, the ground (lowest) floor of the proposed residential building would intercept the TPZ of Tree 55 by ~4.7%. This is considered minor TPZ encroachment under the Australian Standard (AS4970) and this level of incursion is not expected to impact the tree's ongoing viability or condition. It is noted in Figures 5&6, that fill is proposed between the new building and both tree stems. The following is recommended to prevent fill impacts to the tree root zone:
- i. The level of the existing permeable environment should remain unaltered.
 - ii. Fill over the existing asphalt area will likely be tolerated although this should be kept to a depth of <100mm within 5 metres of the trees.
 - iii. If a retaining wall is required to achieve this, the wall should be supported by isolated pegs or similar, i.e. a continuous strip footing should not be used.

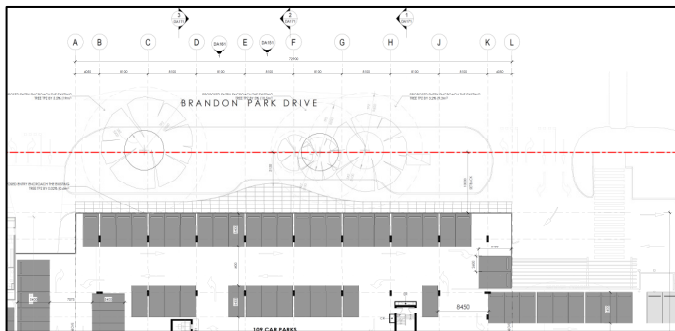
Figure 13. Extract of DA101 – Proposed level 1 plan.

- c. **Above ground floors:** The section diagram at Figure 14 measures the relative setback of the building edge to the site boundary at ~10m. This should be sufficient space for construction activities to take place without requiring any canopy pruning. The only part of the design that comes closer is the architectural canopy extending from the first floor, although as shown in Figure 13, this is positioned outside the canopy of the larger trees so it is also not expected to necessitate any canopy pruning.
