G0092:RPH 29327 Doc Review 52 Golf Rd, Oakleigh Sth-Rev01

## Desktop Review of Environmental Assessment Reports for 52 Golf Road, Oakleigh South, Victoria

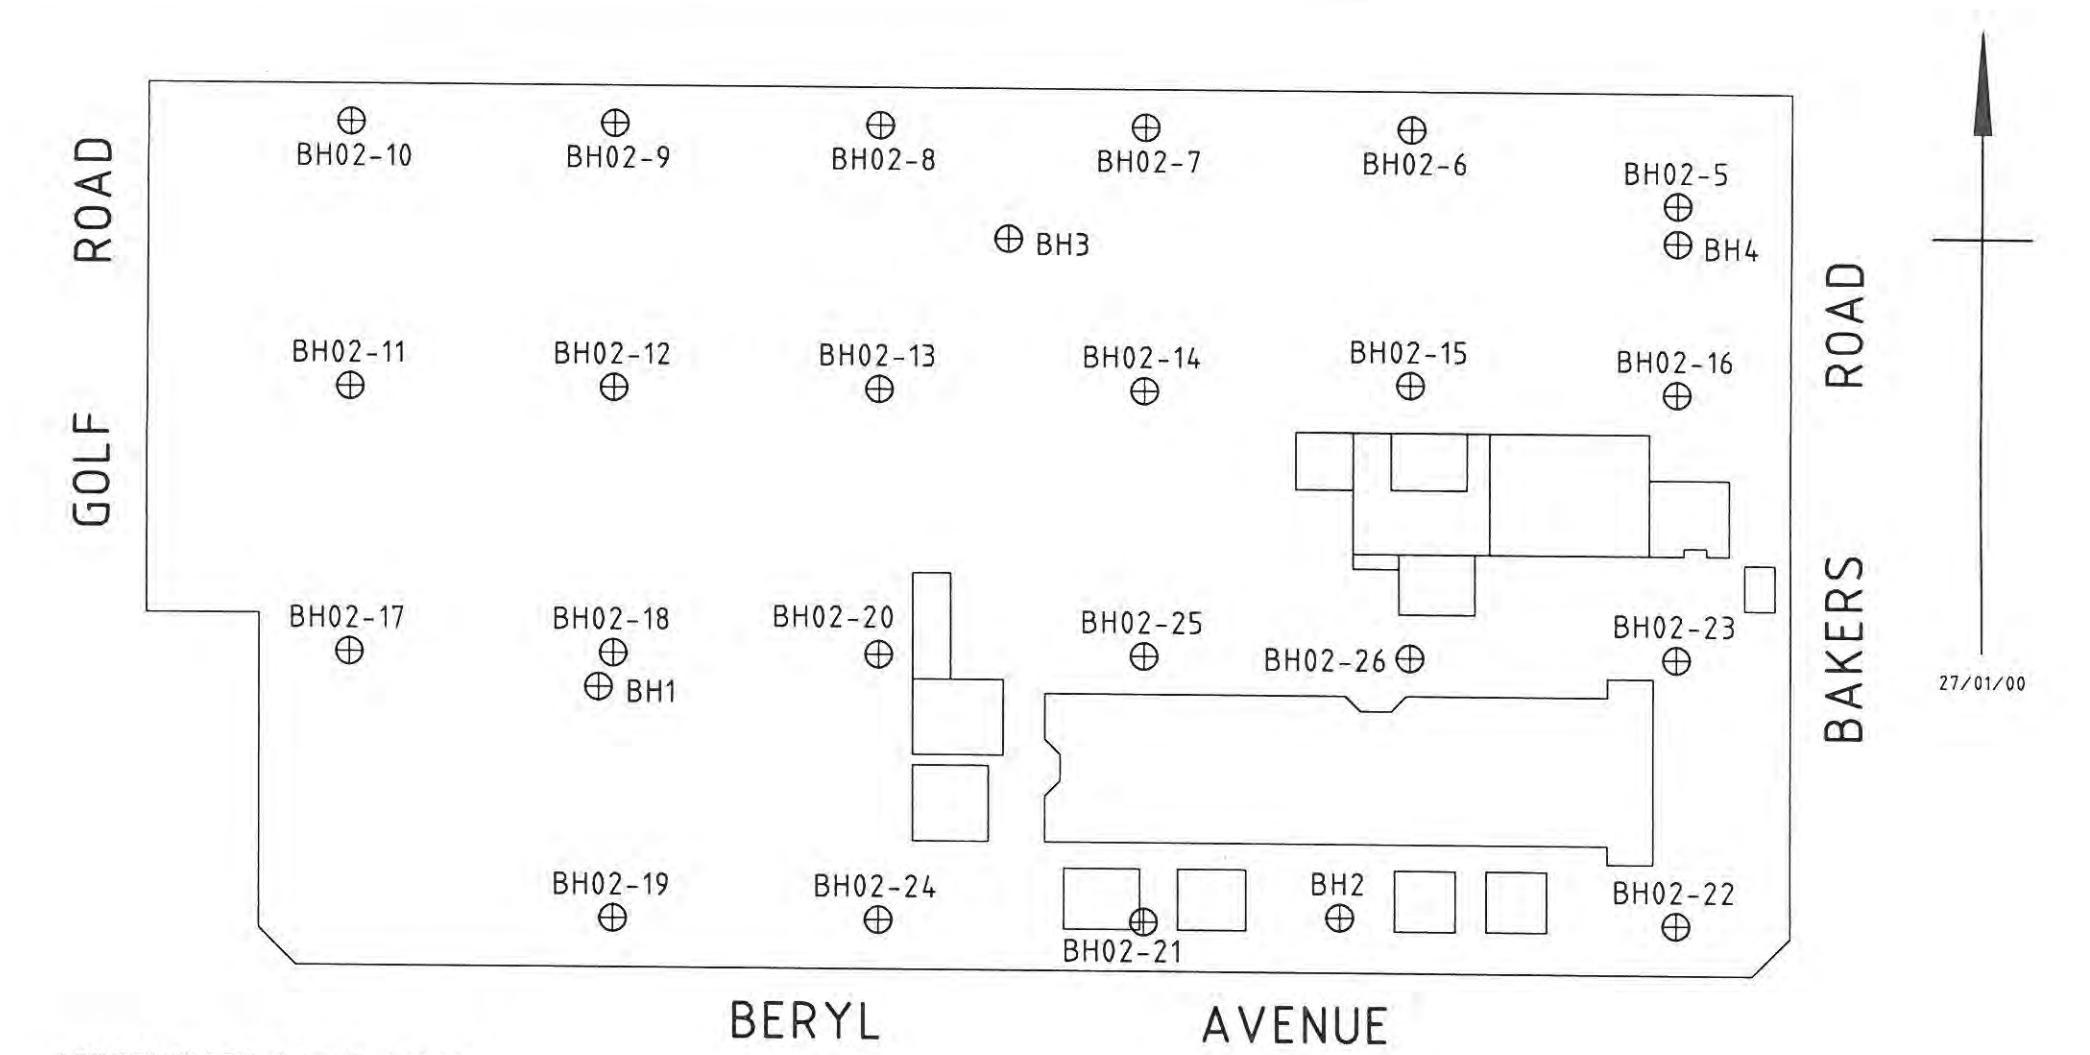
APPROXIMATE SCALE 1:1000
⊕ BH1 DENOTES APPROXIMATE LOCATION OF BOREHOLES.

Beveridge Williams completed a contamination assessment at the Site in 2003, which included establishment of twenty-two (22) gridded boreholes (BH02-05 to BH02-26), with soil samples collected throughout the soil profile. A site plan depicting the sampling locations has been attached to this report **(Attachment B).** The figure also identifies four (4) boreholes (BH1 to BH4) previously established by Beveridge Williams in 2000.

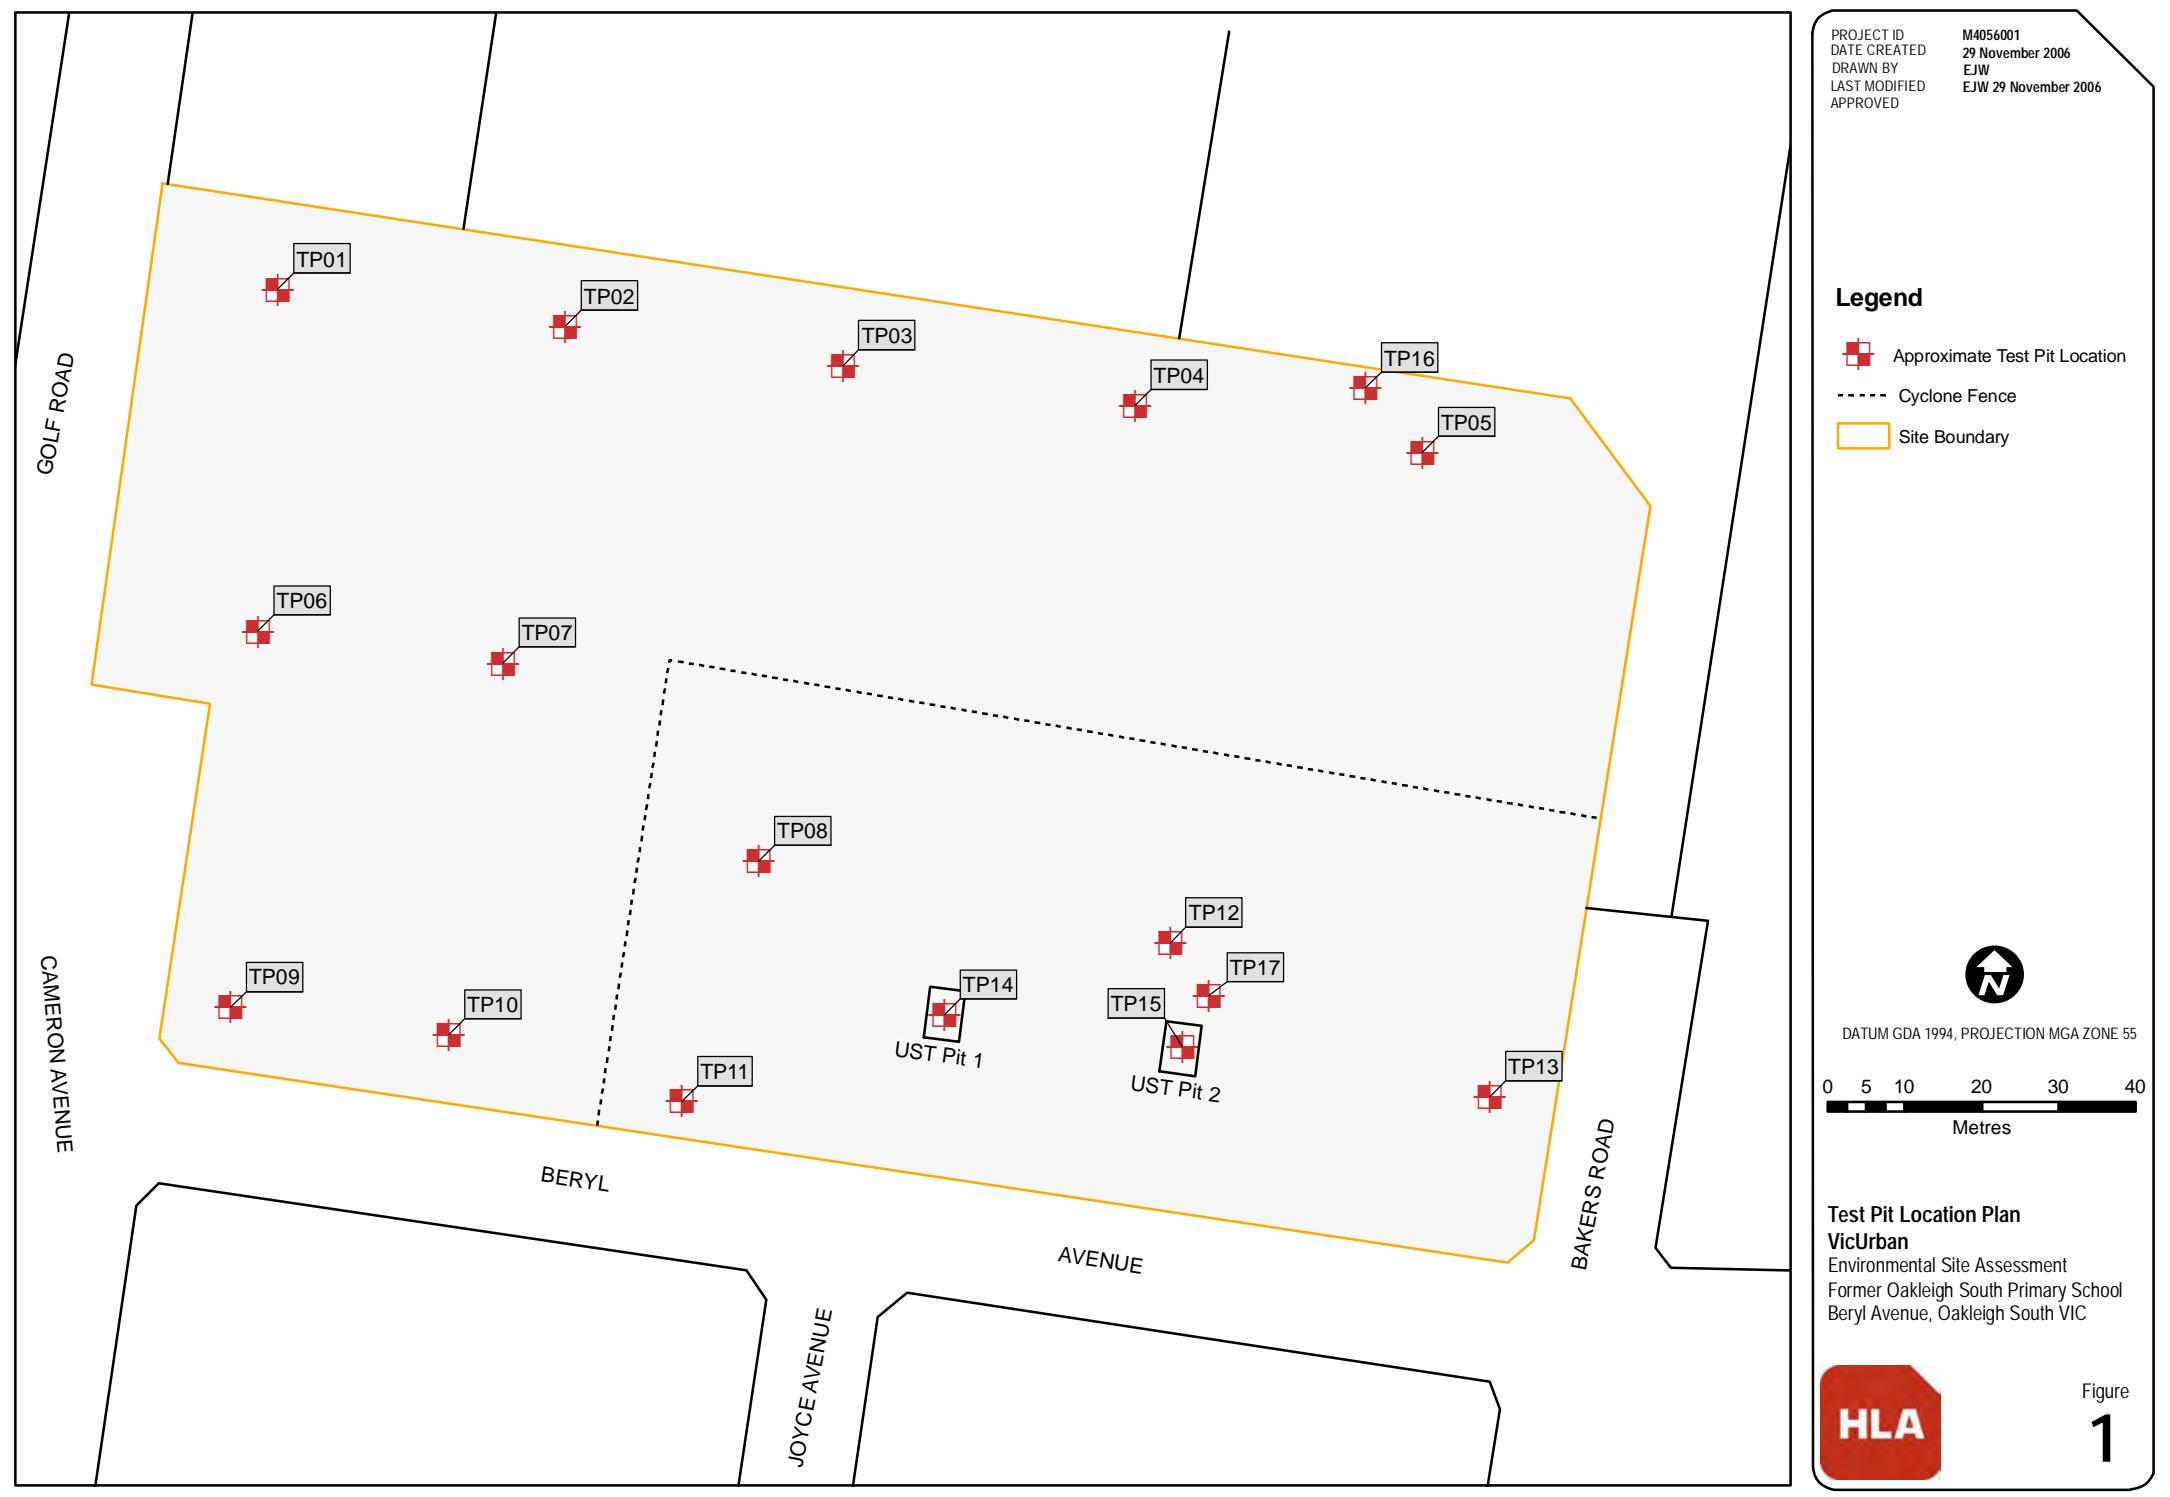
HLA completed an environmental site assessment at the Site in 2006. It is noted that Prensa only had access to the body of the report and limited attachments (one (1) figure and bore logs only). The assessment included excavation of 17 test-pits across the site, to target previously identified fill and to target two (2) former UST pits. A site plan depicting the sampling locations has been attached to this report **(Attachment C)**.

Fill was encountered to depths of 0.4 m to 0.9m bgl in the west, central and southern areas of the site. Fill consisted of 'reworked natural' (silty sand and sandy clay) containing varying amounts of gravel, basalt fragments, brick fragments, and concrete. PID results were not recorded on the test pit logs. The test pit logs have been attached to this report **(Attachment C)**.
