re: 1041 Centre Road, Oakleigh South

Introduction

I am informed there is proposed to be a re-development of the above site. Currently the property is largely covered with a warehouse and concrete car park. Galbraith and Associates has been requested by the Pellicano Group to report on each tree or group of trees located within and close to the site. Each is discussed in terms of its species type, size, condition, origin, whether native as defined under the planning scheme, DBH, height by spread, worth for retention in any re-development and tree protection zones as per the relevant Australian Standard.

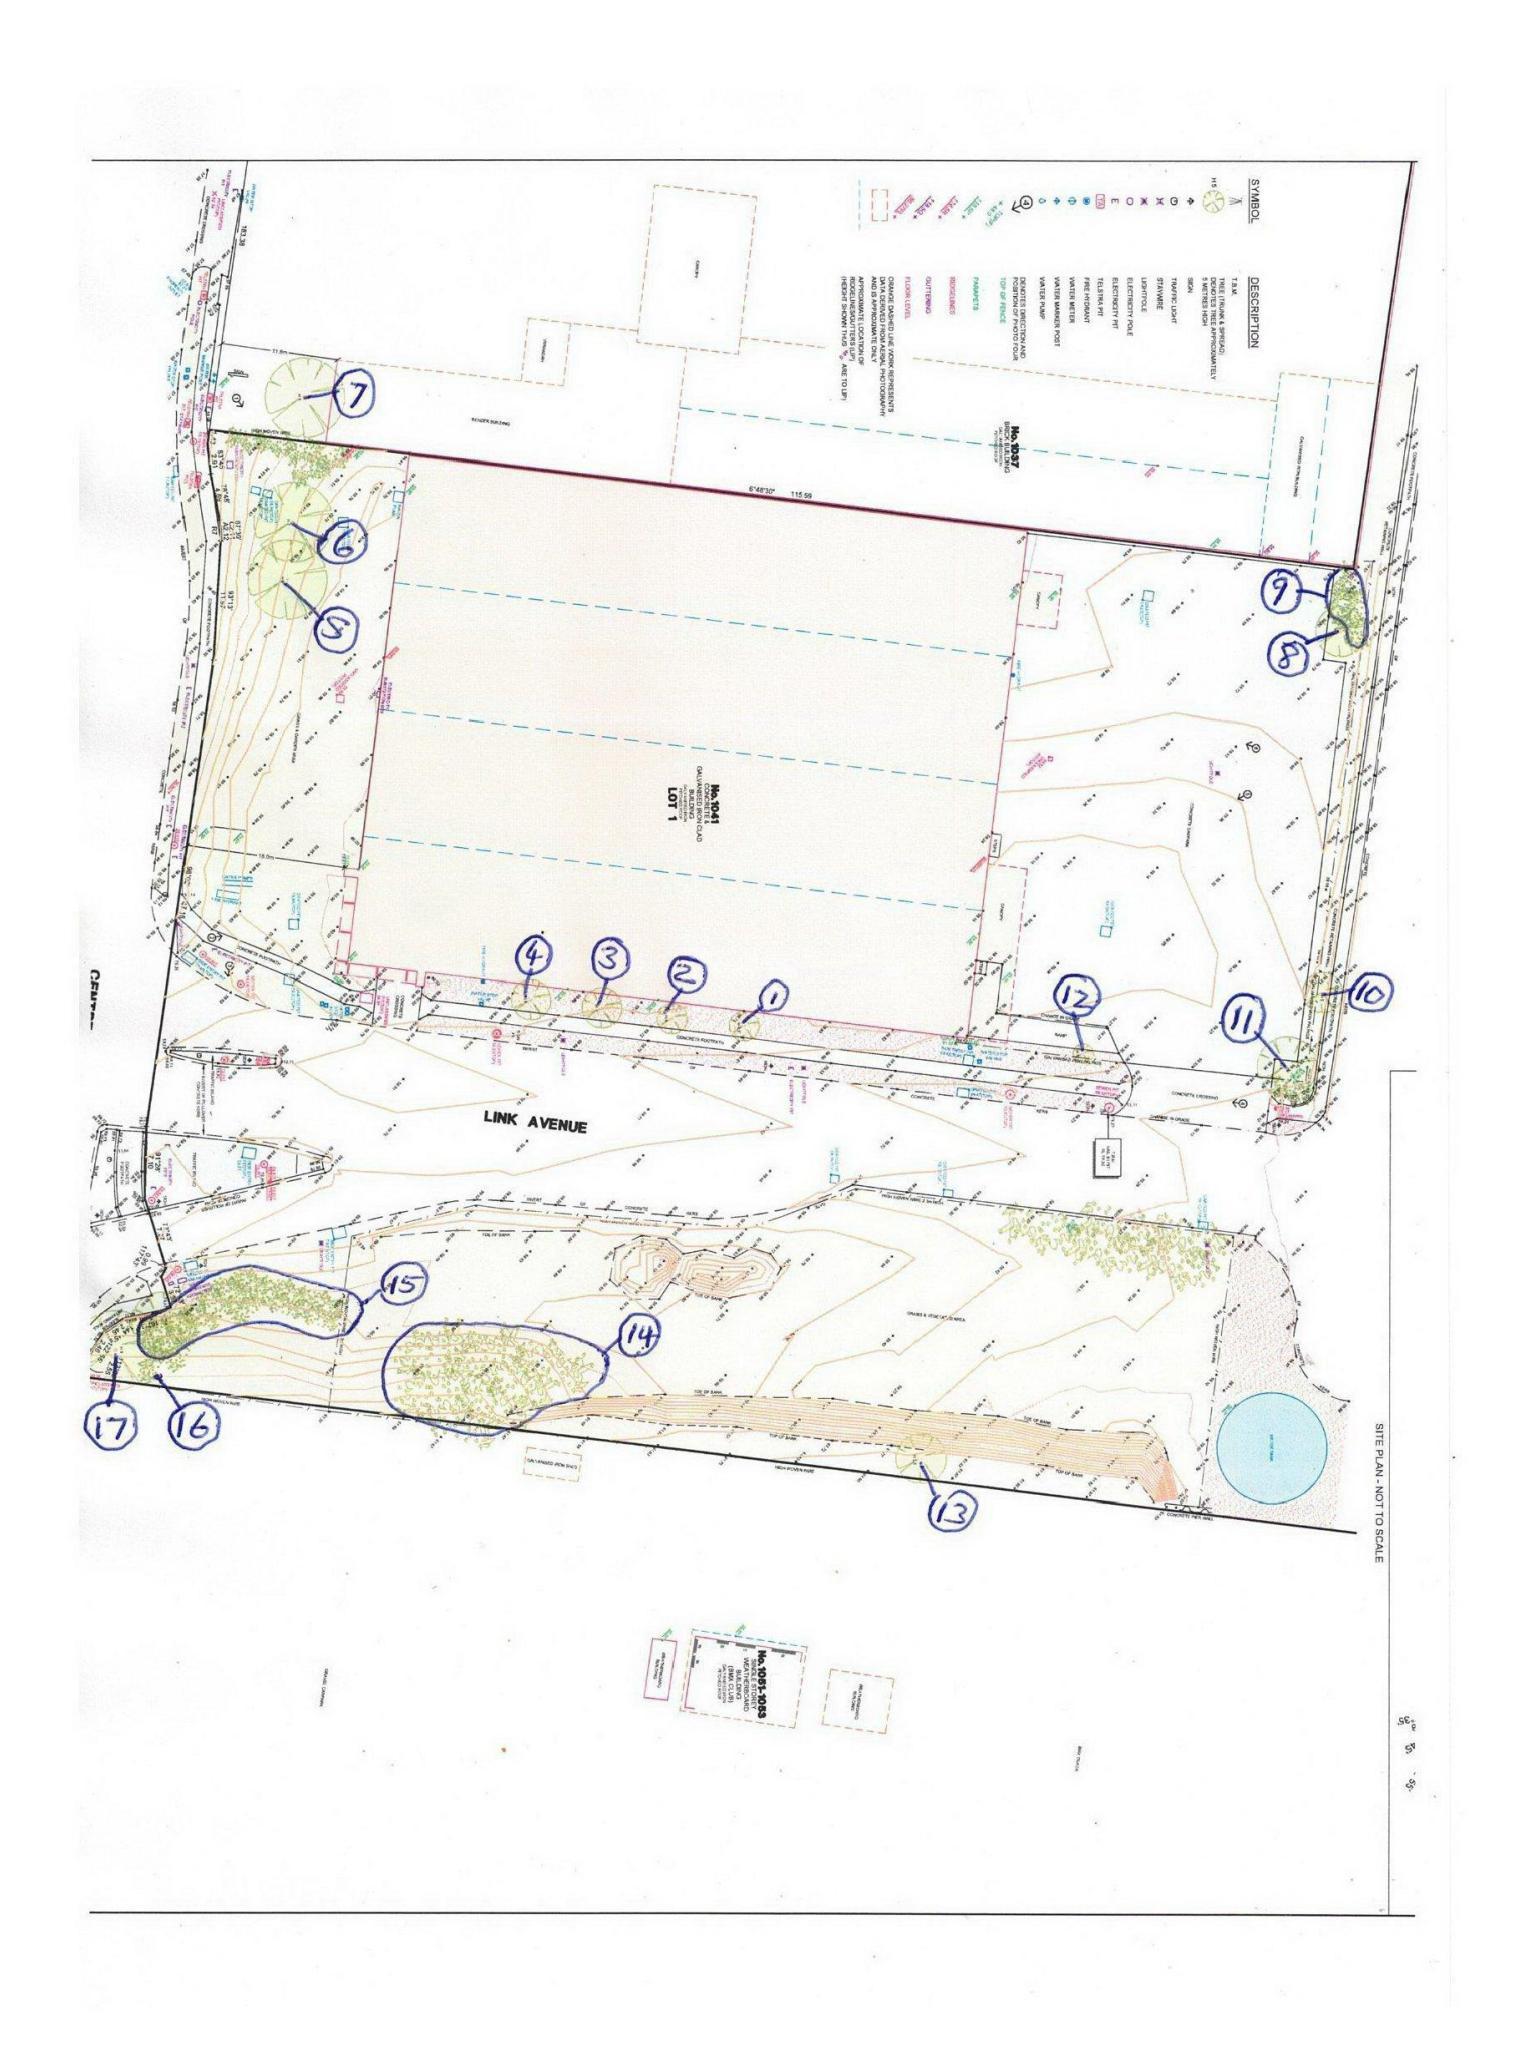
Each tree is located and numbered on the accompanying extract of the existing site conditions survey on page 2 and described on page 3.
