Strelden Avenue, Huntingdale

MAP - Removals, Replacements and Infill Planting

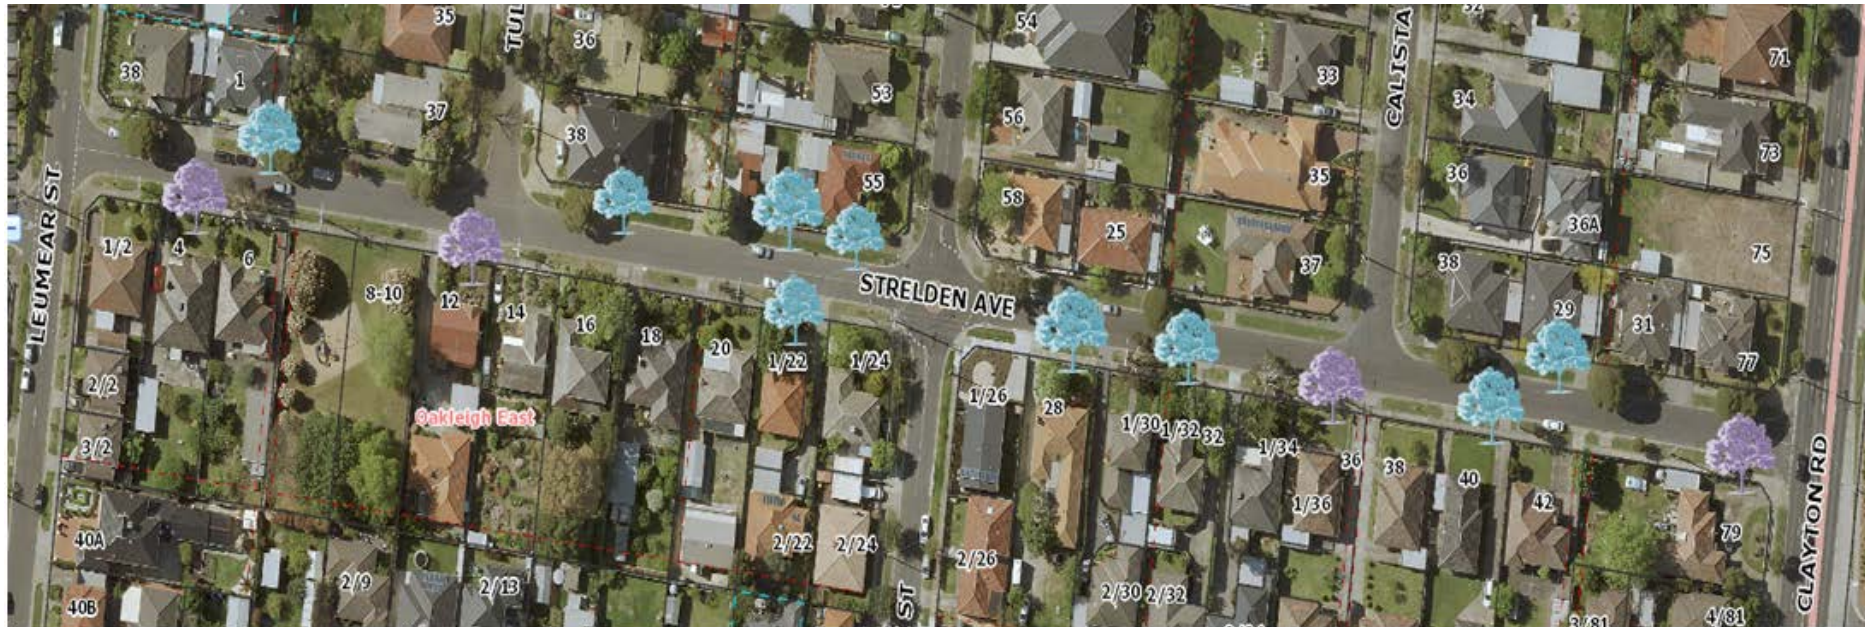
The map below details the removals, replacements and infill plantings. All other trees have been assessed as having more than 2 years useful life and will be retained.
